Andrewsville Bridge Site No. 015-0013

Investigation and Recommended Rehabilitation Report

McCORMICK RANKIN
CORPORATION

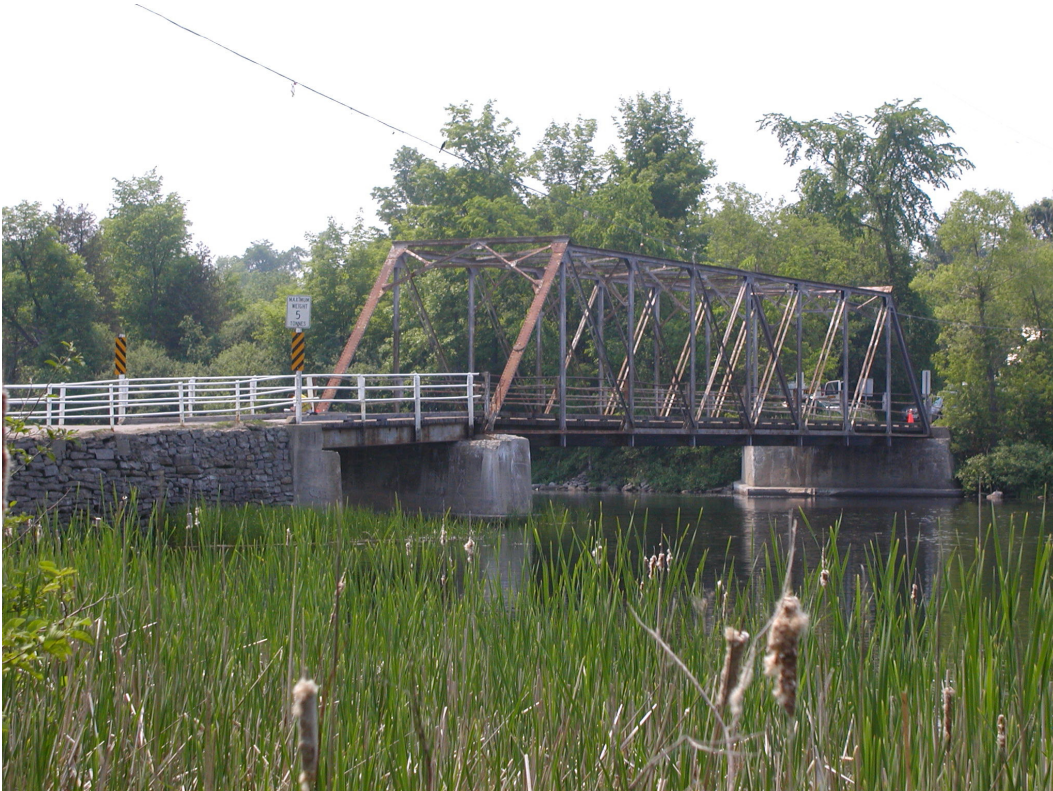
Photograph 1: North elevation of Andrewsville Bridge.

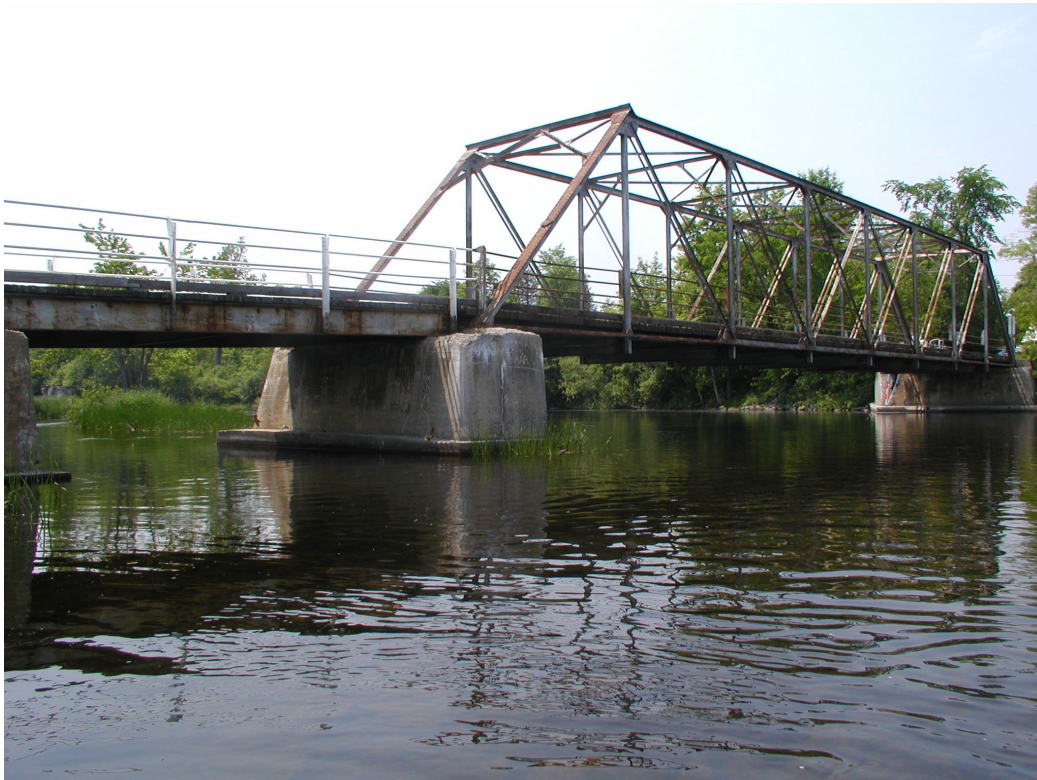
Photograph 2: Detail of truss span and slab on girder span.

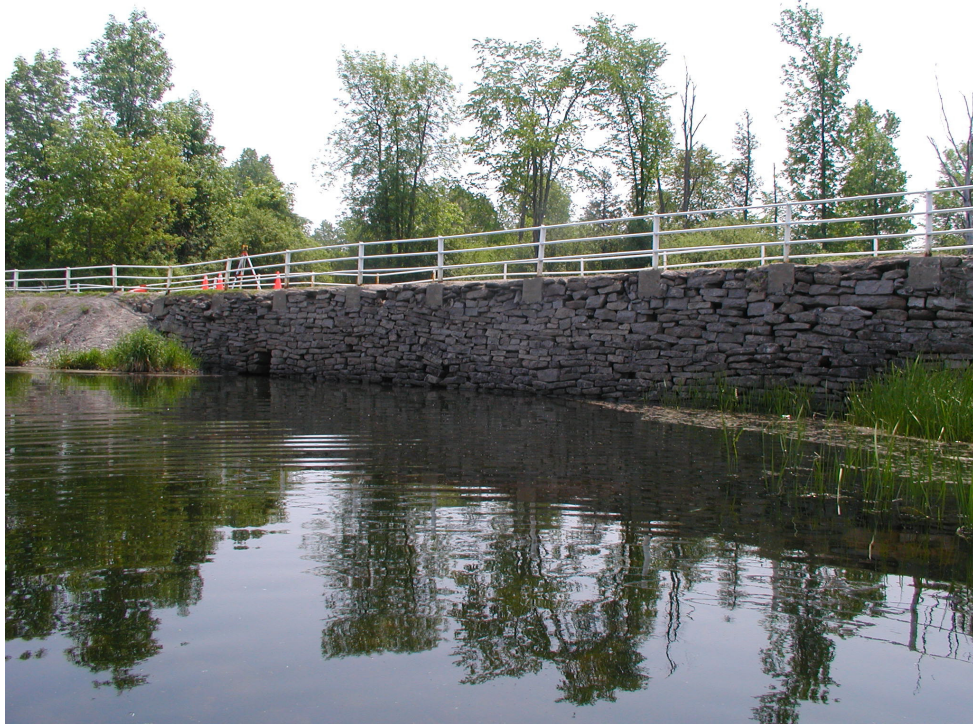
The fills in the east approach are retained by an ungrouted masonry retaining wall (photograph 3). The wall is in fair to poor condition. The wall has settled on the south side, which has deformed the guiderail (Photograph 34).

Similar to the bridge railing, the approach railing is substandard and has been damaged in several locations. On the east approach, the railing posts are cast into concrete blocks that sit on an ungrouted masonry wall (Photograph 3).

Photograph 3: North elevation of east stone retaining wall.

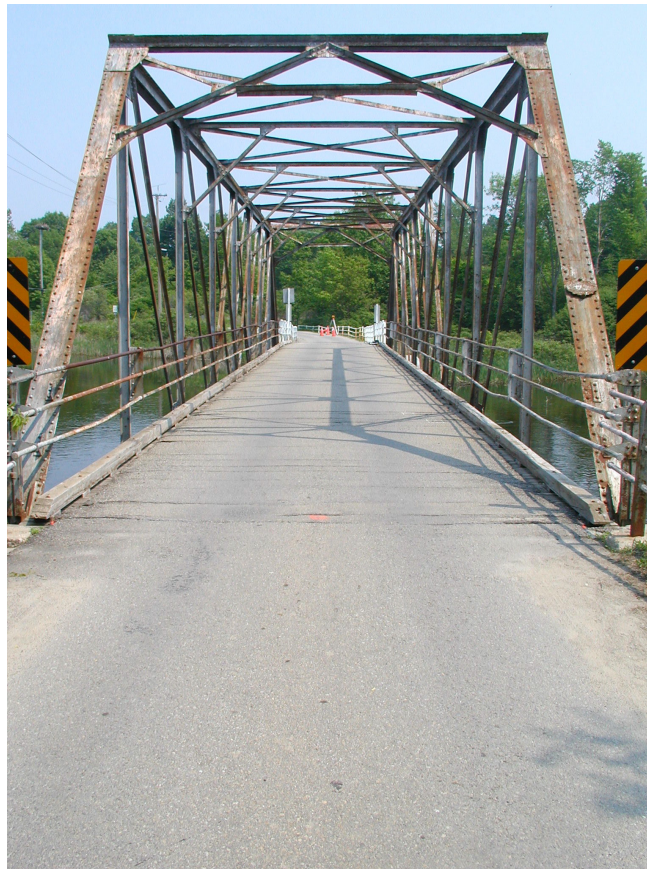
The bridge railing, consisting of 3 x 50 mm diameter hollow tubular steel sections mounted to the truss members exhibits extensive light to medium corrosion and has been damaged in several locations (Photograph 4). The bridge railing is substandard with respect to current code requirements.

Photograph 4: View across truss span, looking east.

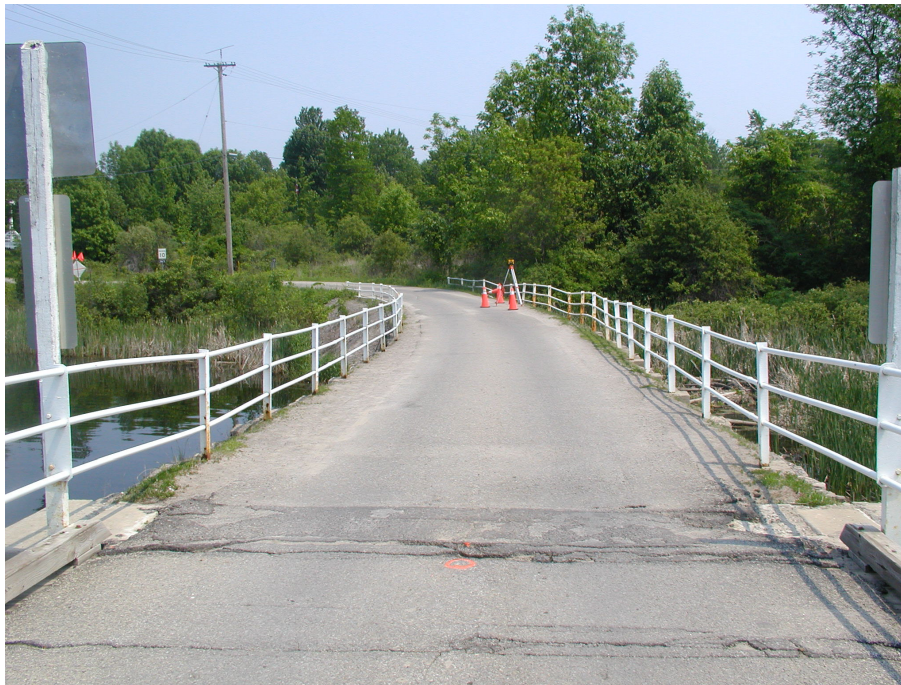
Photograph 5: View of east approach, looking east from East Abutment.

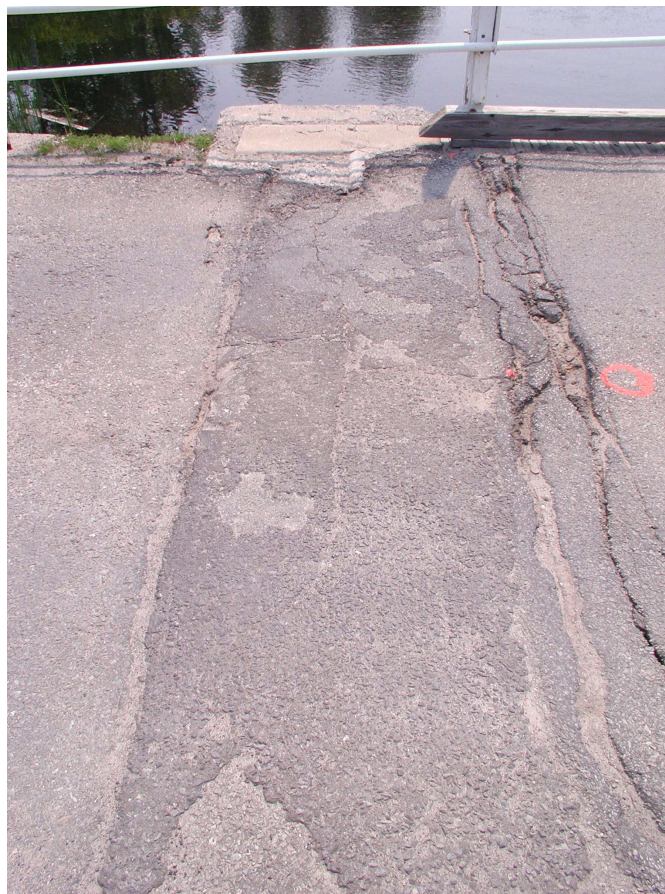
Photograph 6: East expansion joint, looking south.

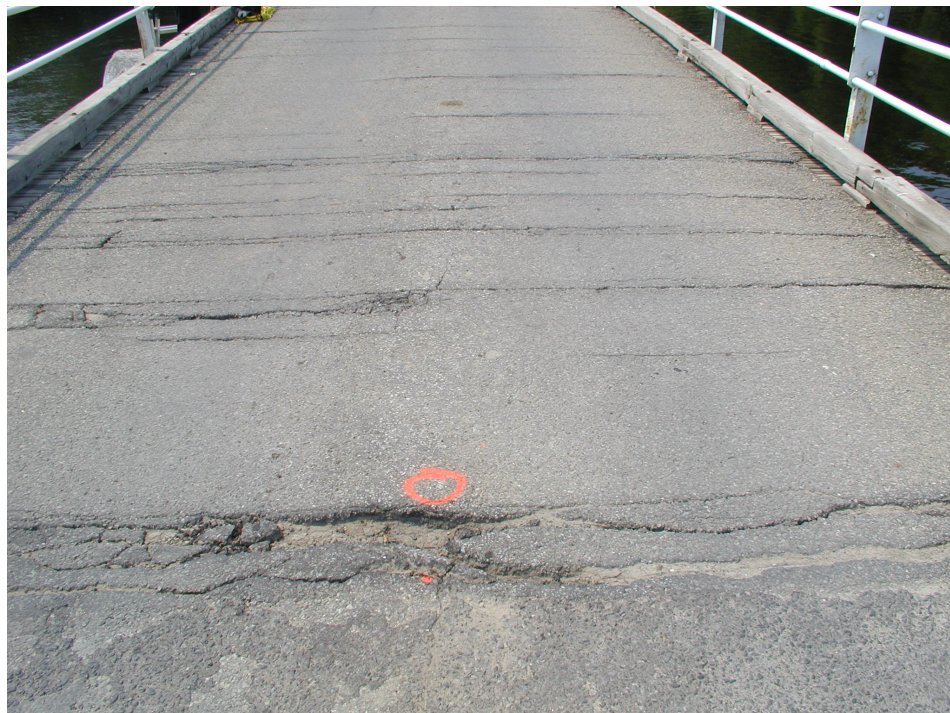
Photograph 7: View of west expansion joint, looking east.

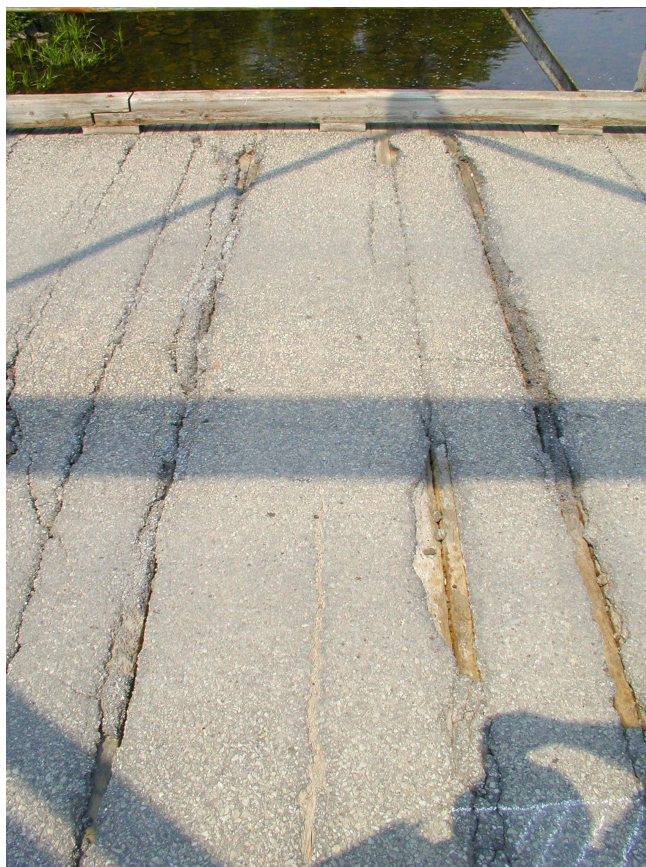
Photograph 8: Detail of asphalt deterioration on timber deck.

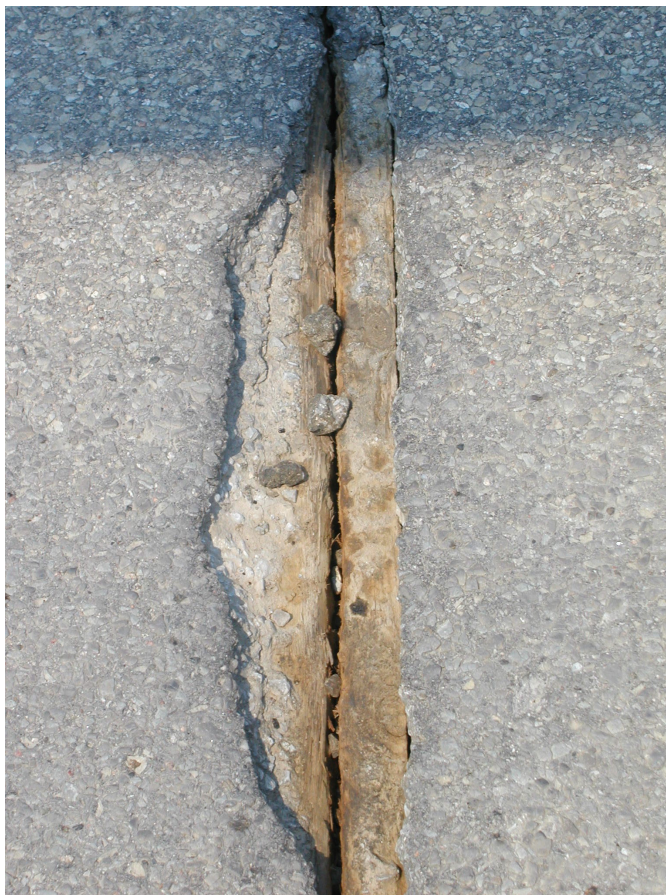
The timber deck is in fair to poor condition. The timbers are connected to the stringers with steel clip angles (Photograph 18). At many of these clip angles, the timbers have separated (Photograph 9), permitting runoff through the timbers. The runoff has removed the protective creosote in these locations, and there is evidence of brown and white rot in the timbers (Photographs 10, 11, 12). The asphalt wearing surface has also failed in these locations (Photographs 7 and 8). The deck has separated from the steel stringers in several locations and the timbers were observed to deflect upwards under traffic loads. There is evidence of numerous previous repairs to the asphalt over the expansion joints (Photograph 6).

Photograph 9: Detail of deteriorated asphalt showing gap between underlying timbers.

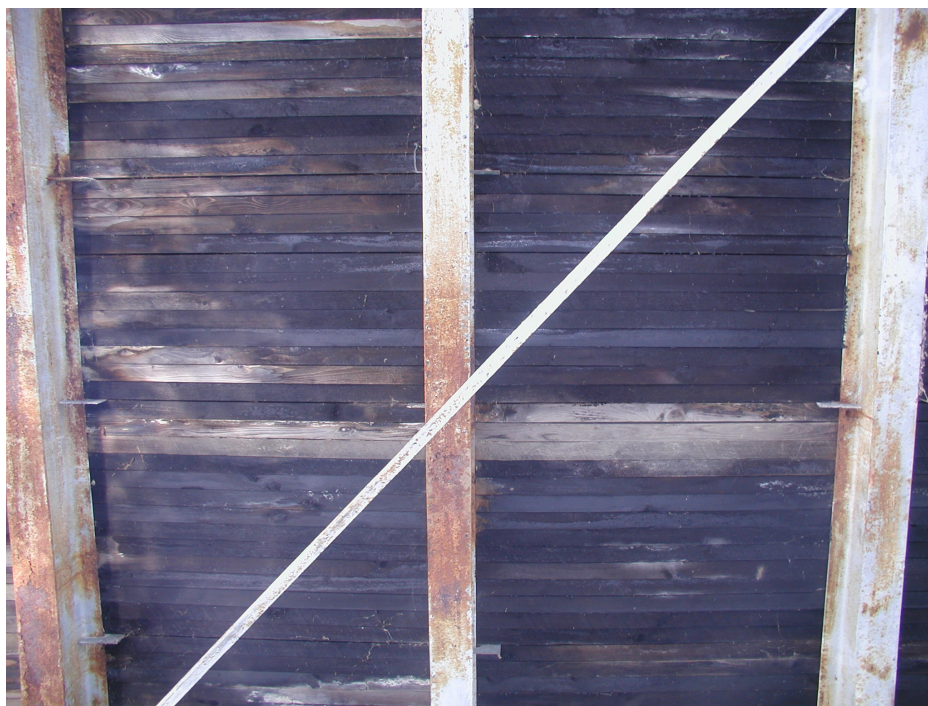
Photograph 10: Typical condition of underside of deck.

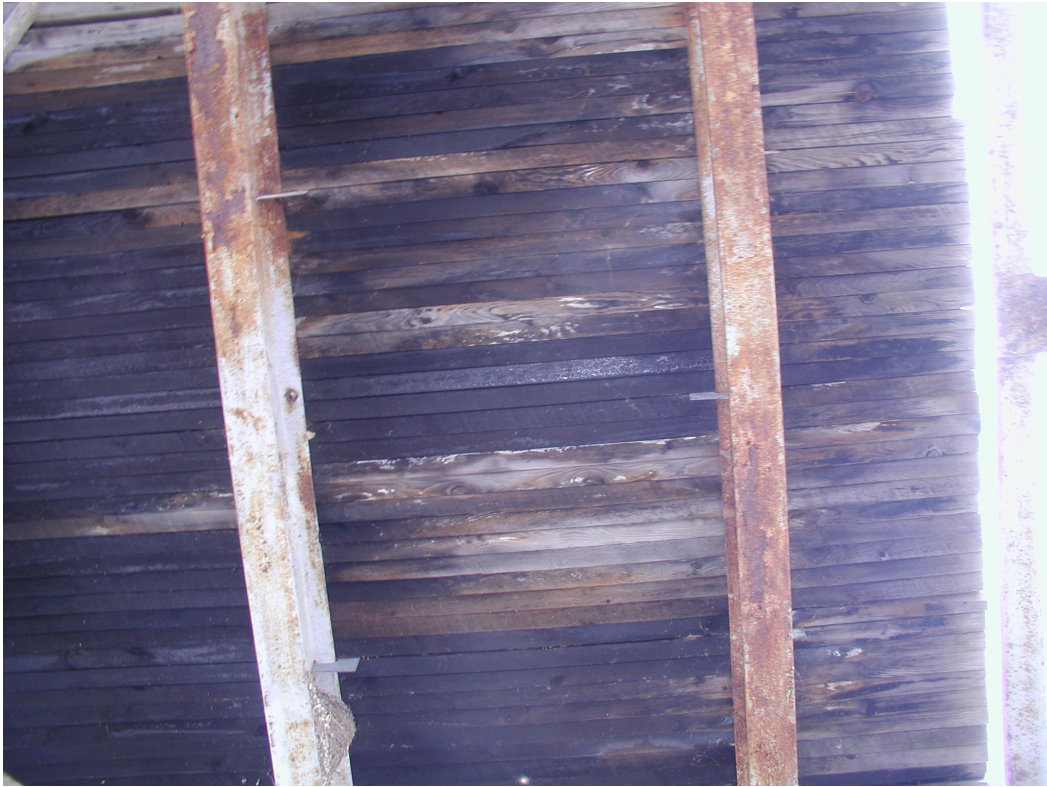
Photograph 11: Exterior stringers typically exhibit more corrosion than interior stringers.

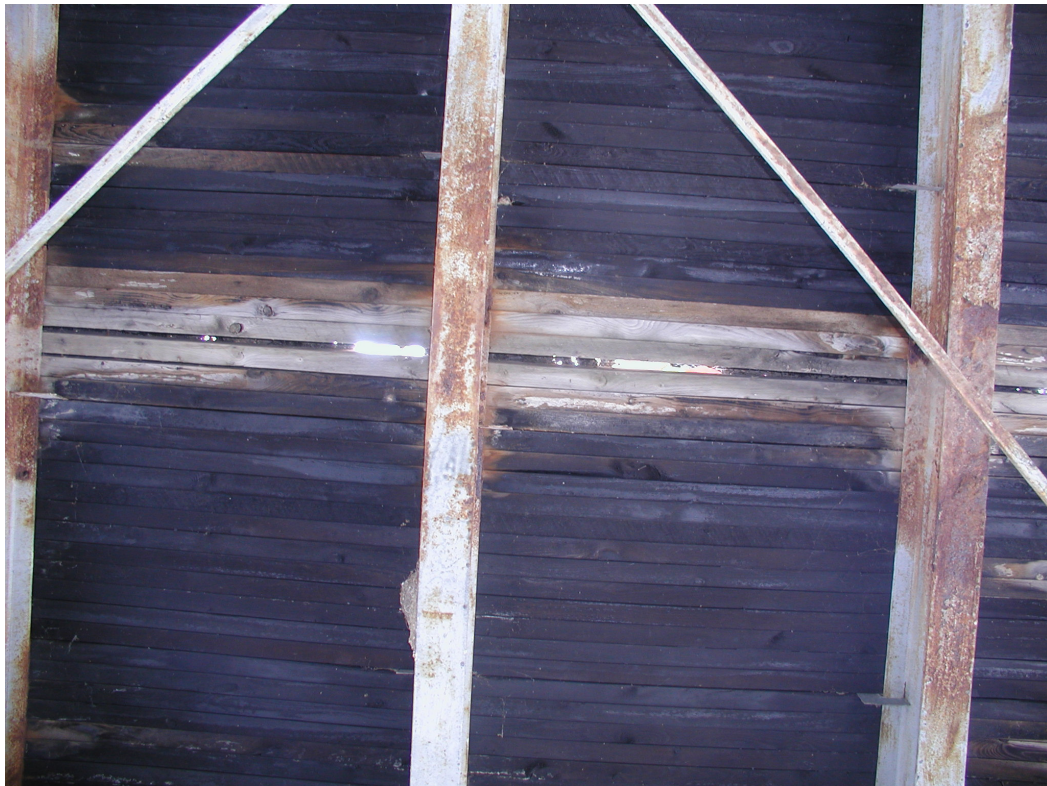
Photograph 12: Creosote is generally missing on timbers in locations of gaps, which have allowed penetration of water.

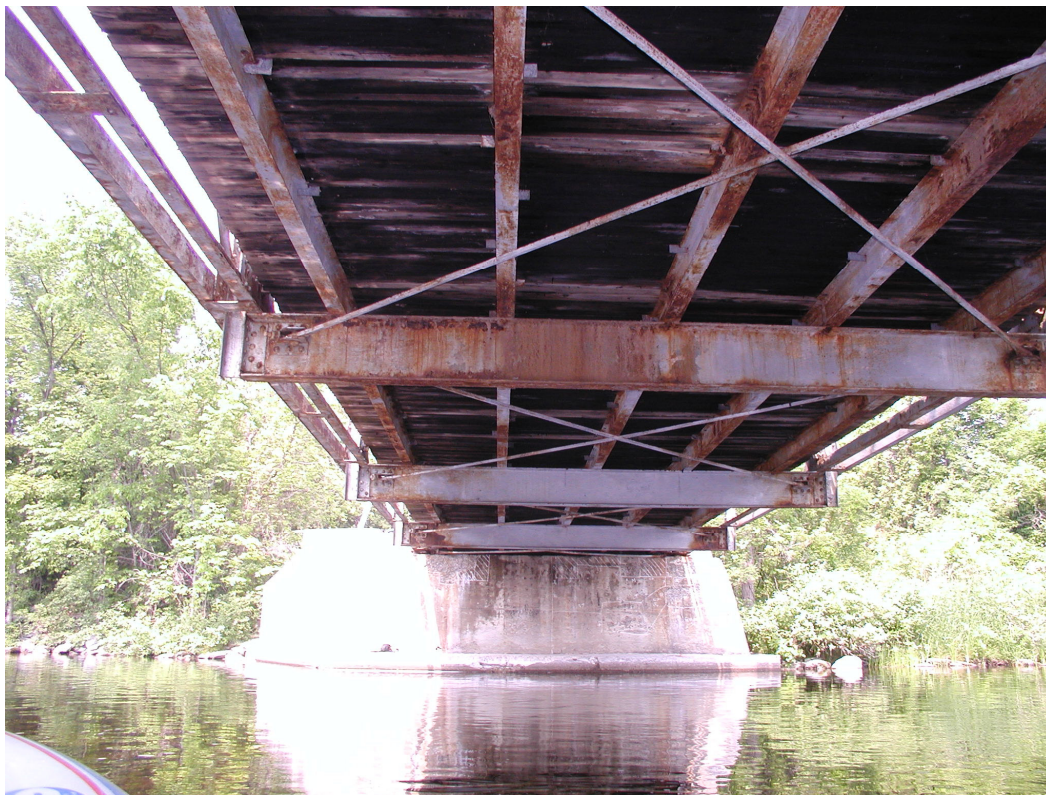
Photograph 13: Configuration of below-deck structural steel in truss span.

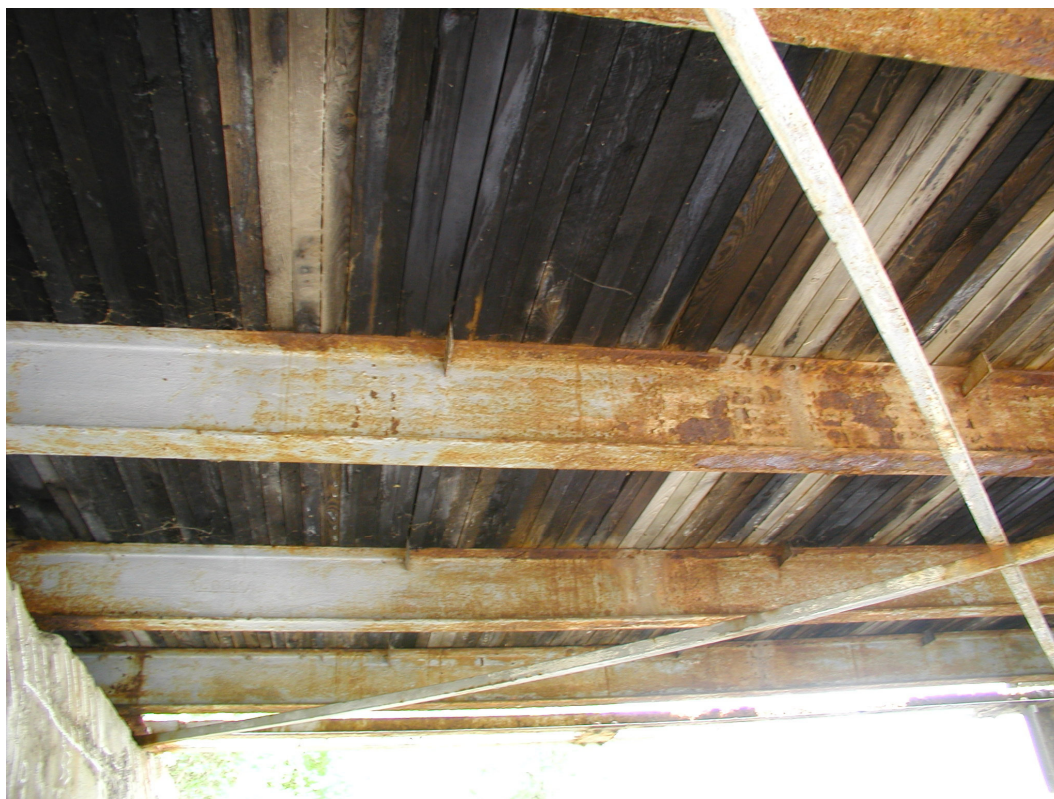
Photograph 14: View of longitudinal stringers and deck just west of pier.

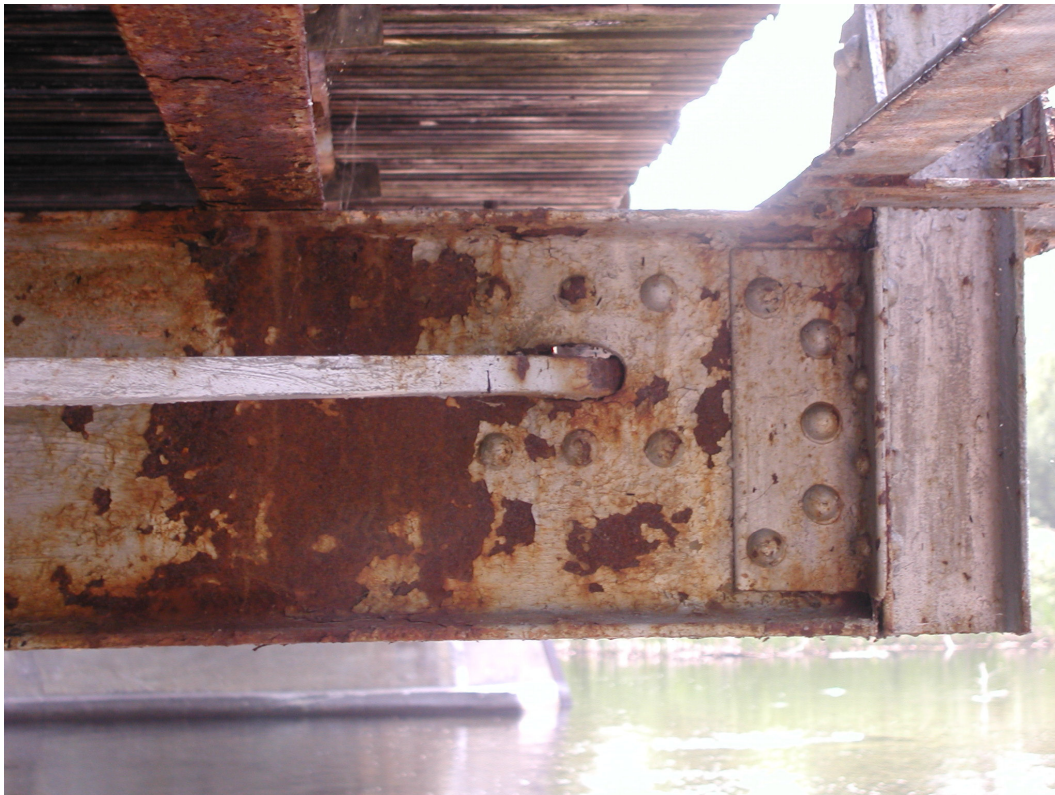
Lateral bracing for the steel floor system is provided by square iron bars that are anchored to, and pass through, the floorbeams (Photographs 15 and 16). The bracing is in fair to poor condition.

Photograph 15: Detail of cross-bracing as it passes through the web of the floorbeam.

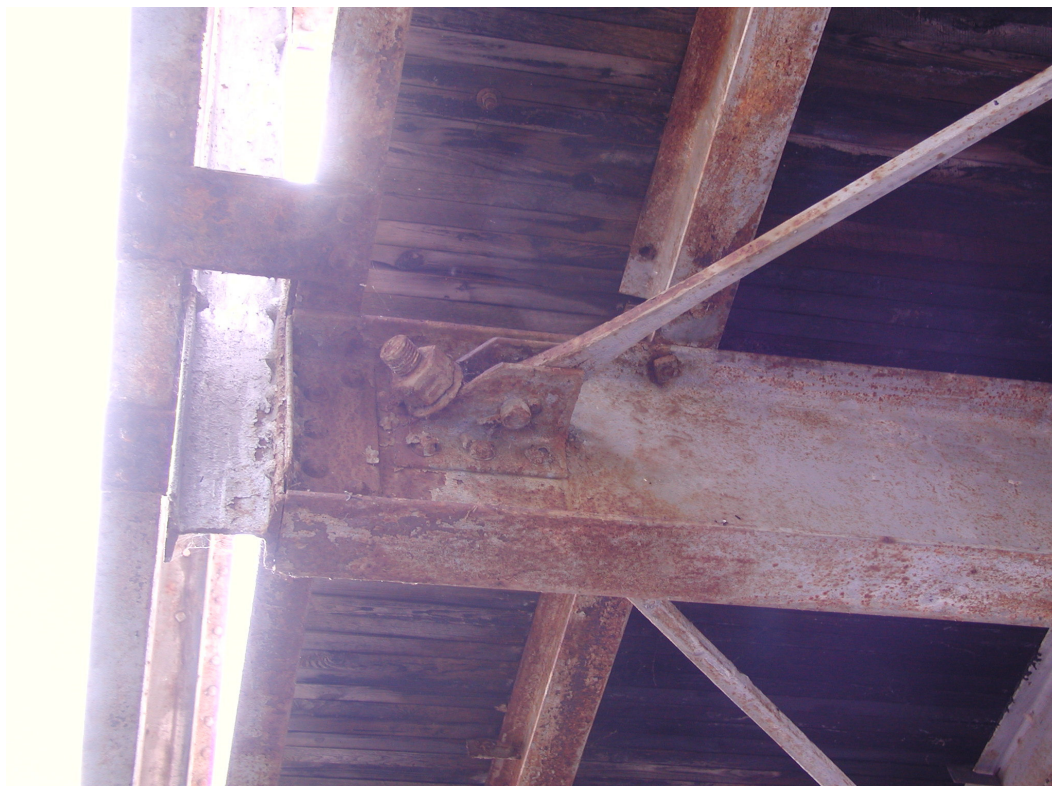
Photograph 16: Detail of cross-bracing connection at floorbeam.

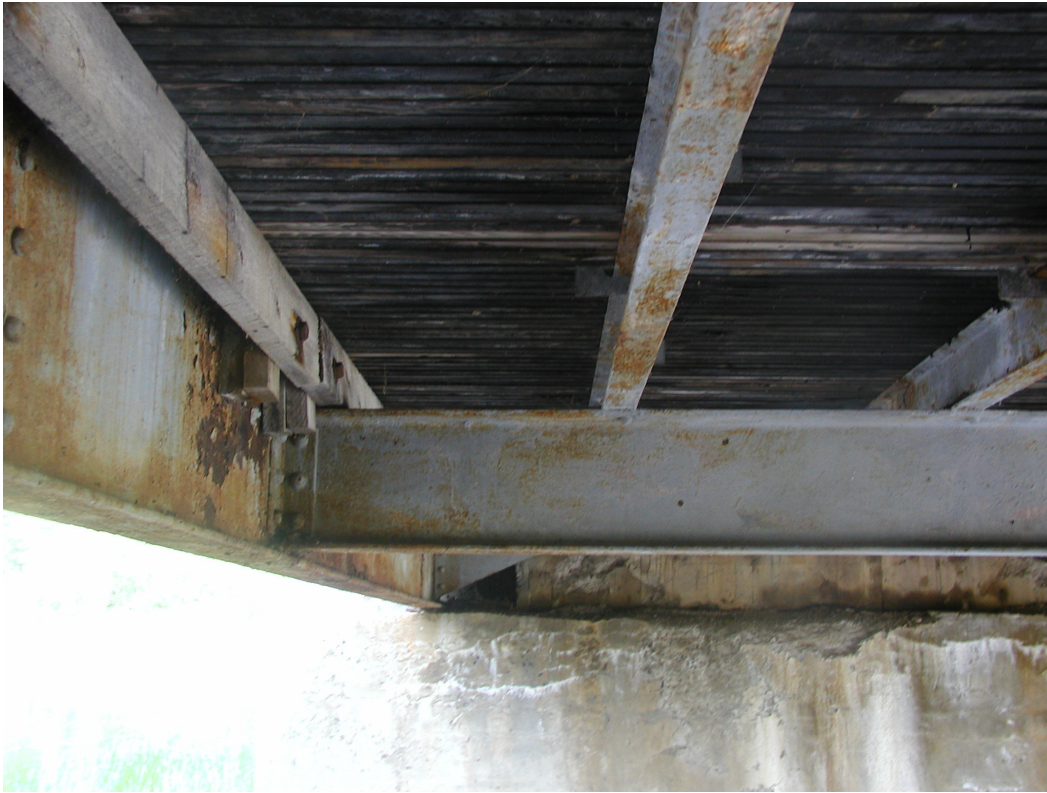
Photograph 17: Configuration of below-deck structural steel in slab-on-girder span.

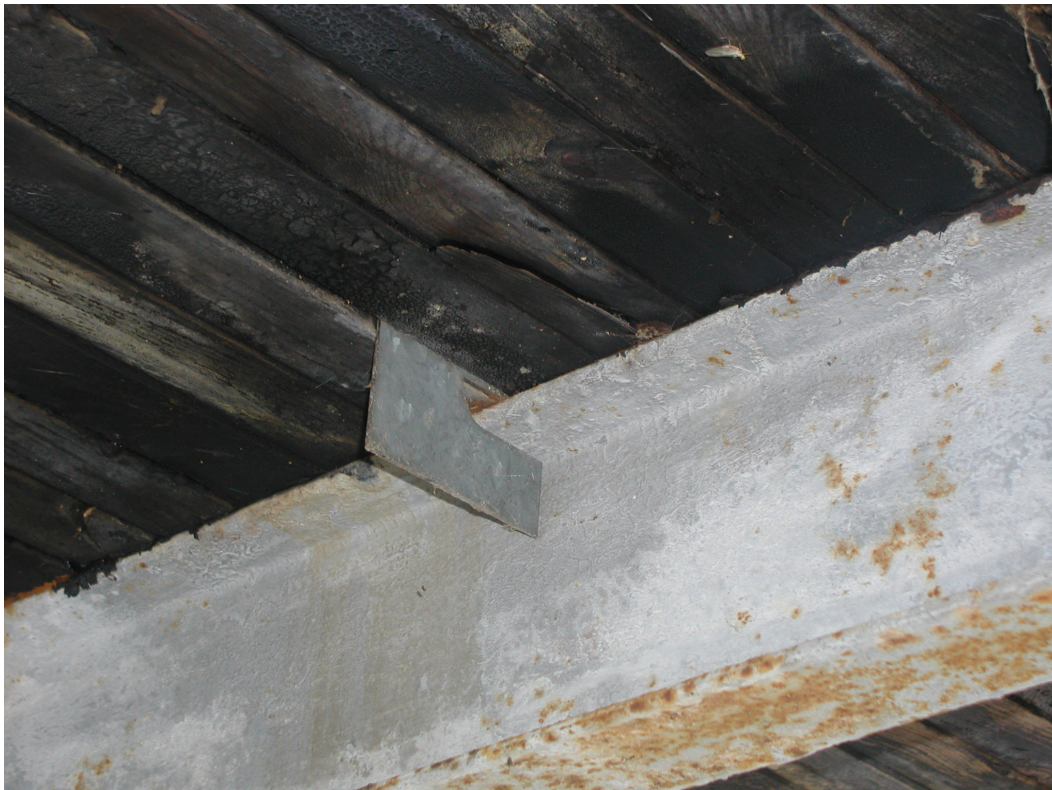
Photograph 18: Detail of clip attaching deck to stringer,

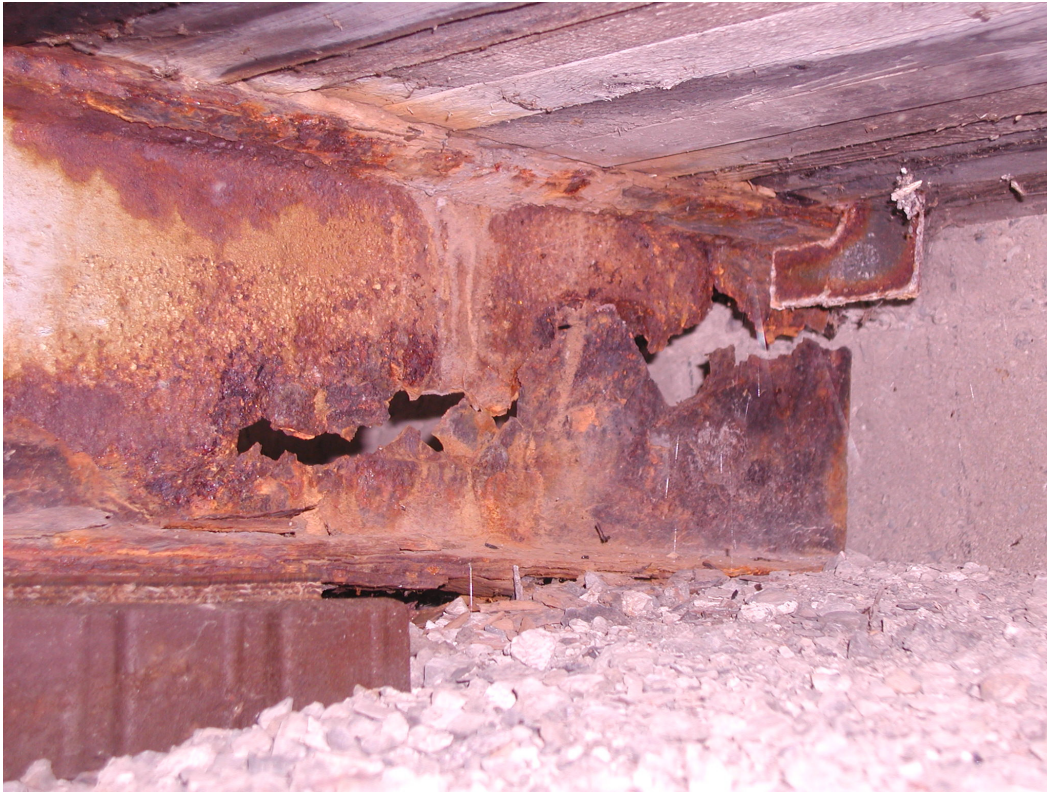
The steel truss is in fair condition, with widespread light corrosion and minor section loss throughout. The structural steel in the truss is typically in better condition above deck than below deck. The below deck steel floor system consists of longitudinal stringers and transverse floorbeams, which are suspended below the bottom chord in the truss span (Photograph 13) and tie into the exterior girder in the short span (Photograph 17). The steel floor systems are generally in fair condition, with the exception of the stringers at the West Abutment, which exhibit very severe section loss (Photographs 19 and 20).

Photograph 19: Very severe section loss in web of middle stringer, West Abutment.

It is recommended that the webs of three of the stringers in the truss span at the West Abutment be strengthened by replacing a section of the deteriorated stringer. It is further recommended that this work be undertaken in the fall of 2005. The cost for this work is estimated to be \$7,000.00.

Three of the stringers supported on the West Abutment exhibit very severe deterioration and it is recommended that they be repaired immediately by removing a 600 mm long section of the deteriorated stringer and replacing it with a section of S200x27. A complete scope of work for, and details of, the repair may be found in Appendix B.

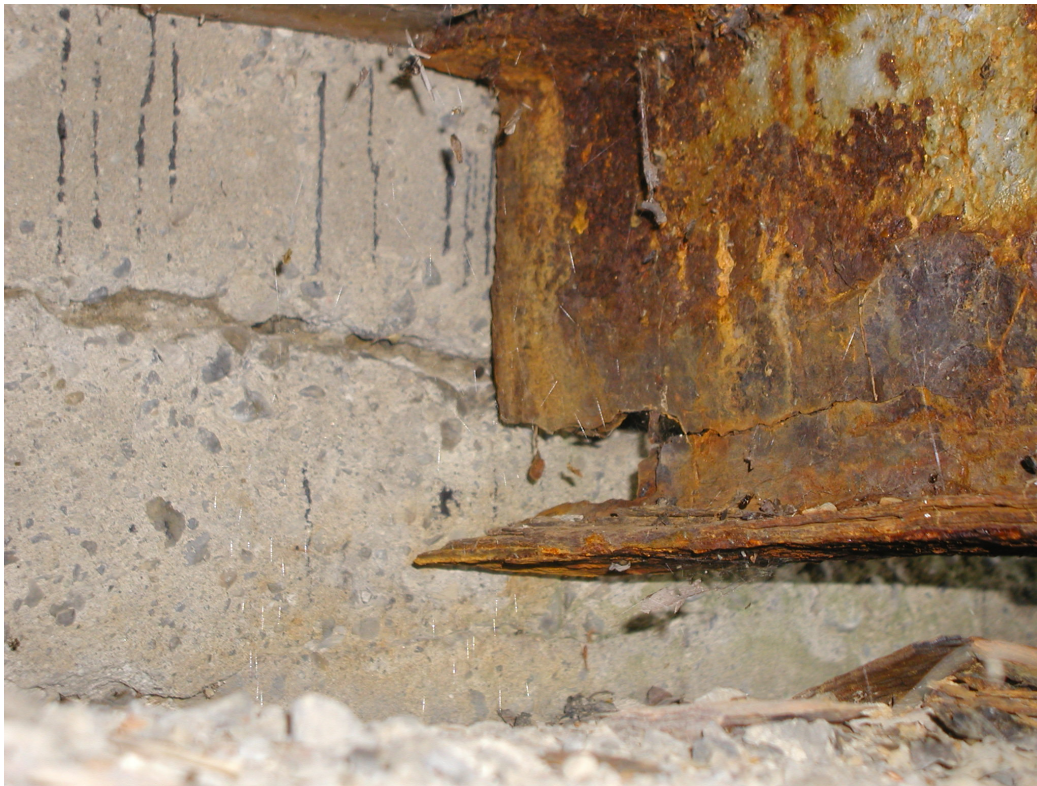
Photograph 20: Section loss and crack in web of exterior stringer, West Abutment.

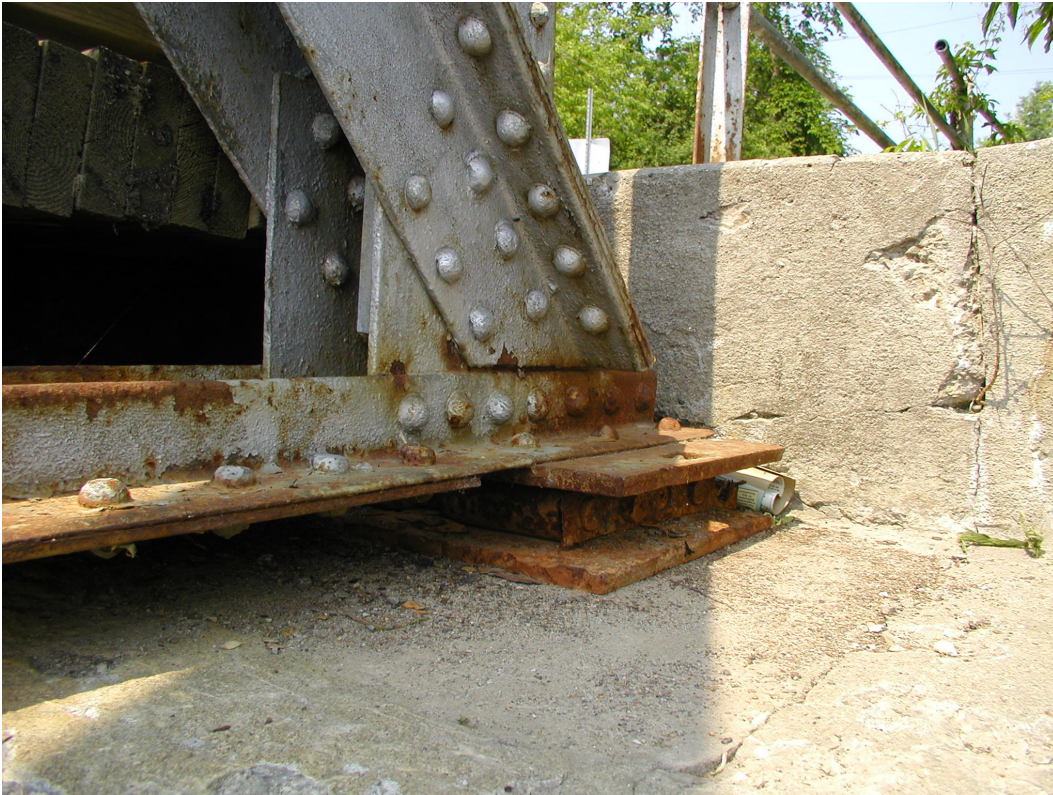
The truss bearings are fixed steel bearing plates at the pier and nested roller bearings at the West Abutment. The north roller bearing is in poor condition (Photographs 21 and 22), and the south roller bearing is in fair to good condition (Photograph 23). The longitudinal stringers on the truss do not tie into the transverse floorbeams at the bearings, but are individually supported on brick bearing pads (Photograph 24). The short span is fixed at both ends.

Photograph 21: Bearing configuration at West Abutment.

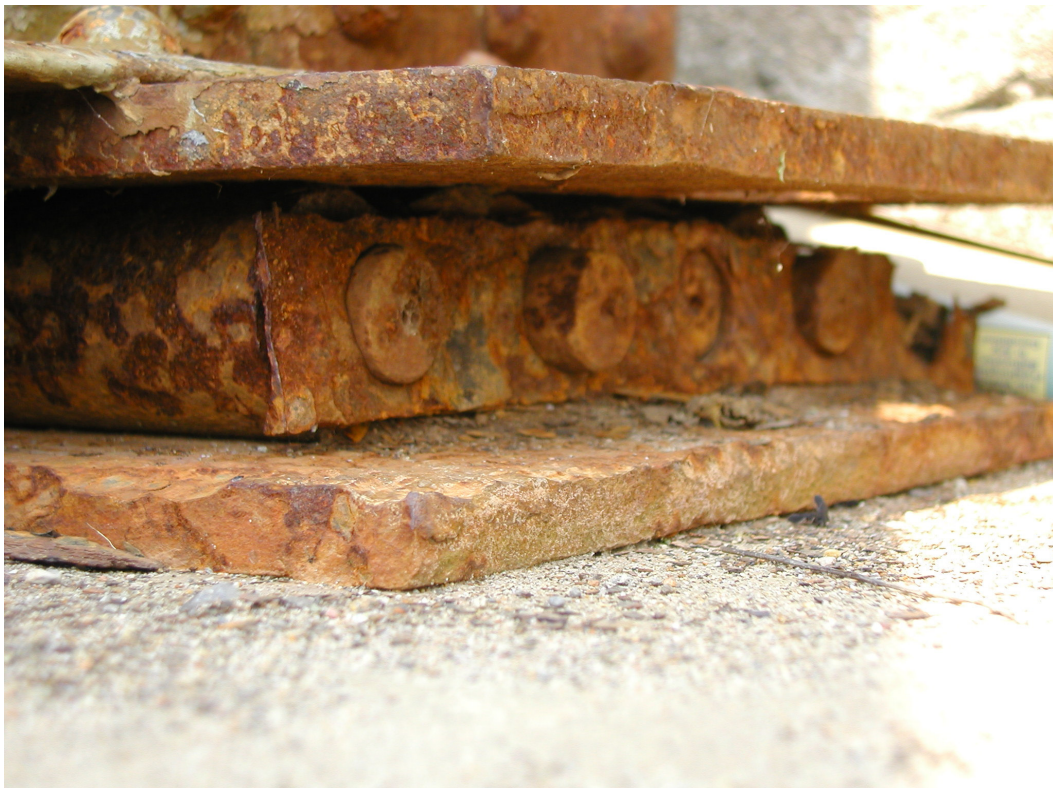
Photograph 22: Detail of deterioration of north roller bearing, West Abutment.

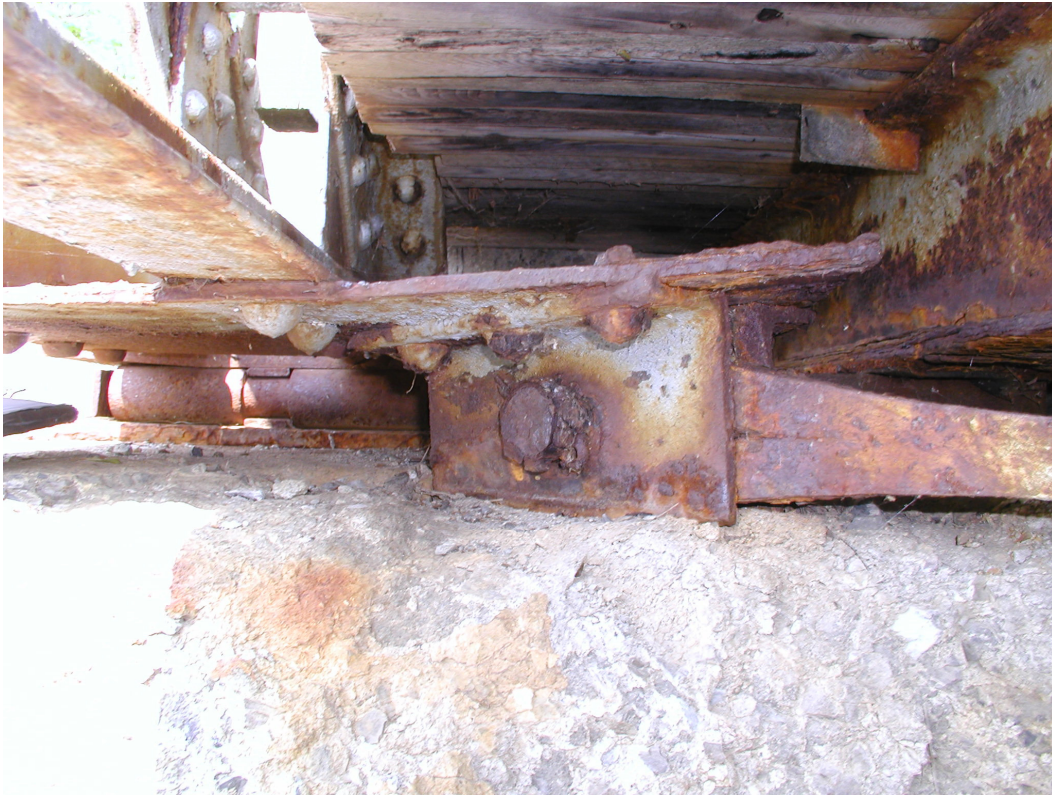
Photograph 23: Detail of south roller bearing at West Abutment.

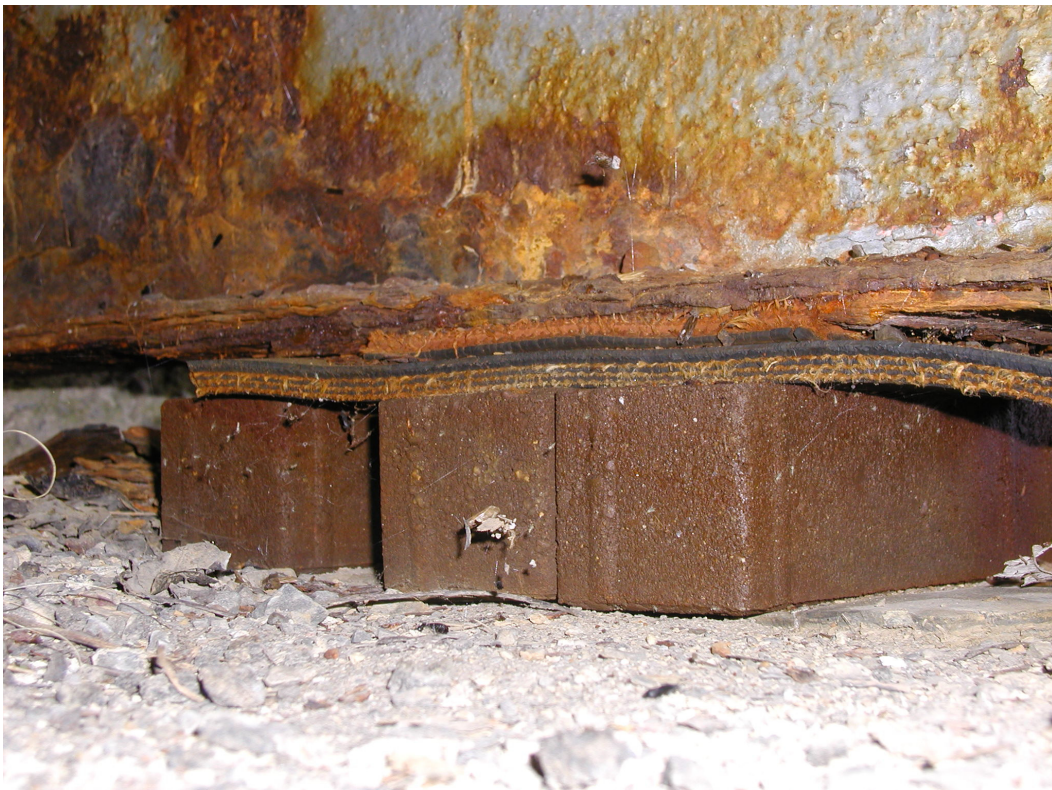
Photograph 24: Detail of bearing pads on interior girders, East and West Abutments.

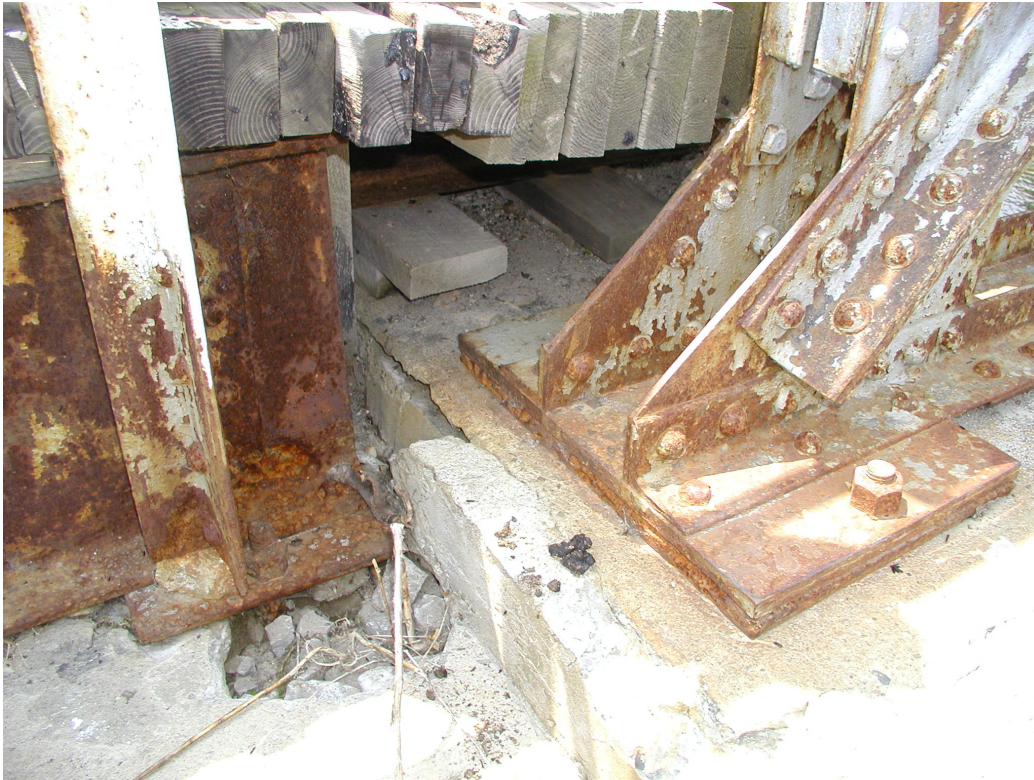
Photograph 25: North bearings at pier. Note undermining of east bearing.

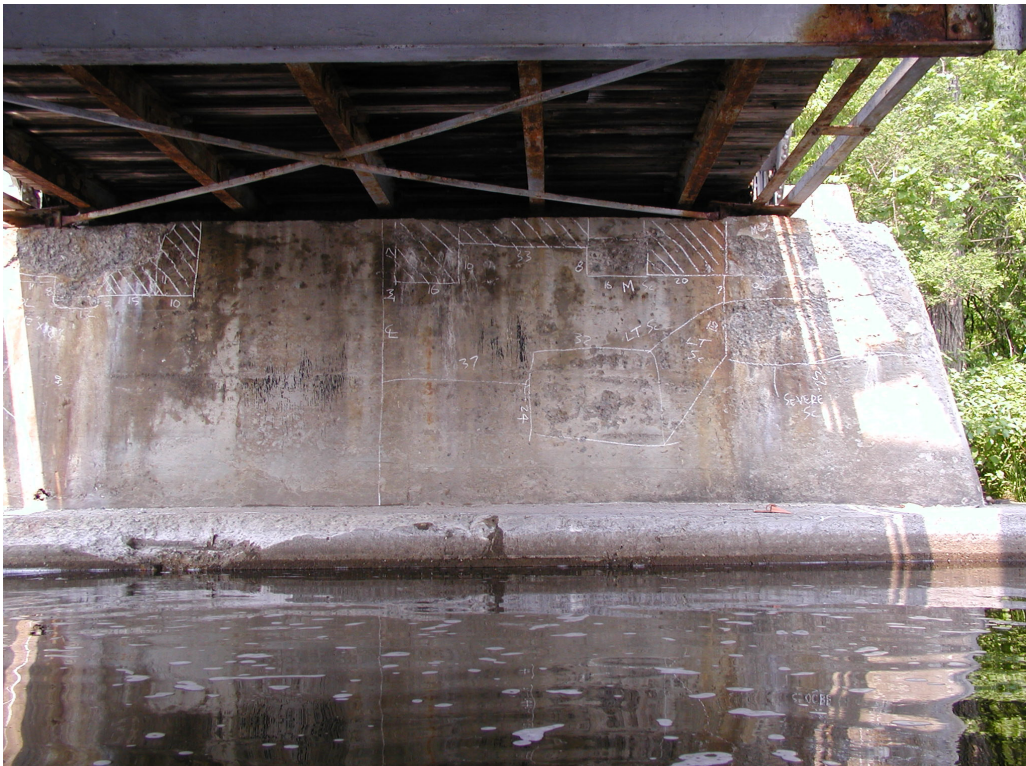
The abutments and pier are in poor condition with extensive scaling, delaminations, spalls, deterioration, and alkali-aggregate reaction (Photographs 27, 26, 28, 29). The bearing seats are similarly delaminated, severely scaled and disintegrated at the pier and East Abutment (Photographs 31 and 32). The East Abutment ballast wall exhibits severe deterioration (photograph 30) and undermining of the north bearing plate (Photograph 25). Based on field observations, it appears that the existing substructure, likely masonry, has been encased in concrete (Photograph 32). However, further investigation would be required to confirm visual observations. The top of the footings were exposed and wide cracks, delamination, and spalls were noted throughout.

Photograph 26: Face of West Abutment is characterized by extensive scaling, delaminations, and alkali-aggregate reaction. Condition of face of East Abutment is similar.

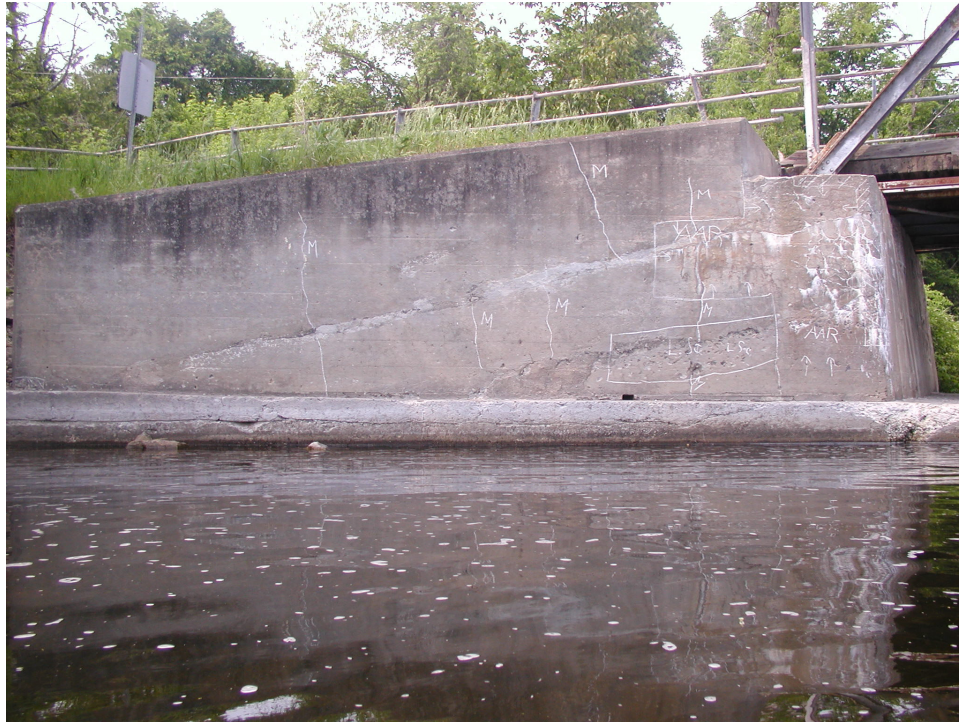
Photograph 27: Elevation of south wingwall at West Abutment.

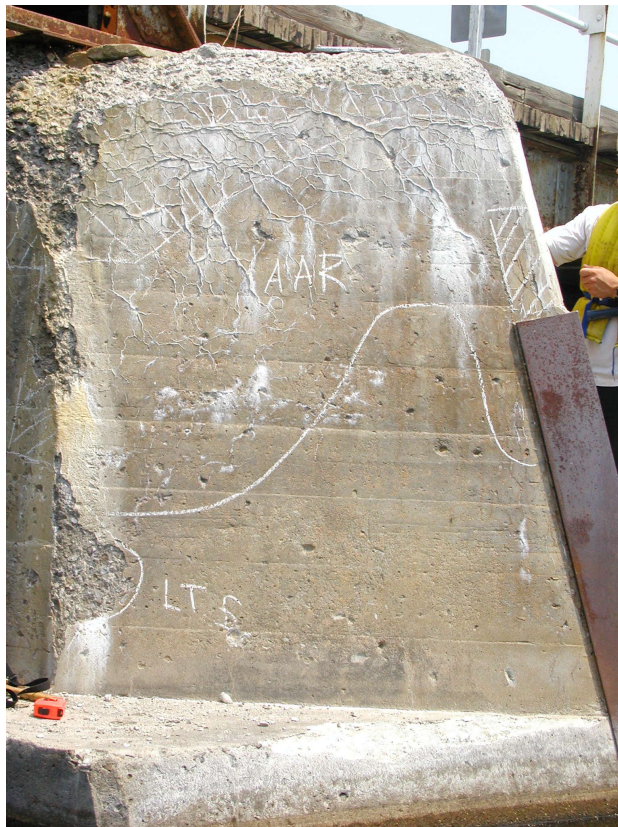
Photograph 28: Deterioration of west face of pier nosing. Note extensive deterioration and alkali-aggregate reaction. Condition of east face is similar.
