Andrewsville Bridge Site No. 015-0013

Investigation and Recommended Rehabilitation Report

McCORMICK RANKIN
CORPORATION

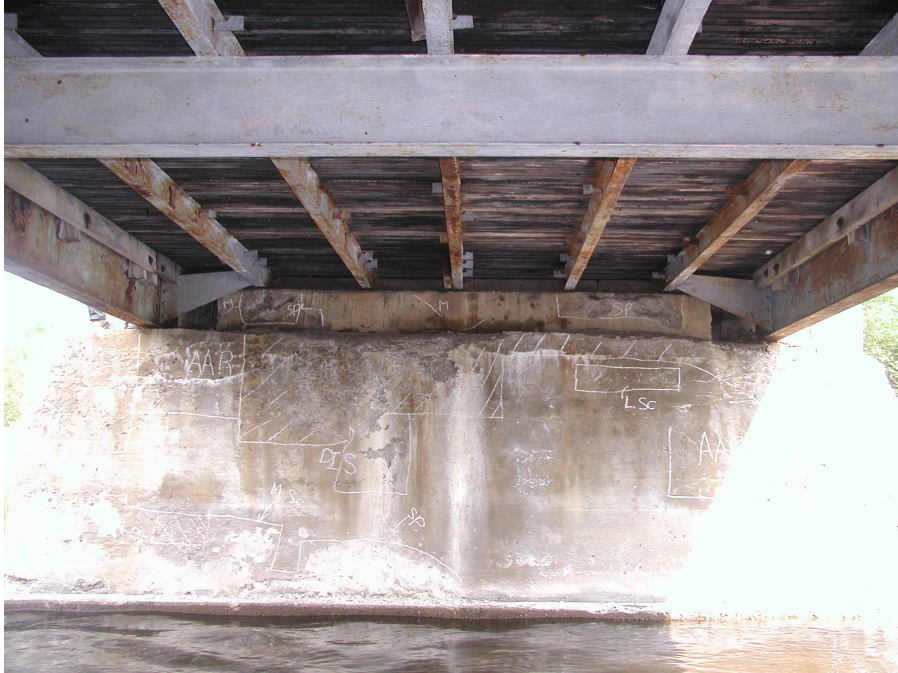
The abutments and pier are in poor condition with extensive scaling, delaminations, spalls, deterioration, and alkali-aggregate reaction (Photographs 27, 26, 28, 29). The bearing seats are similarly delaminated, severely scaled and disintegrated at the pier and East Abutment (Photographs 31 and 32). The East Abutment ballast wall exhibits severe deterioration (photograph 30) and undermining of the north bearing plate (Photograph 25). Based on field observations, it appears that the existing substructure, likely masonry, has been encased in concrete (Photograph 32). However, further investigation would be required to confirm visual observations. The top of the footings were exposed and wide cracks, delamination, and spalls were noted throughout.

Photograph 29: Condition of east face of pier. Condition of west face is similar.

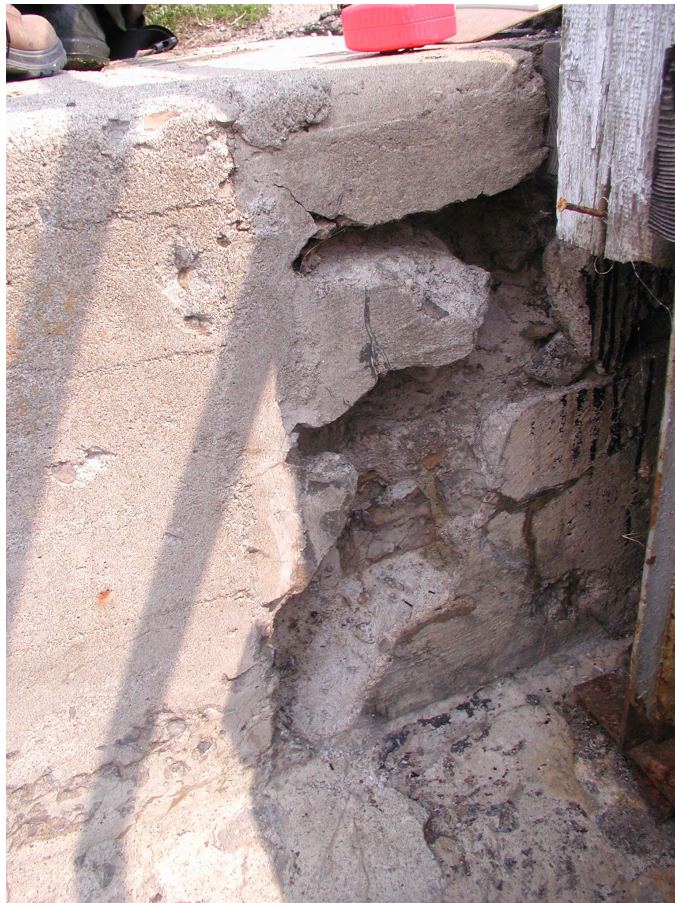
Photograph 30: Detail of deterioration of ballast wall of East Abutment, north side.

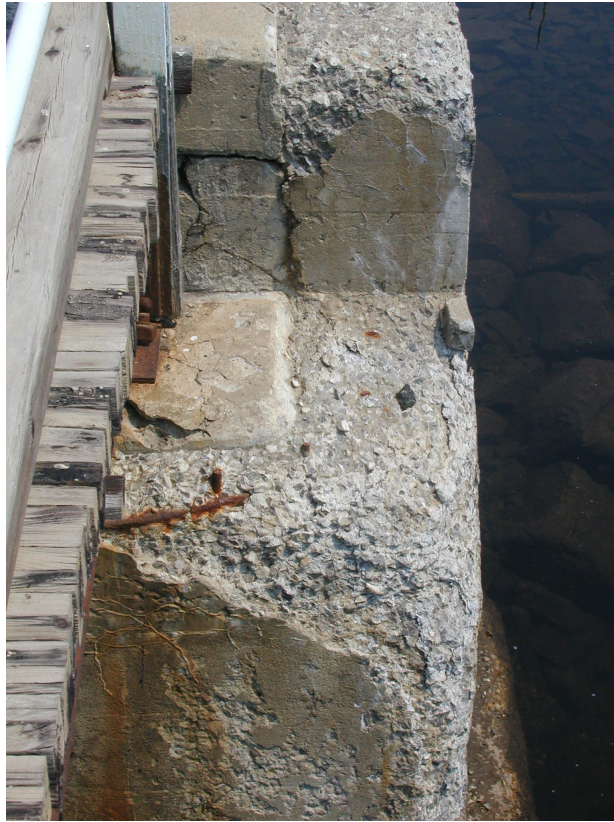
The severe deterioration of the substructure components is consistent with the deterioration typical when masonry structures are encased in concrete. It is therefore likely that the existing substructure was constructed of masonry shafts with concrete bearing seats and ballast walls (see Photographs 31 and 32).

Photograph 31: Deterioration of bearing seat and ballast wall, East Abutment.

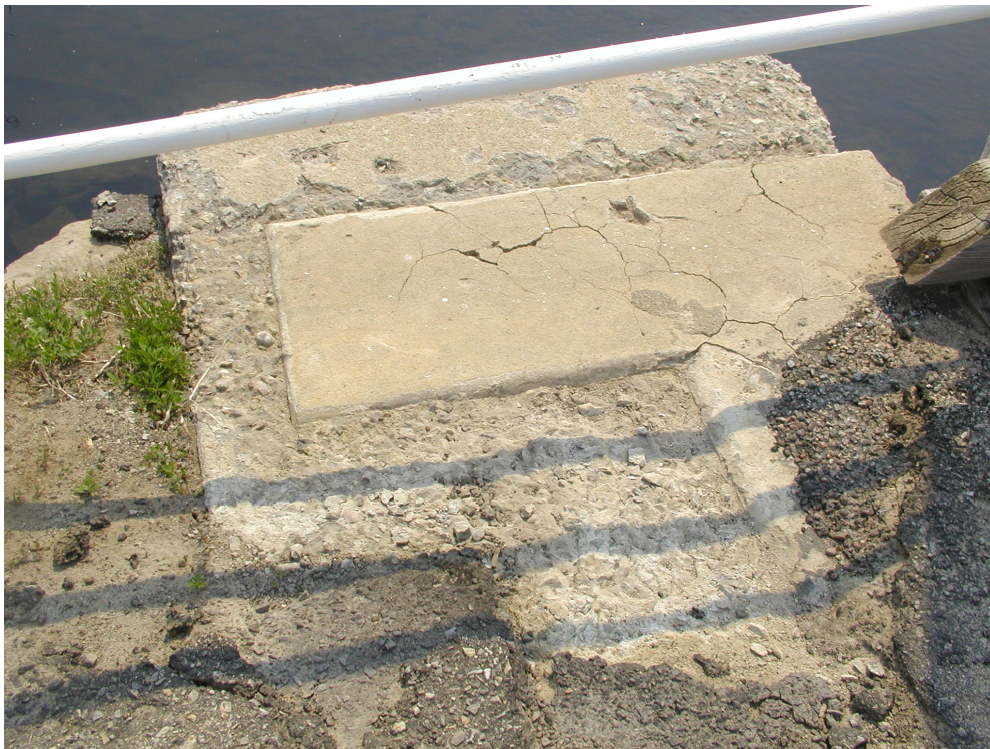
Photograph 32: Detail of top of East Abutment, showing concrete encasement. West Abutment similar.

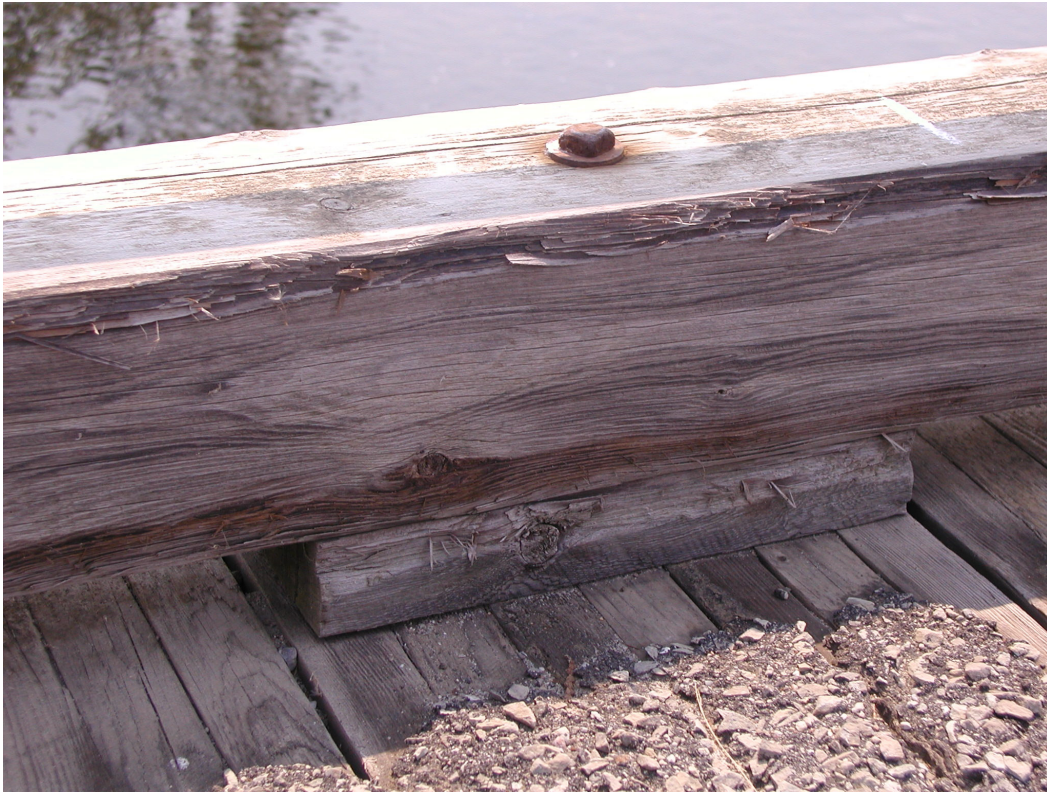
The curb on the deck consists of 152 mm x 152 mm timbers (Photograph 33), and is in fair to good condition.

Photograph 33: Detail of curb on timber deck.

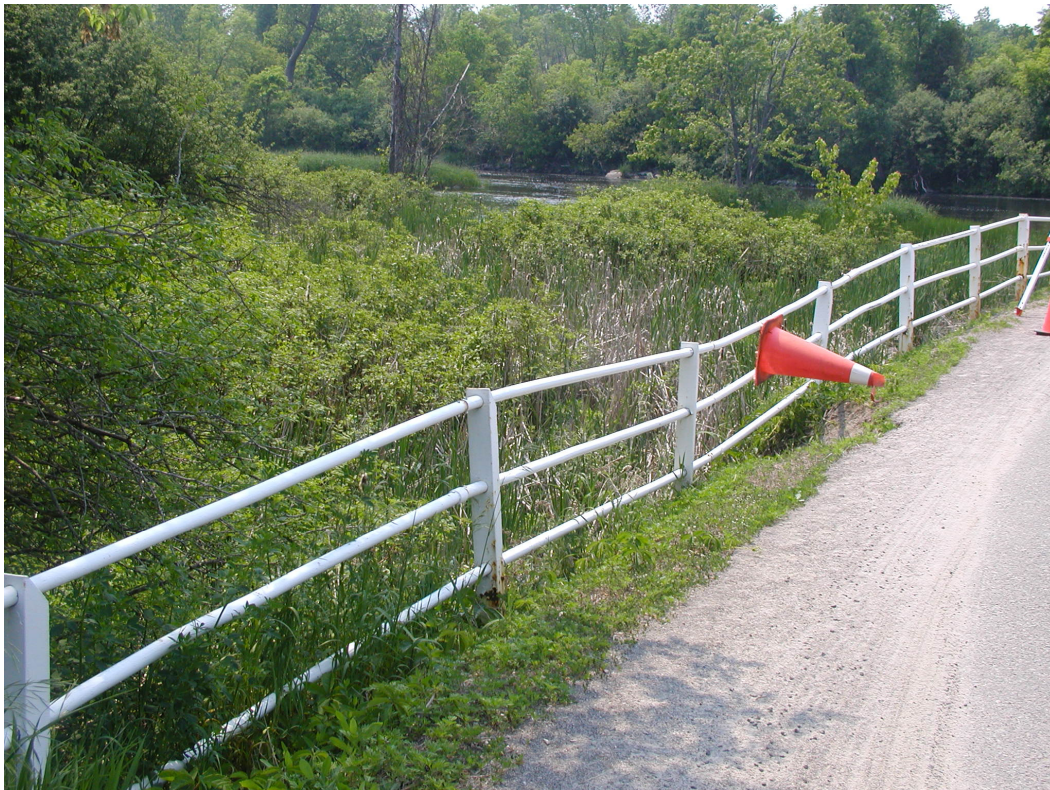
The fills in the east approach are retained by an ungrouted masonry retaining wall (photograph 3). The wall is in fair to poor condition. The wall has settled on the south side, which has deformed the guiderail (Photograph 34).

Photograph 34: Deformed railing on south side of east approach retaining wall as a result of slope erosion undermining posts.
