**MINUTES
FIRST MEETING OF 2007
PUBLIC WORKS COMMITTEE OF THE WHOLE**

ANDREWSVILLE BRIDGE REHABILITATION /REPLACEMENT OPTIONS

Andrewsville Bridge Site No. 015-0013

Structural Evaluation Report

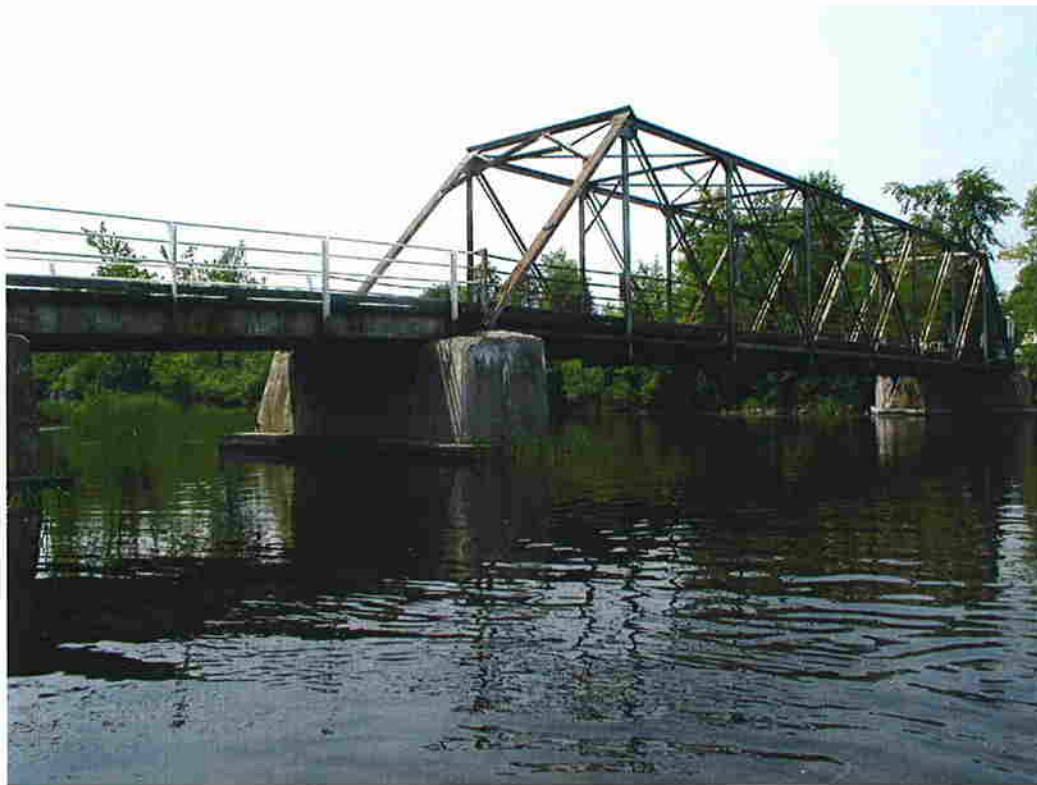
Photograph 1: North elevation of Andrewsville Bridges, showing truss and slab on girder spans.

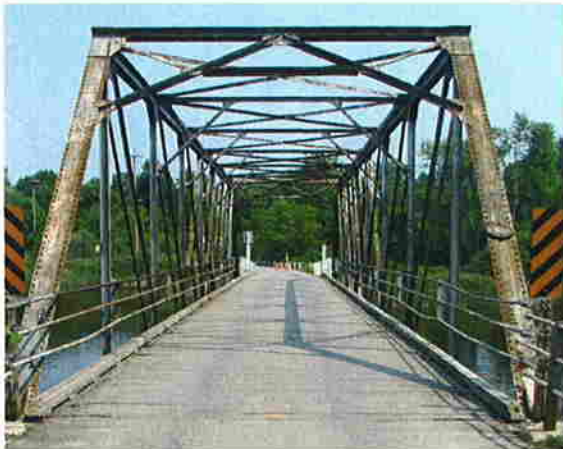
Photograph 2: View across truss, looking east.

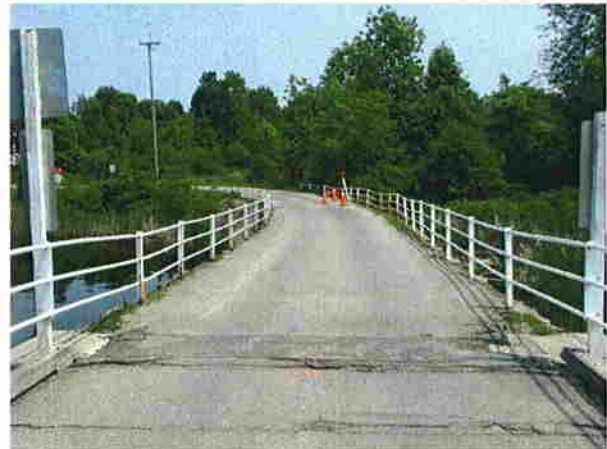
Photograph 3: View of single lane east approach on dry stone retaining walls, looking east.

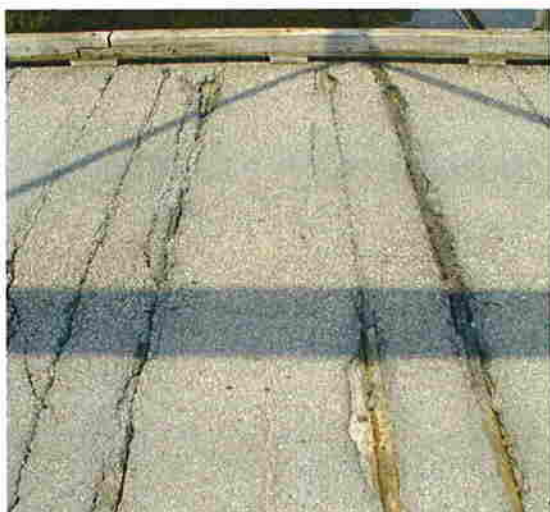
The timber deck is in fair to poor condition. The timbers have separated in numerous locations, permitting runoff through the timbers and removing the protective creosote (Photographs 4 and 5). Timber rot was also observed in a few areas where the creosote was missing. The deck has separated from the steel stringers in several locations and the timbers were observed to deflect upwards under traffic loads. The asphalt wearing surface has also failed in these locations. There is evidence of numerous previous repairs to the asphalt over the expansion joints.

Photograph 4: Deterioration of the asphalt and separation of the deck timbers.

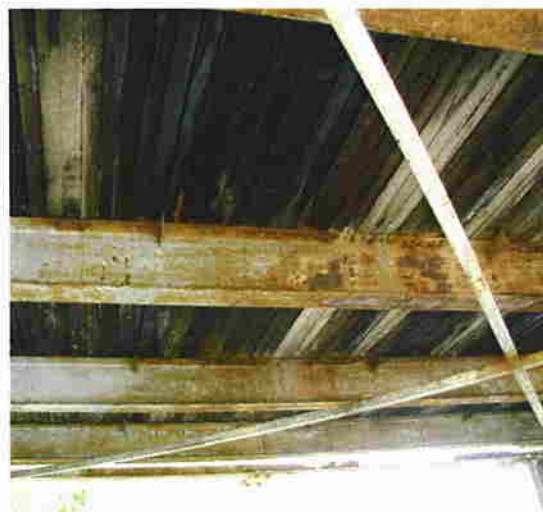
Photograph 5: Deterioration of the timber deck due to loss of creosote protection. Note the widespread light corrosion of the below-deck steel floor system.

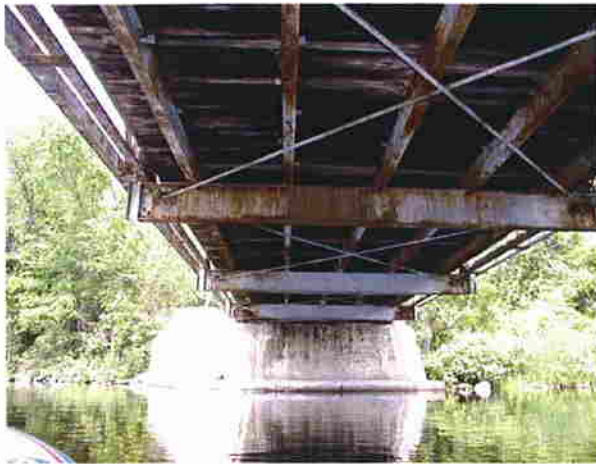
The steel truss is in fair condition, with widespread light corrosion and minor section loss throughout (Photograph 6). The structural steel in the truss is typically in better condition above deck than below deck. The steel floor systems are generally in fair condition, with the exception of the stringers at the West Abutment. During the June 2005 inspection, it was noted that the stringers at the West Abutment exhibited very severe section loss and perforations. The October 2005 report recommended that these stringers be retrofit, which had been done by the time of the February 2007 inspection (Photograph 7).

Photograph 6: Typical condition of below-deck structural steel in truss.

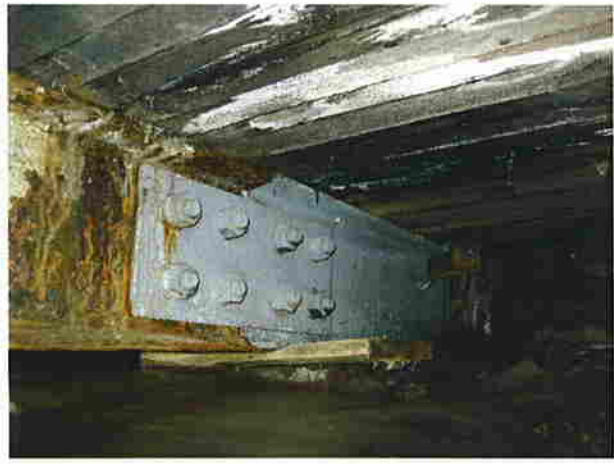
Photograph 7: Detail of repaired stringer at the West Abutment.

Three of the stringers supported on the West Abutment exhibit very severe deterioration and it is recommended that they be repaired immediately by removing a 600 mm long section of the deteriorated stringer and replacing it with a section of S200x27. A complete scope of work for, and details of, the repair may be found in Appendix B.

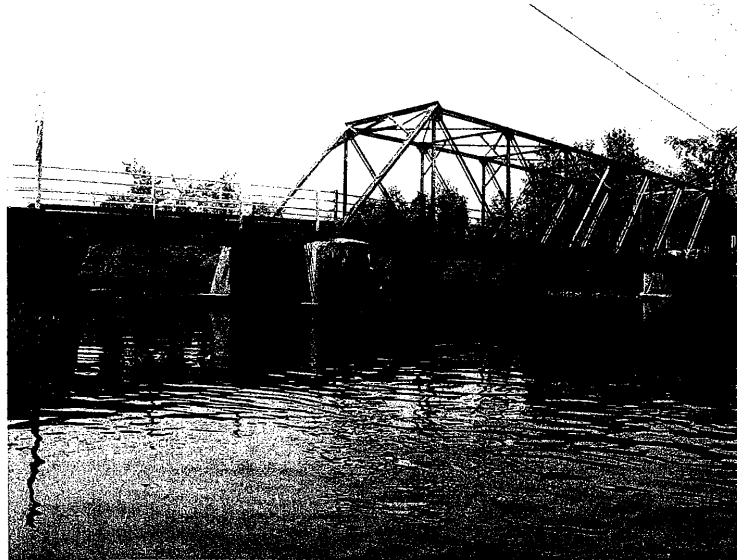
Photograph 1: South elevation of Andrews ville Bridge as viewed from the southeast quadrant.

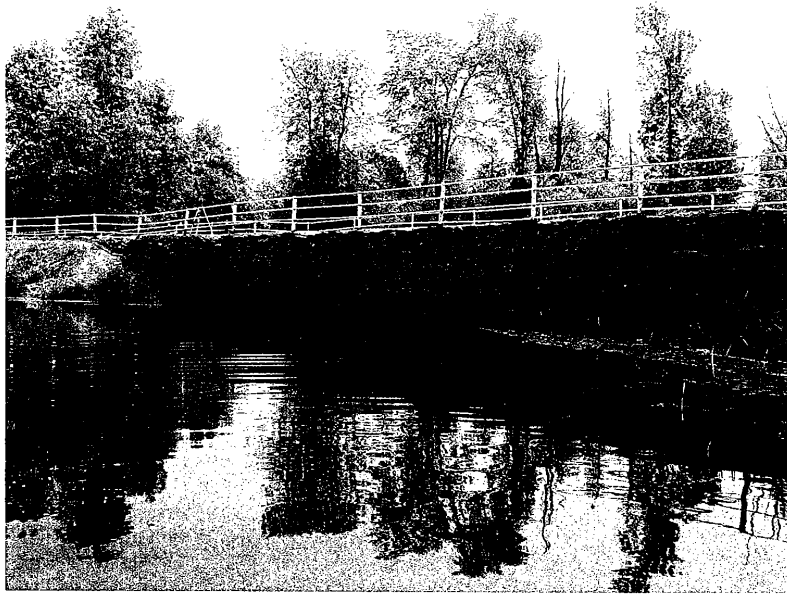
Photograph 5: Dry stone retaining wall on east approach.

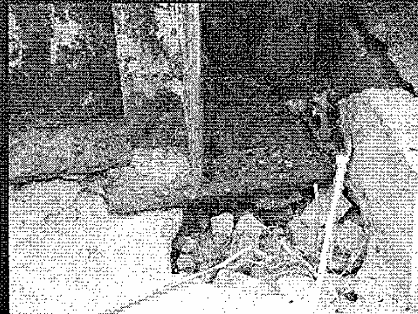
Undermining of south pier bearing
