MUNICIPAL STRUCTURE INSPECTION FORM

Site Number: 015-0013

INVENTORY DATA:			
Structure Name	<u>Andrewsville Bridge (B40)</u>		
Main Hwy/Road #	-	On <input type="checkbox"/> Under <input checked="" type="checkbox"/>	Crossing Type: Rail <input type="checkbox"/> Road <input type="checkbox"/> Ped. <input type="checkbox"/> Other <input type="checkbox"/>
Road Name	<u>Andrewsville Main Street</u>		
Structure Location	<u>Lot 2, Concession A - 1.0 km South of County Road 43</u>		
Latitude	<u>44° 57.069'</u>	Longitude:	<u>75° 49.148'</u>
Owner(s)	<u>County of Lanark</u>	Heritage Not Cons. <input checked="" type="checkbox"/> Cons./not App. <input type="checkbox"/> List/not Desig. <input type="checkbox"/>	Designation: Desig./not List <input type="checkbox"/> Desig. & List <input type="checkbox"/>
MTO Region	<u>Eastern</u>	Road Class:	Freeway <input type="checkbox"/> Arterial <input checked="" type="checkbox"/> Collector <input type="checkbox"/> Local <input type="checkbox"/>

The County of Lanark 2015 OSIM Bridge Inspections

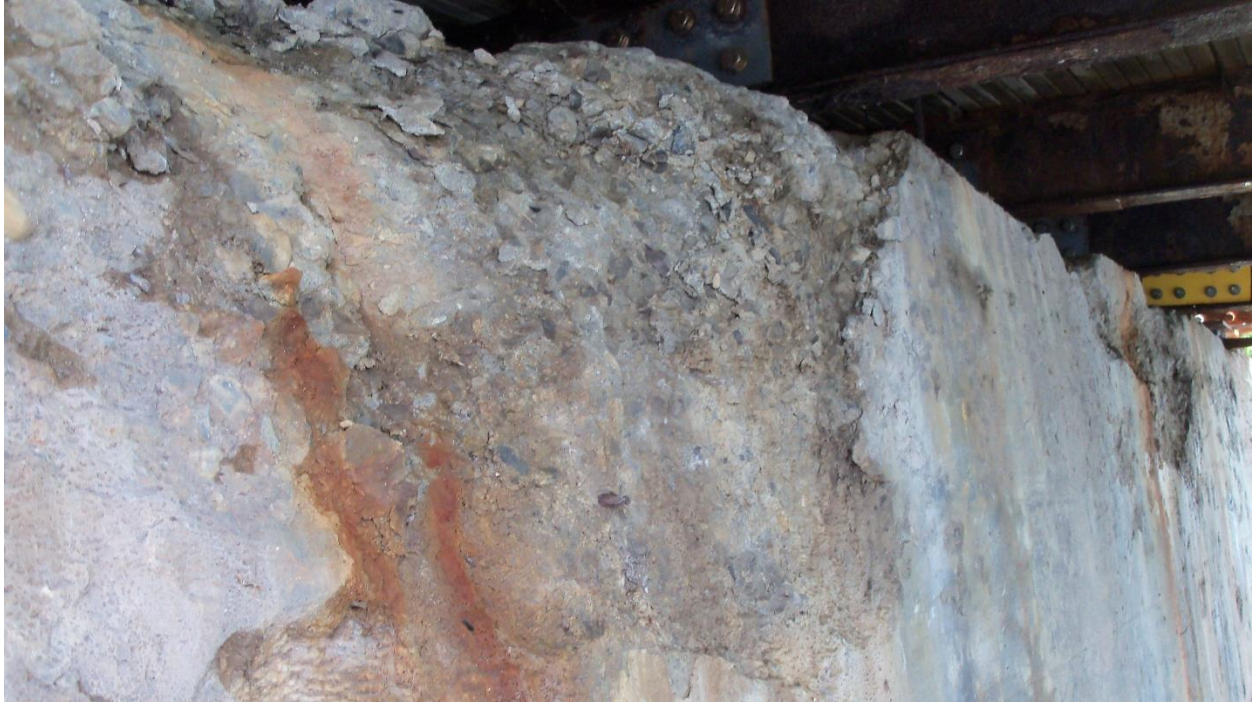
View showing severe spalls and disintegration on abutment

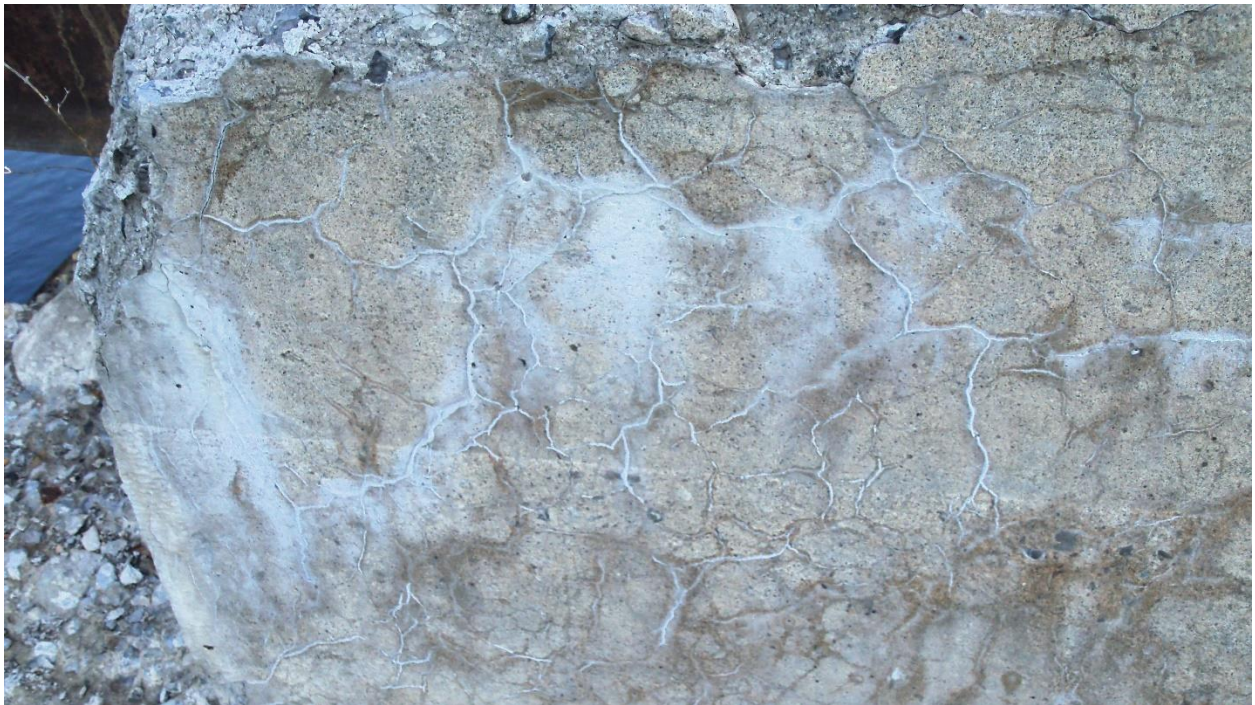
View showing cracking with efflorescence and spalling on the abutment

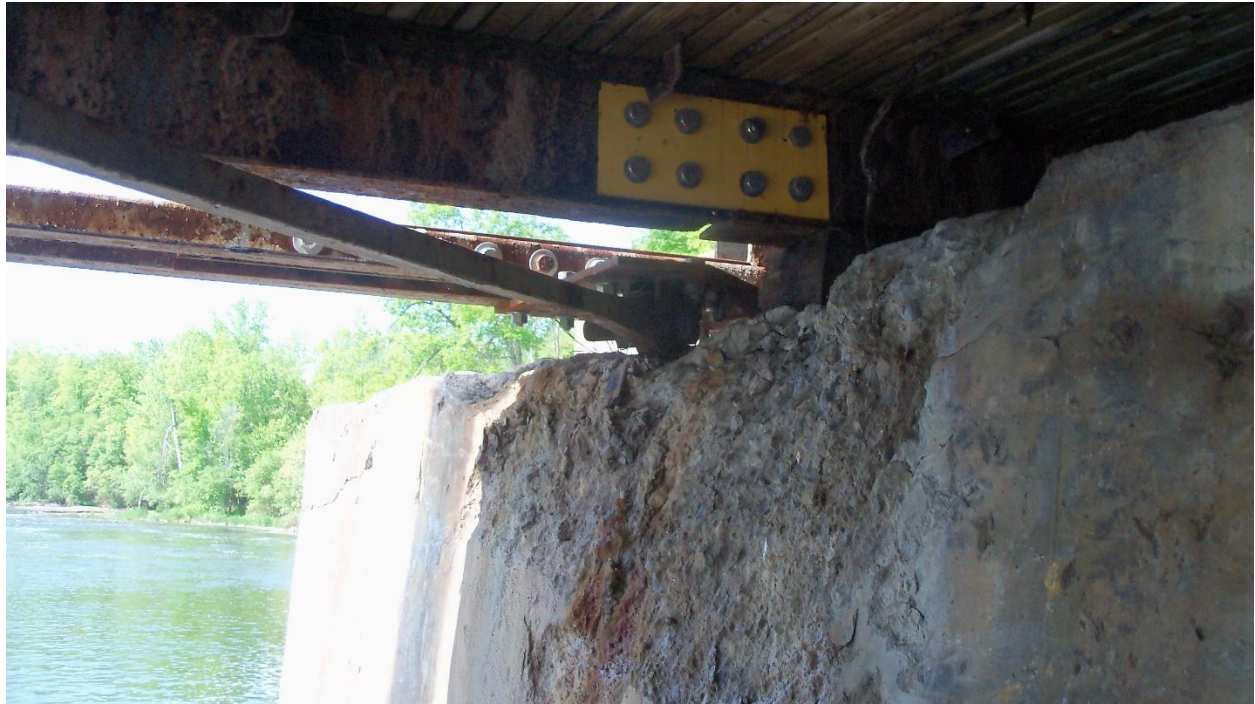
View showing severe spalling of abutment and replaced bolted end plates

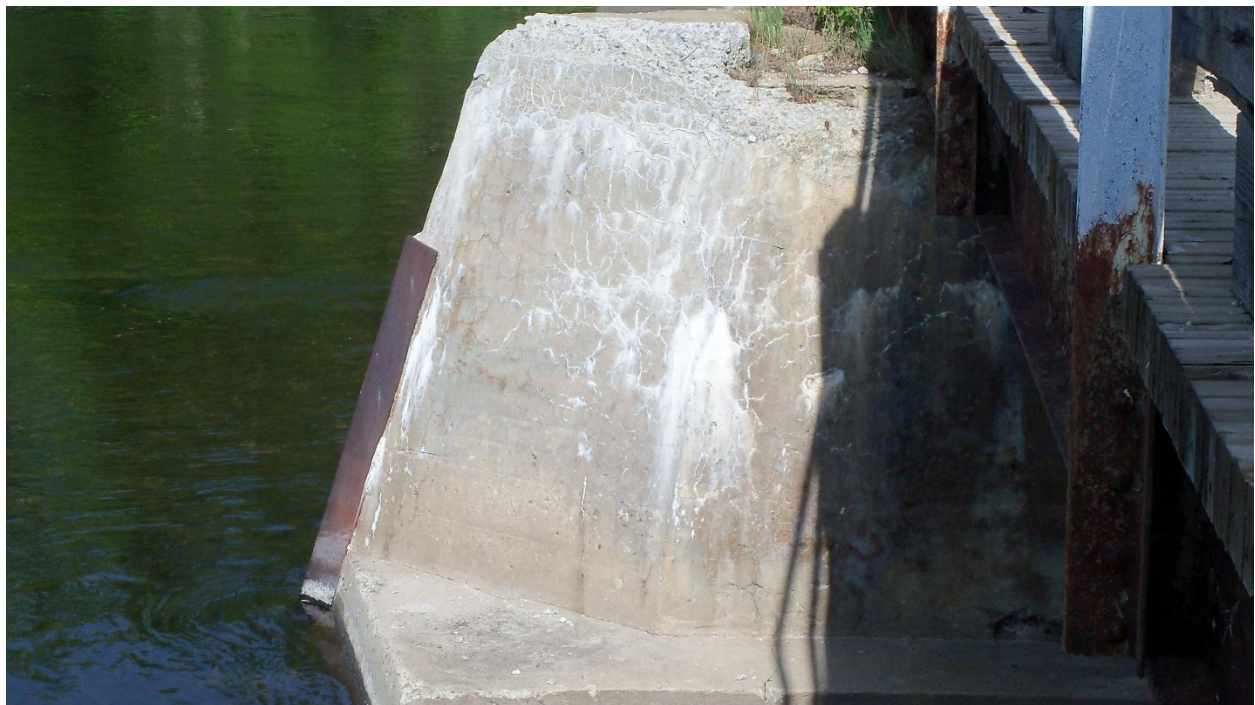
View of pier showing major spalling and efflorescence

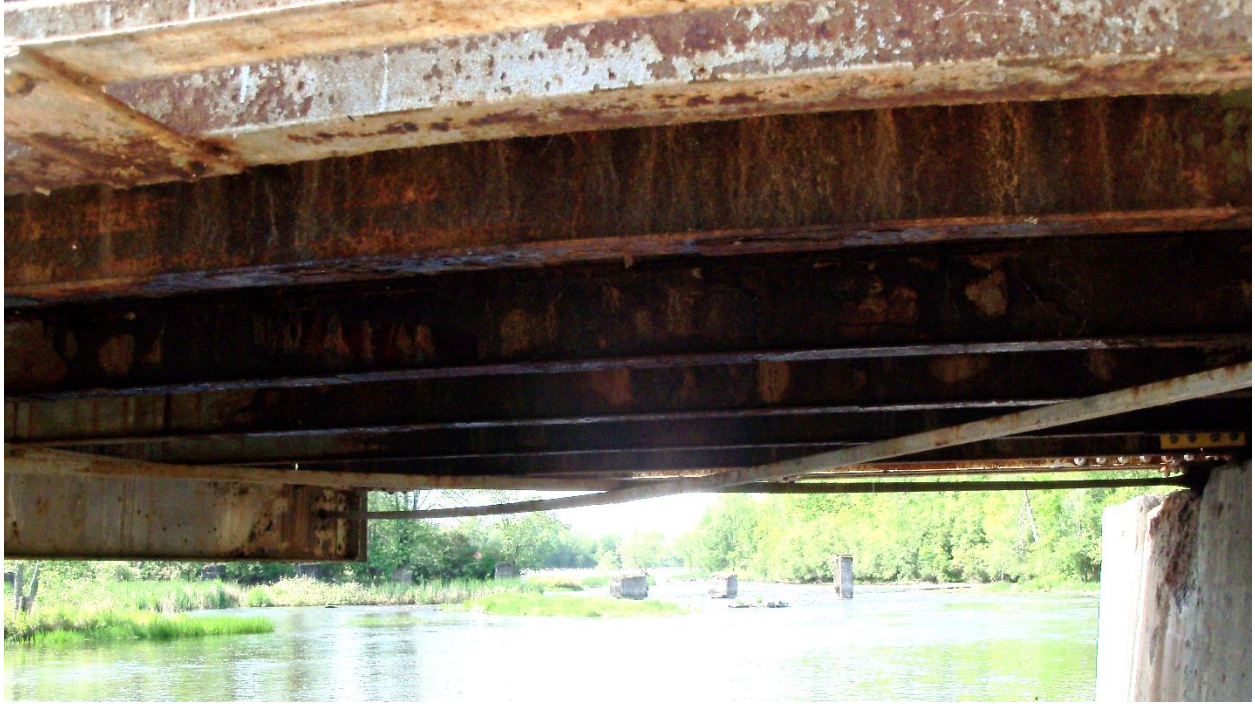
View showing cross bracing and corrosion on girders

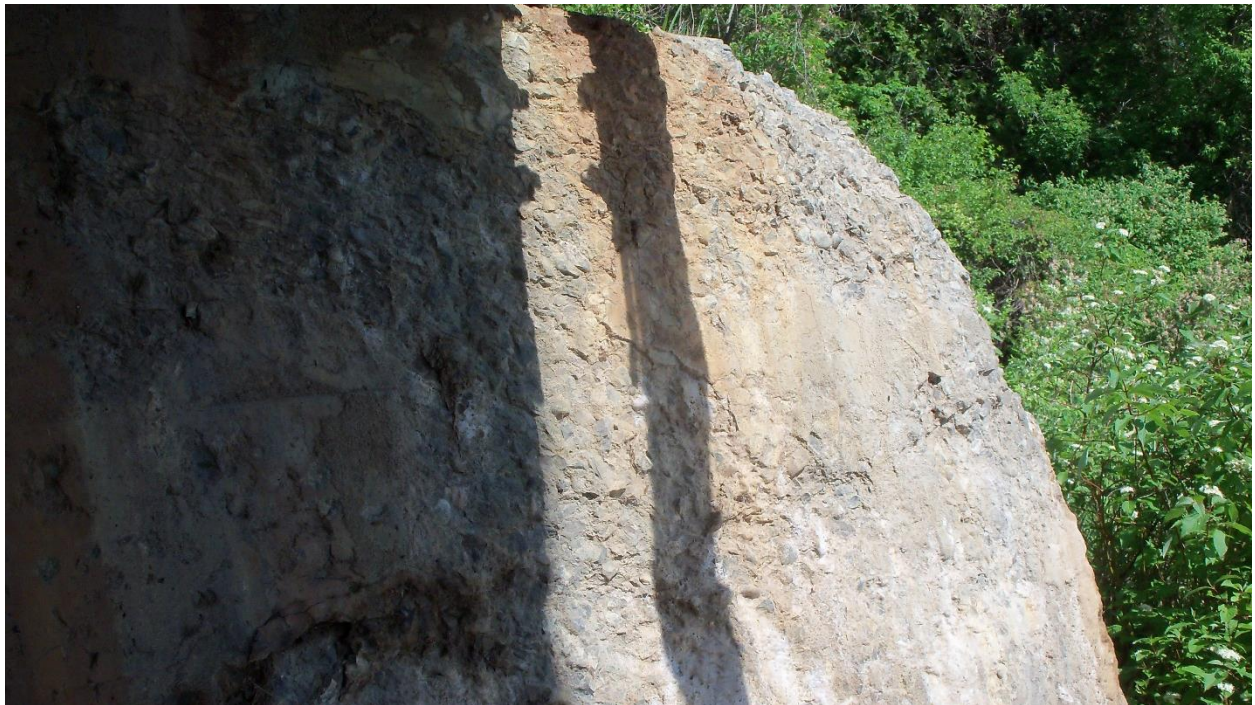
View showing mass spalling and corrosion stains

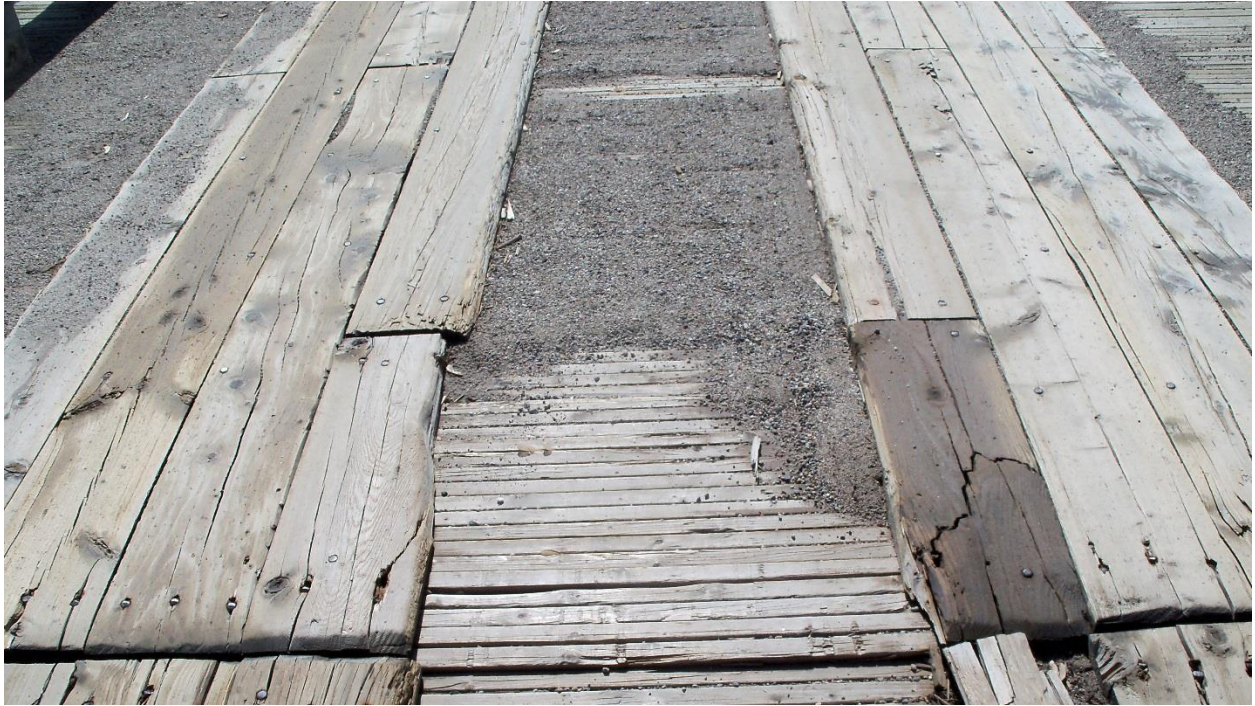
View of deck wearing surface with rot, splits, and checks
