ANDREWSVILLE BRIDGE: OPTIONS FOR THE FUTURE

Re: Andrewsville Bridge

Andrewsville Bridge Wading Inspection

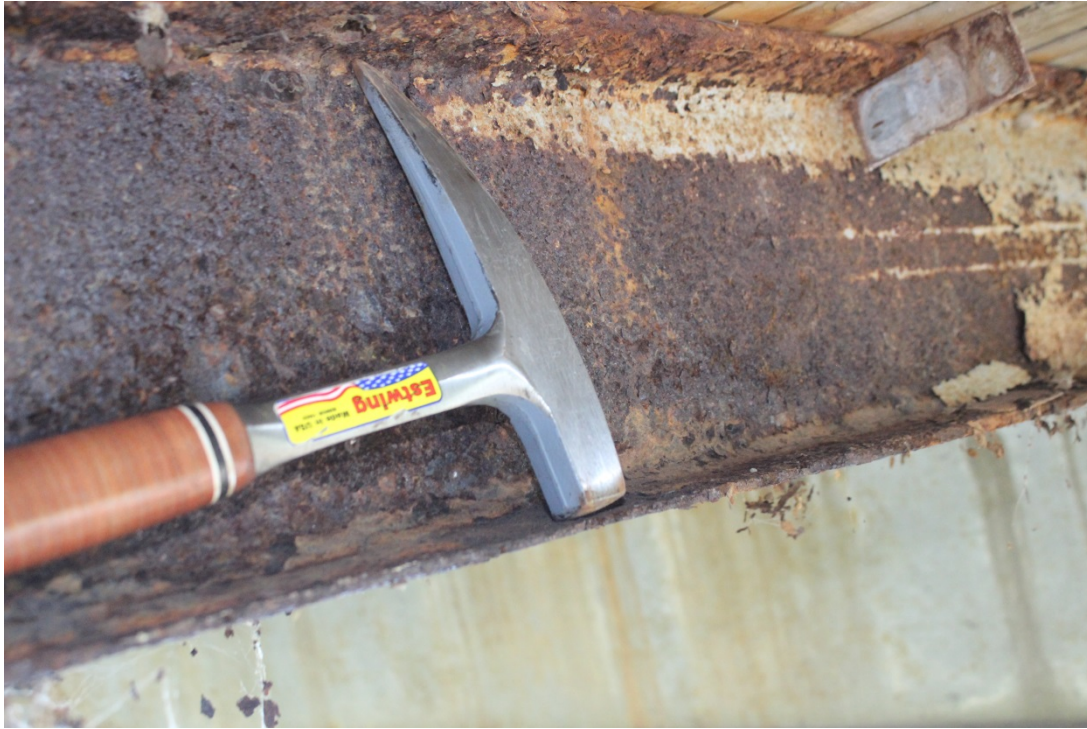
Image 1. Thinning of bottom flange of Stringer 2 in Bay 3

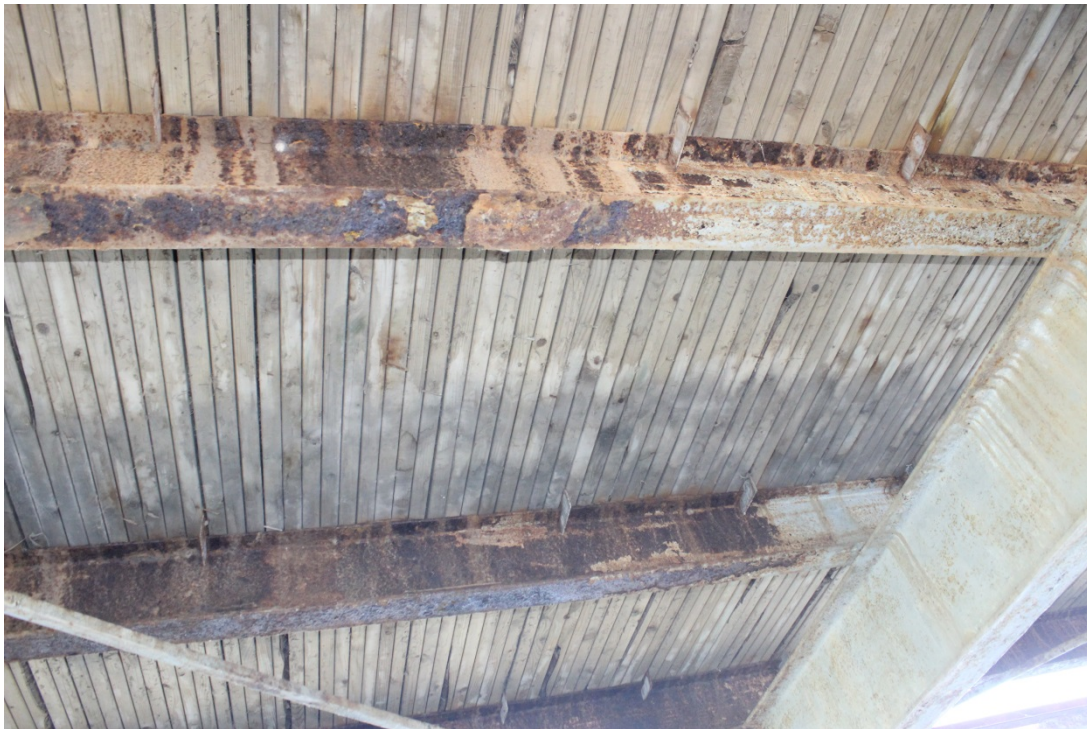
Image 2. Stringers 3 & 4 in Bay 3 looking downstream

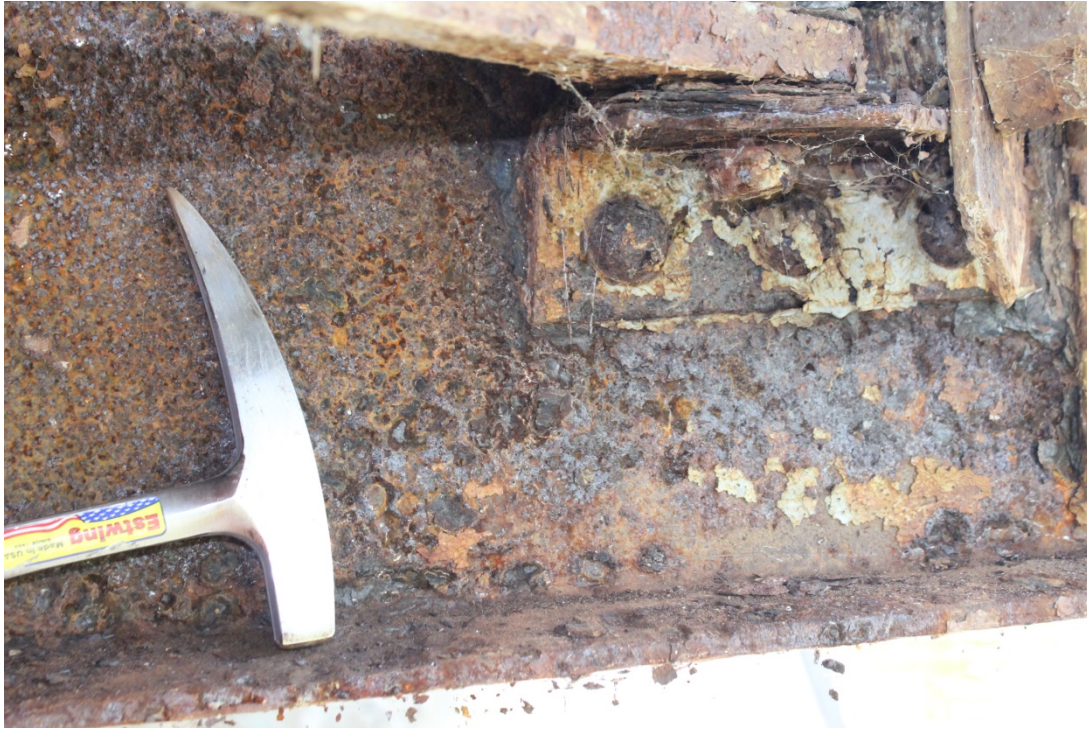
Image 3. South end of Floor Beam between Bays 1 & 2.

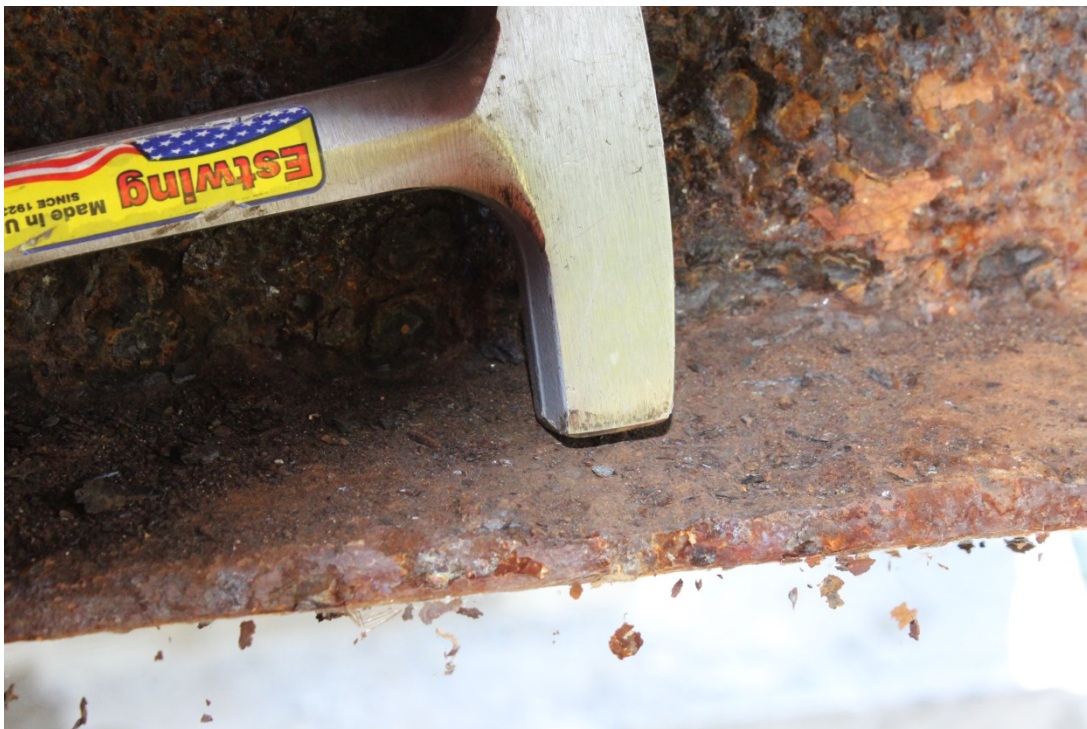
Image 4. Close up of Image 3. Rust dangling from spider webs

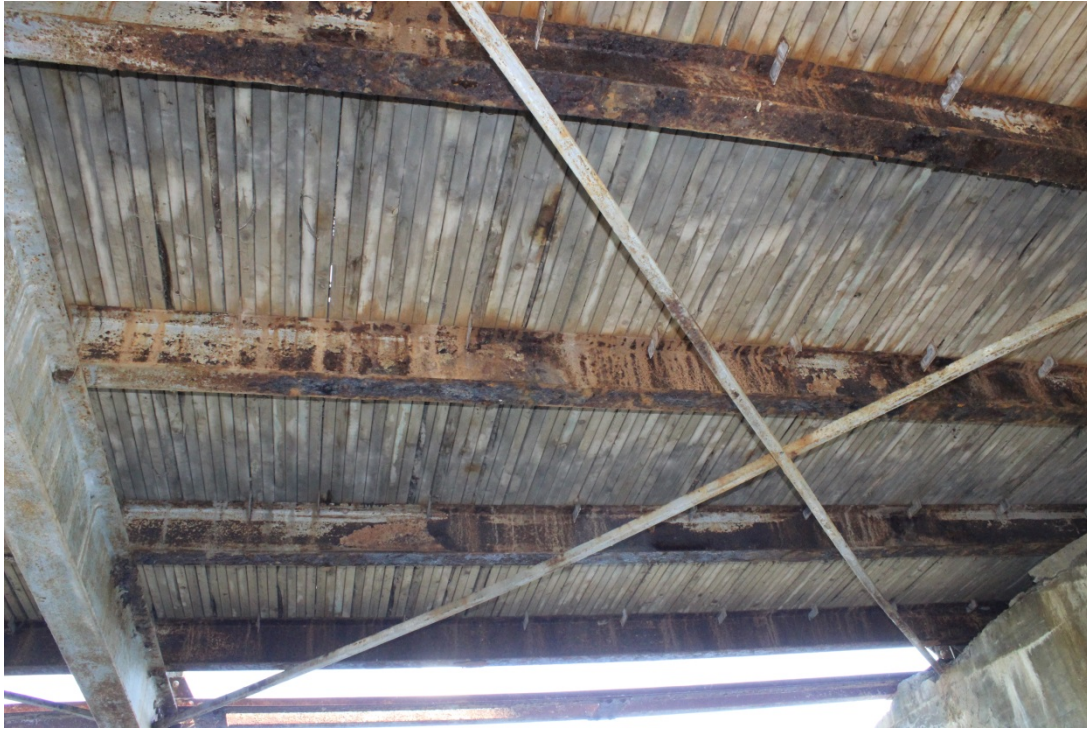
Image 5. Truss Bay 1 adjacent pier, looking downstream

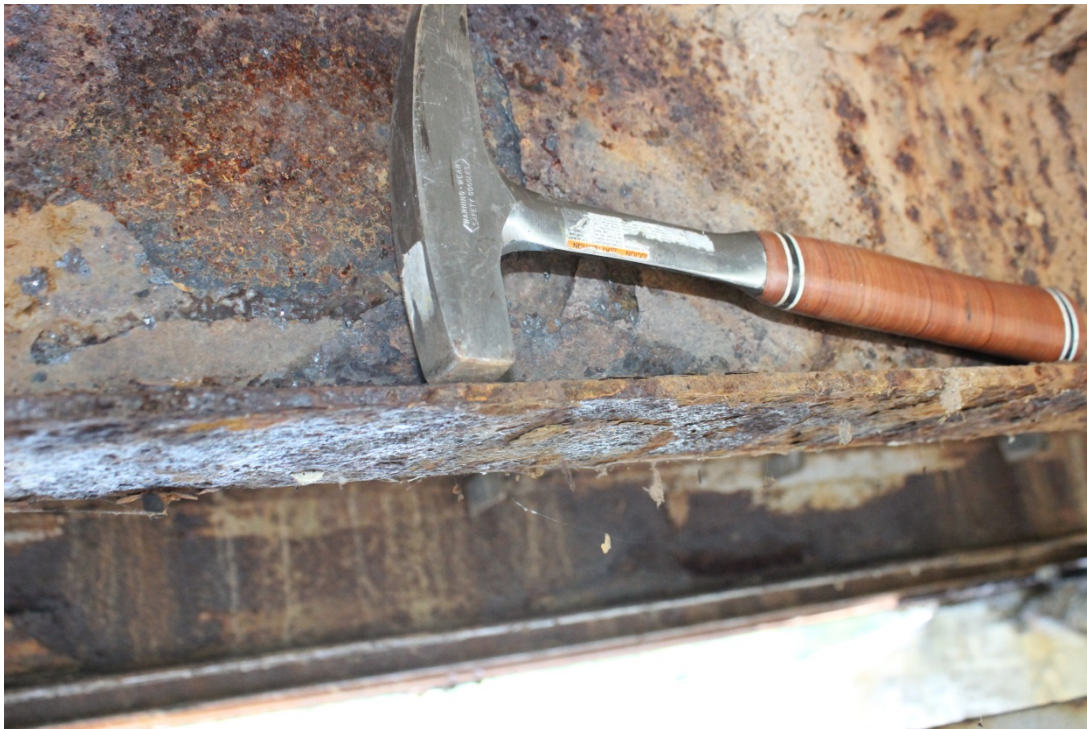
Image 6. Typical corrosion on stringers Bay 1

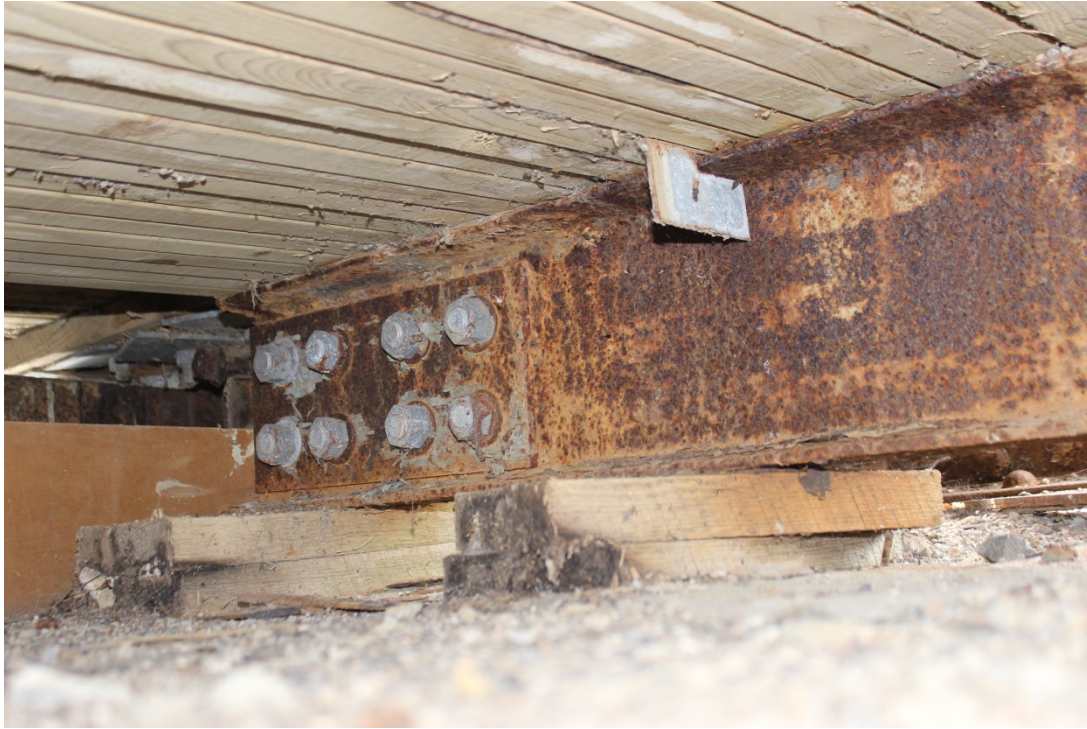
Image 7. Truss Stringer 1 at Pier Bearing

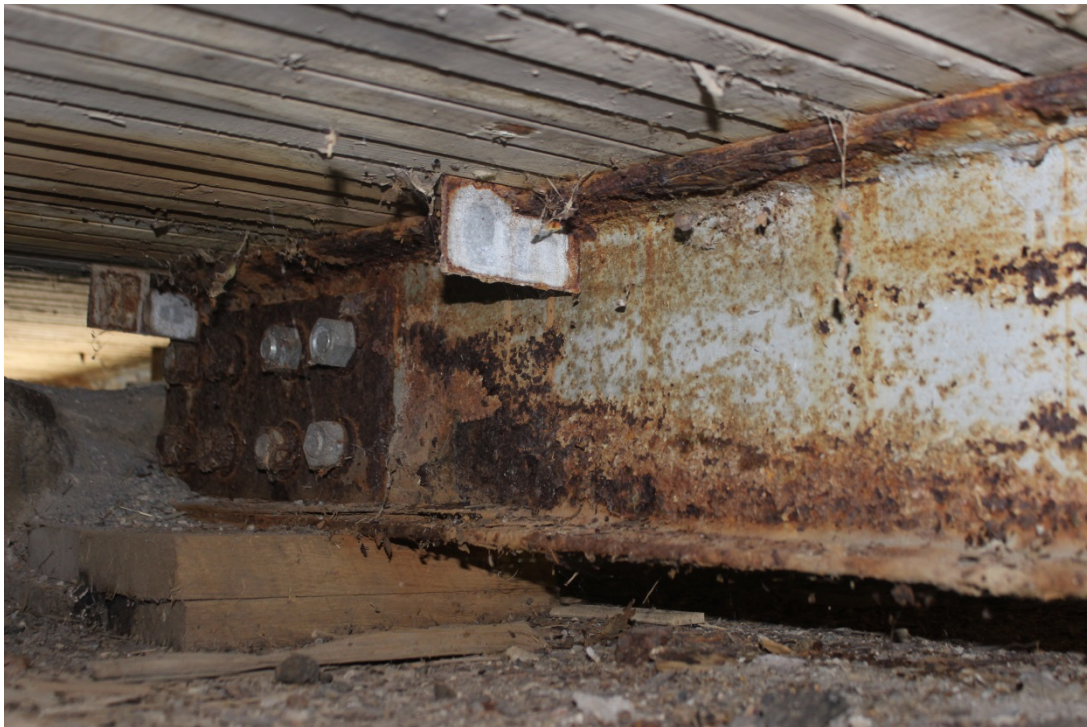
Image 8. Truss Stringer 2 at Pier Bearing

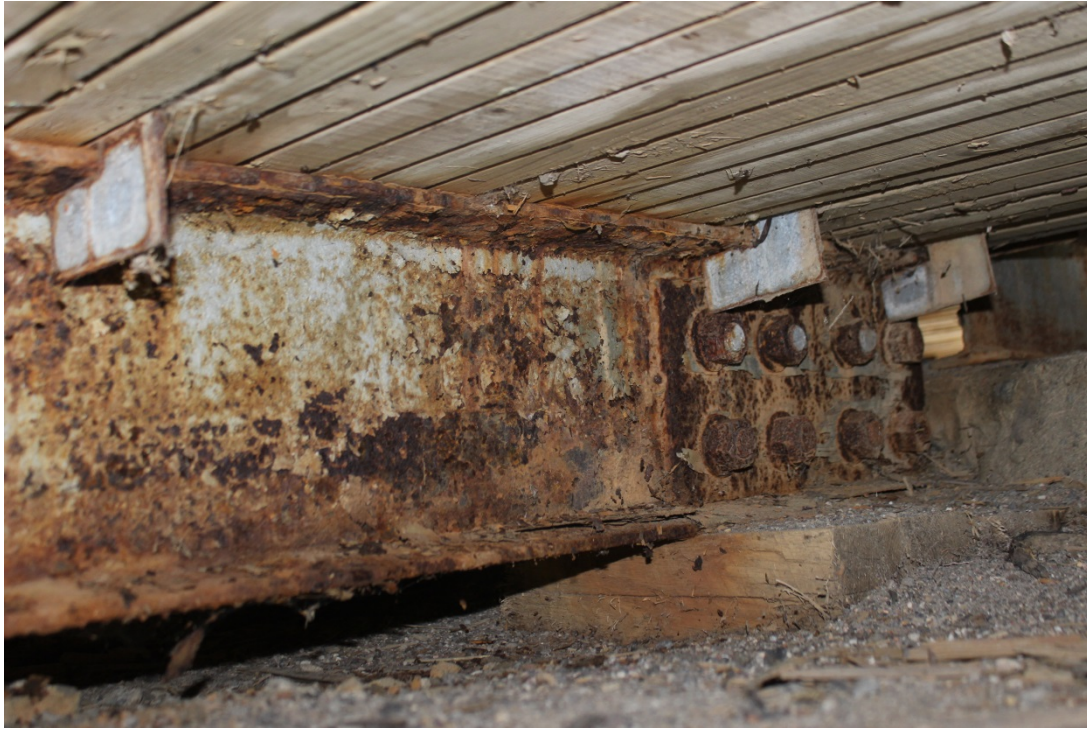
Image 9. Truss Stringer 3 at Pier Bearing

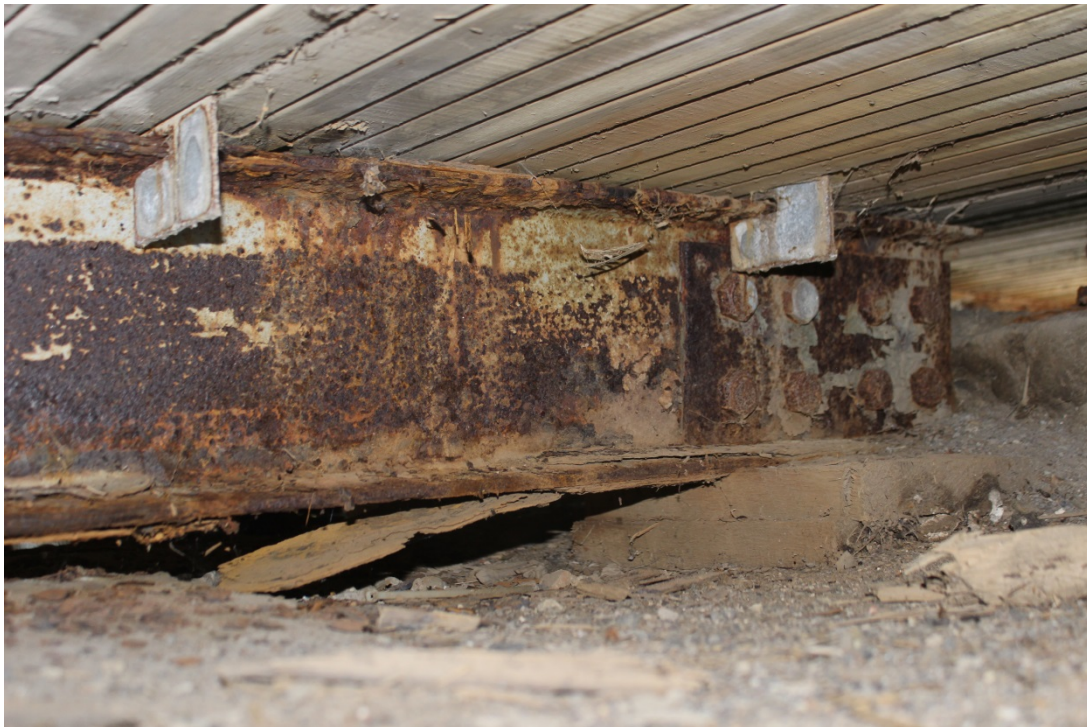
Image 10. Truss Stringer 4 at Pier Bearing

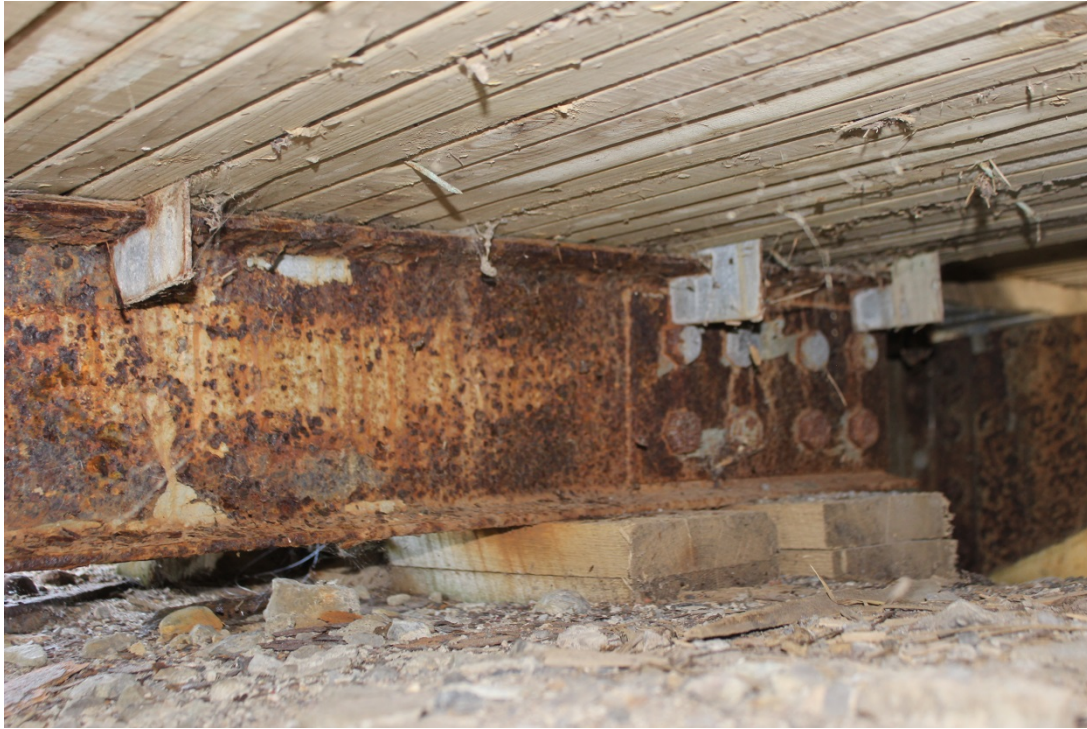
Image 11. Truss Stringer 5 at Pier Bearing

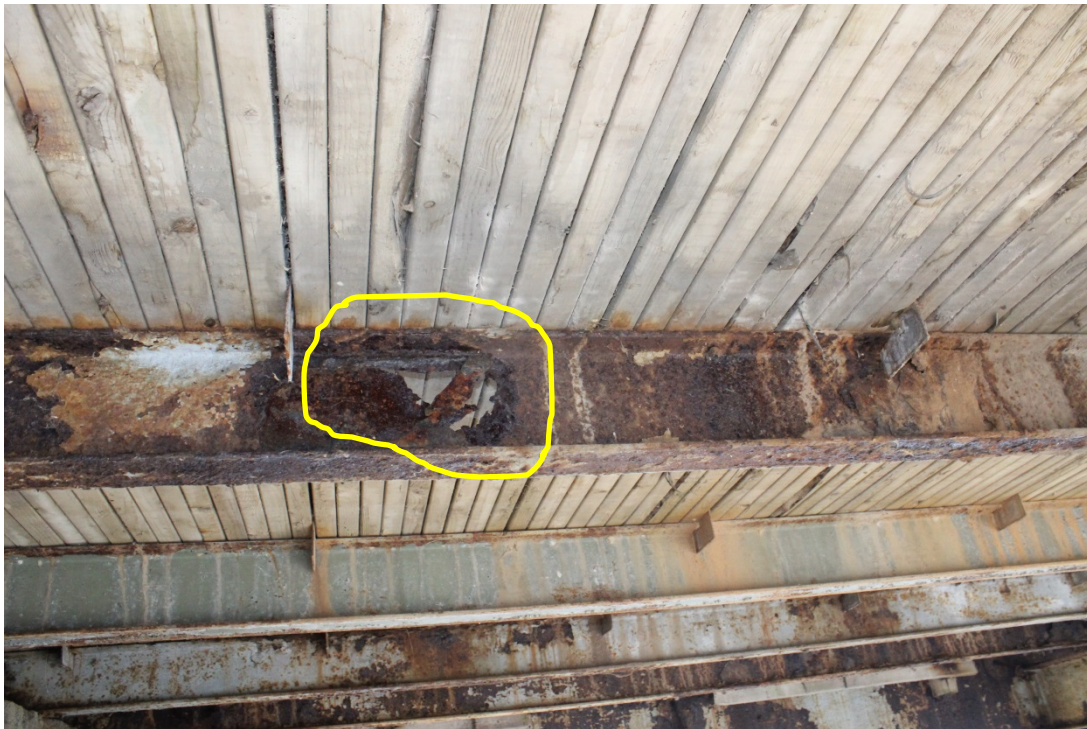
Image 12. Perforation of Approach Stringer 2 before probing

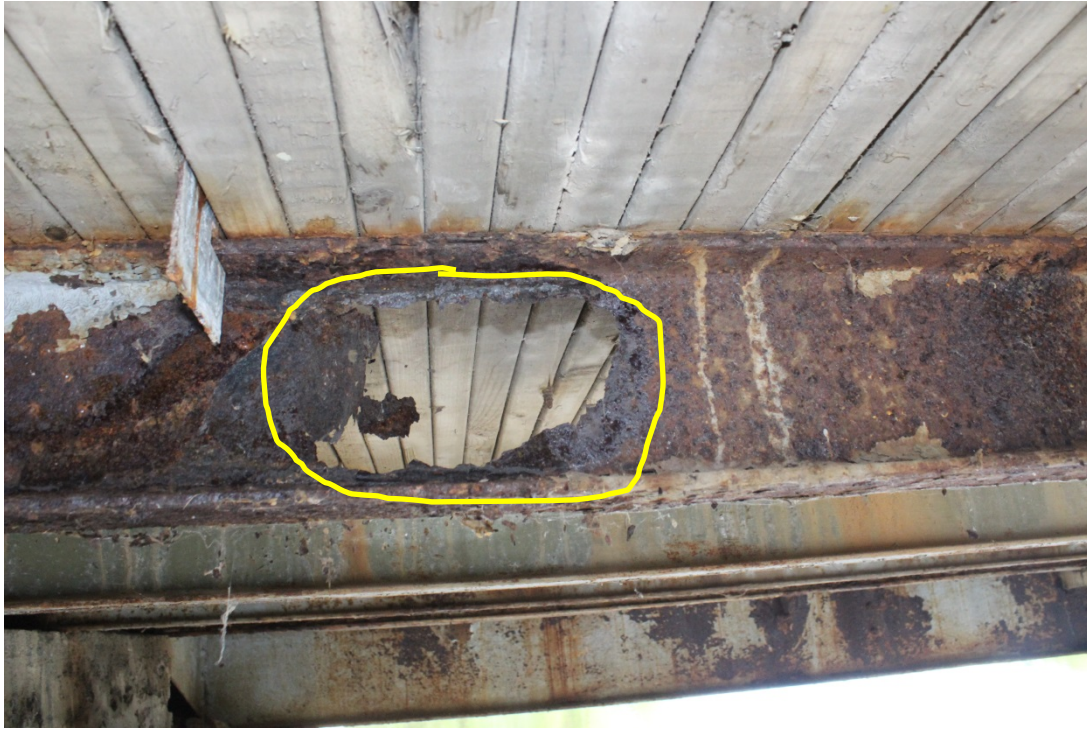
Image 13. Perforation of Approach Stringer 2 after probing

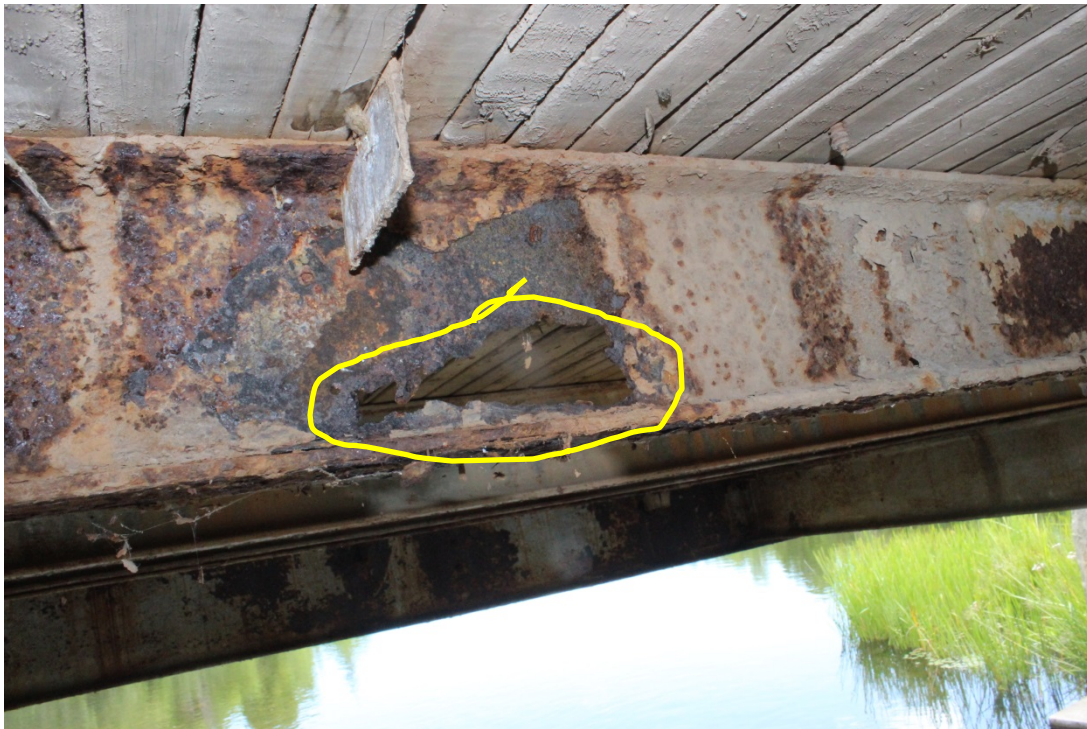
Image 14. Perforation near centre of Approach Stringer 2 west bay.

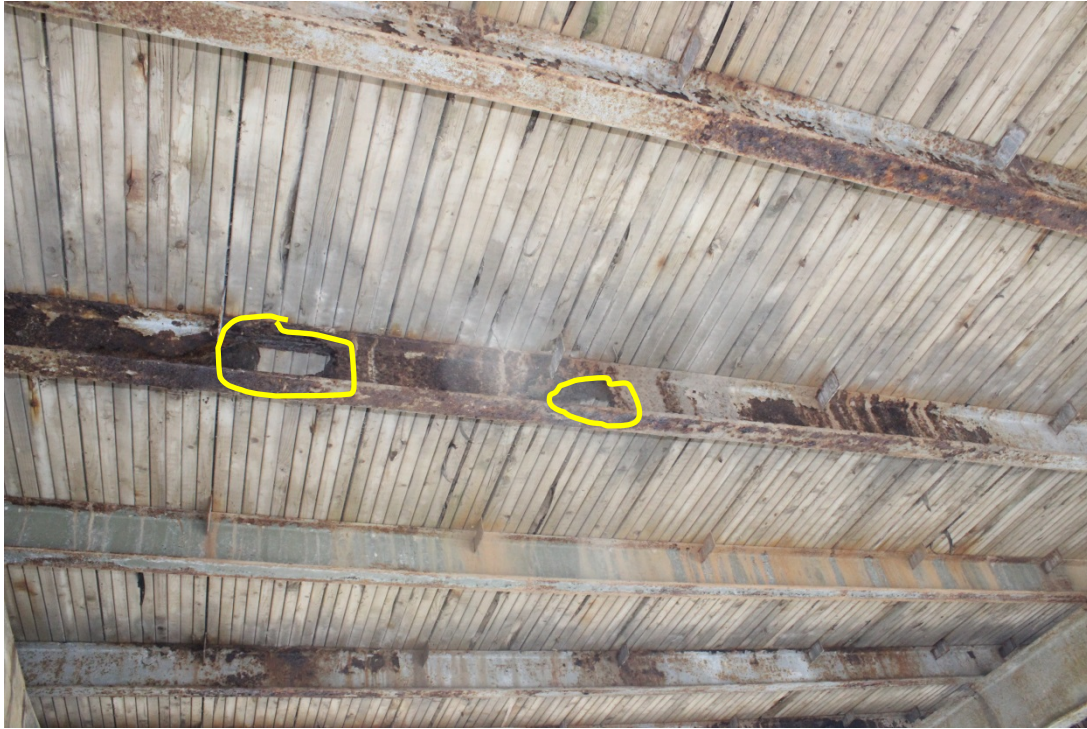
Image 15. General view of west bay of approach span looking downstream. Perforations circled.

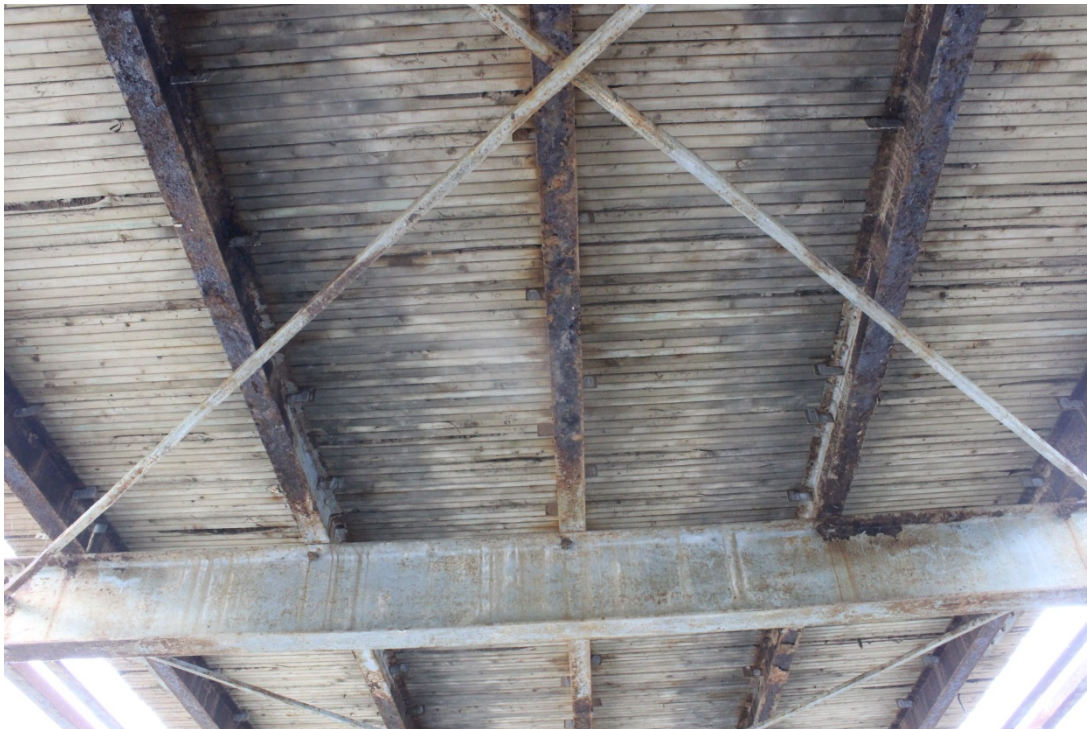
Image 16. Truss Bay 1 looking west

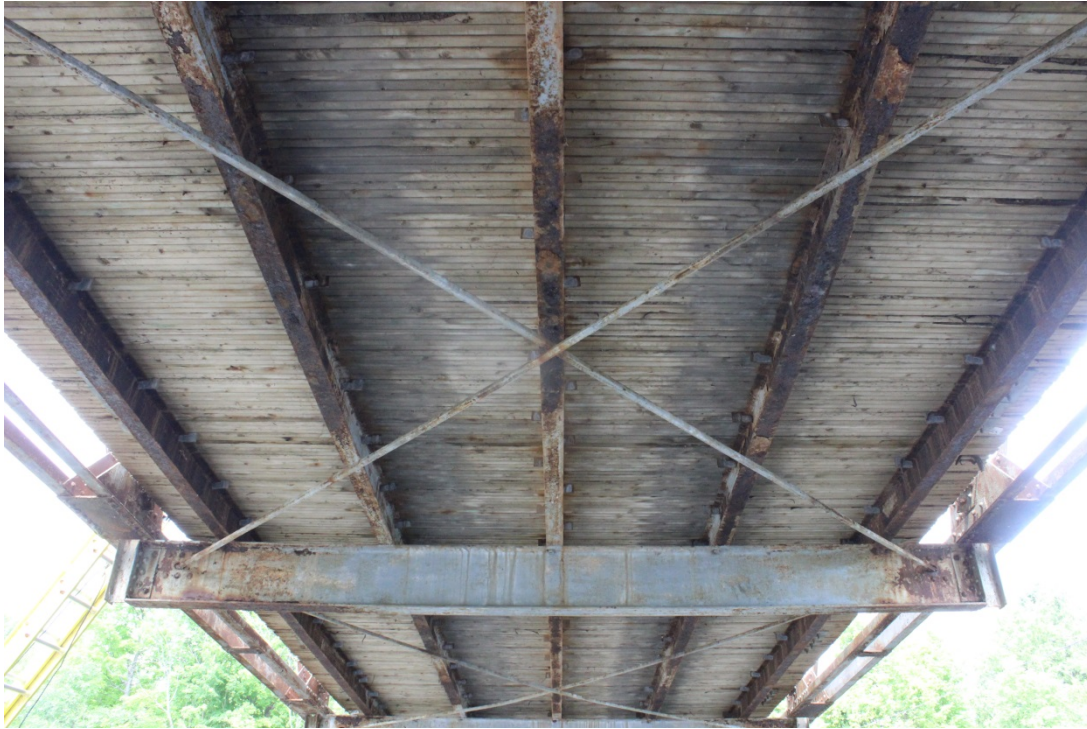
Image 17. Truss Bay 2 looking west

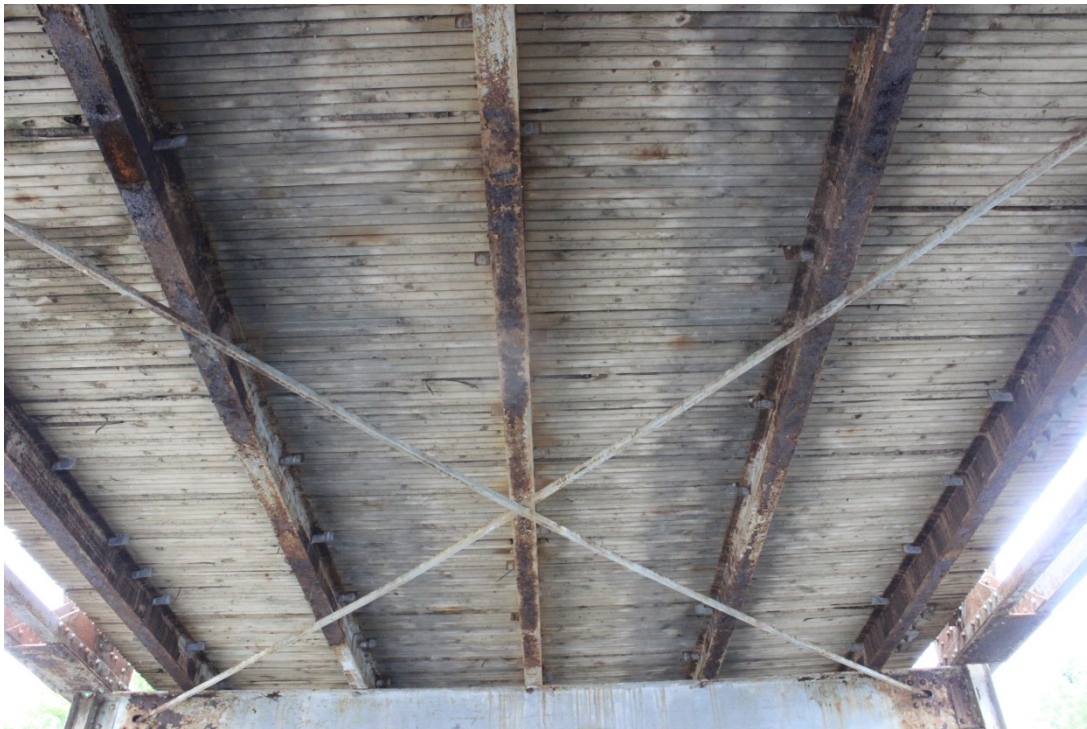
Image 18. Truss Bay 3 looking west

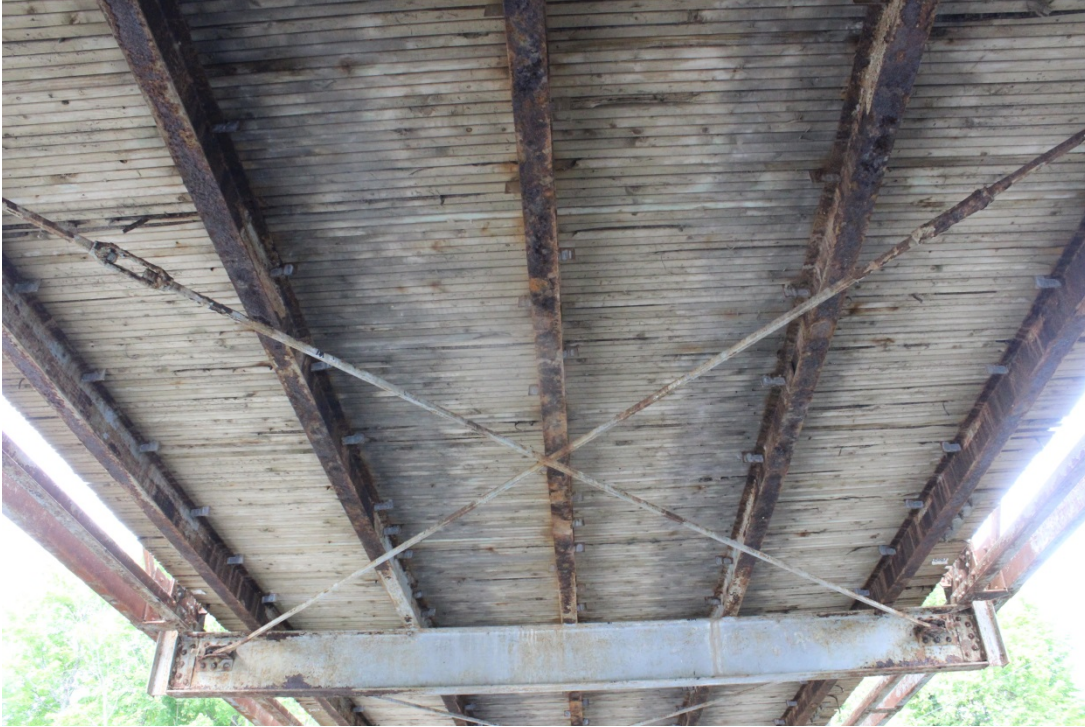
Image 19. Truss Bay 4 looking west

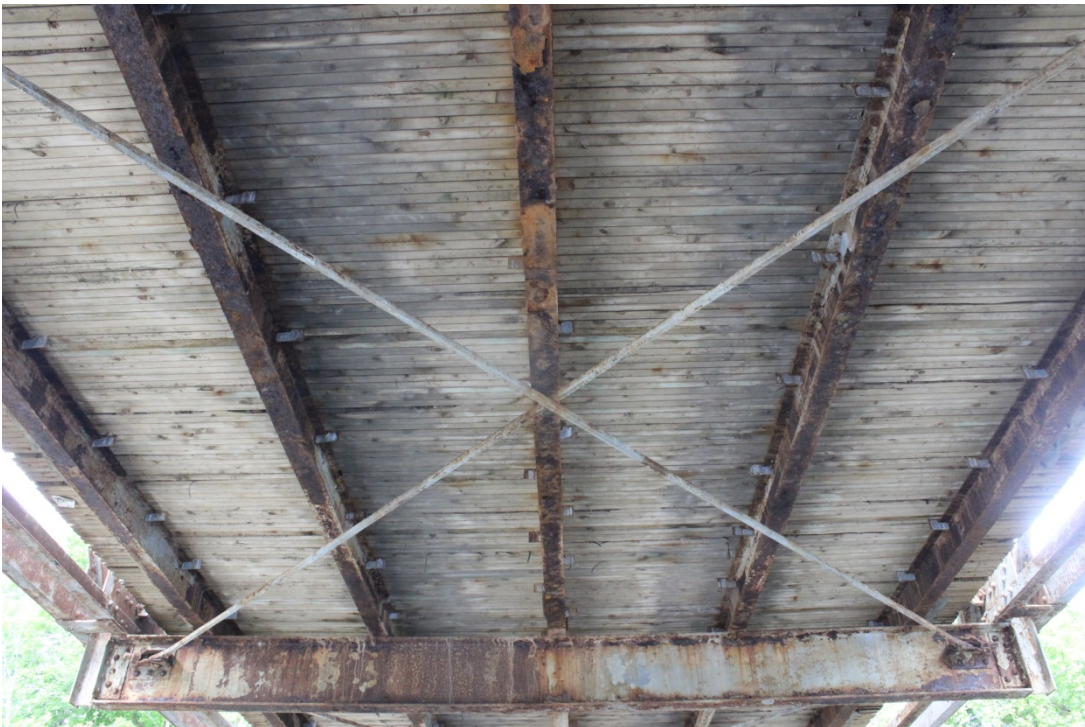
Image 20. Truss Bay 5 looking west

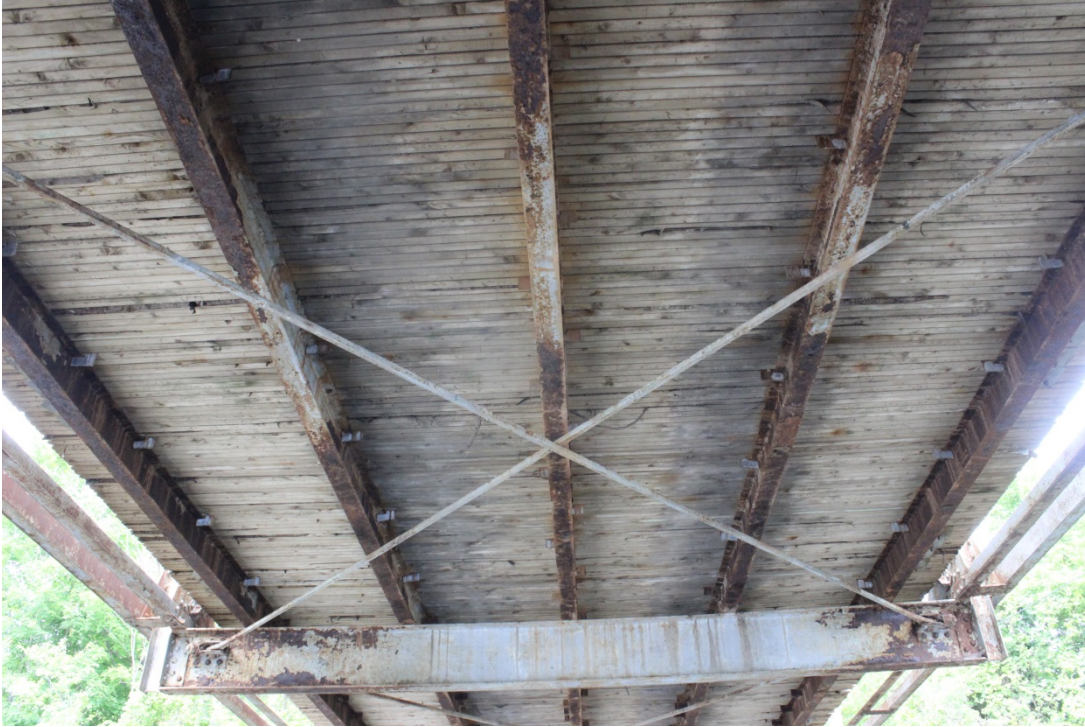
Image 21. Truss Bay 6 looking west

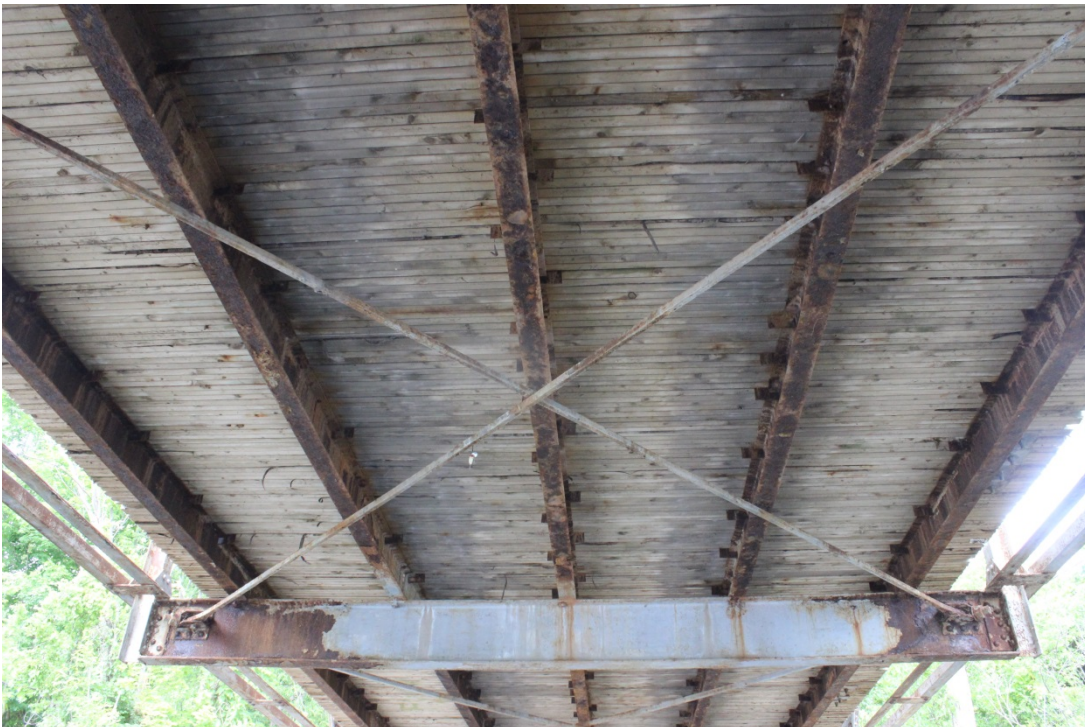
Image 22. Truss Bay 7 looking west

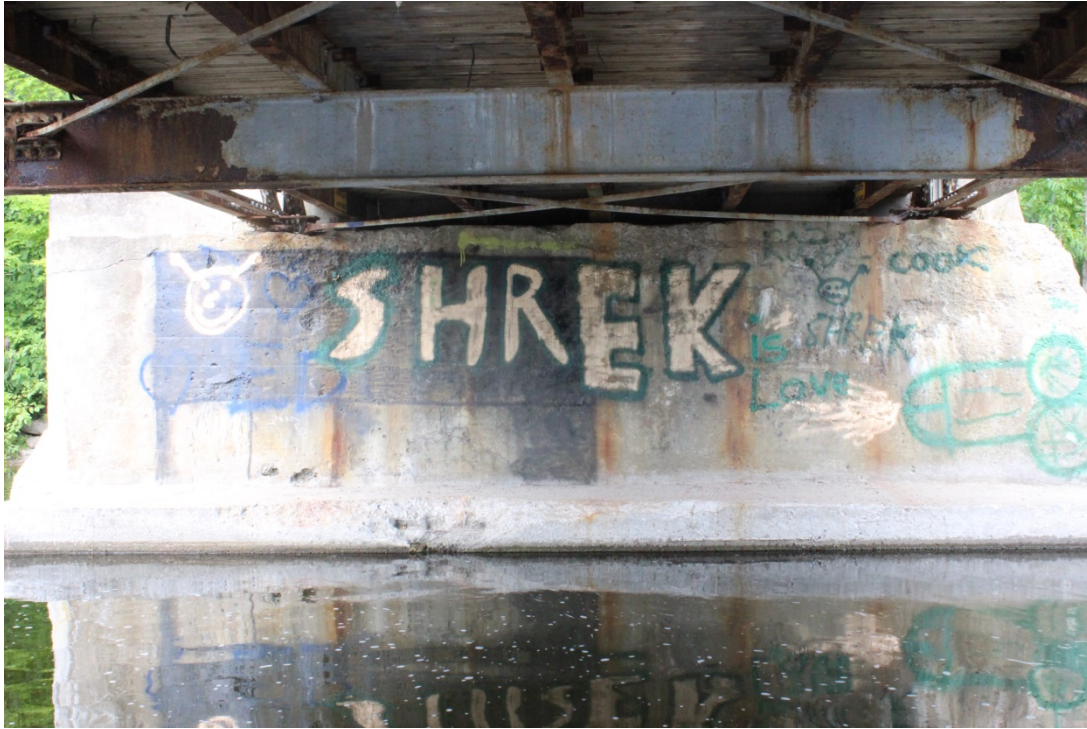
Image 23. West abutment

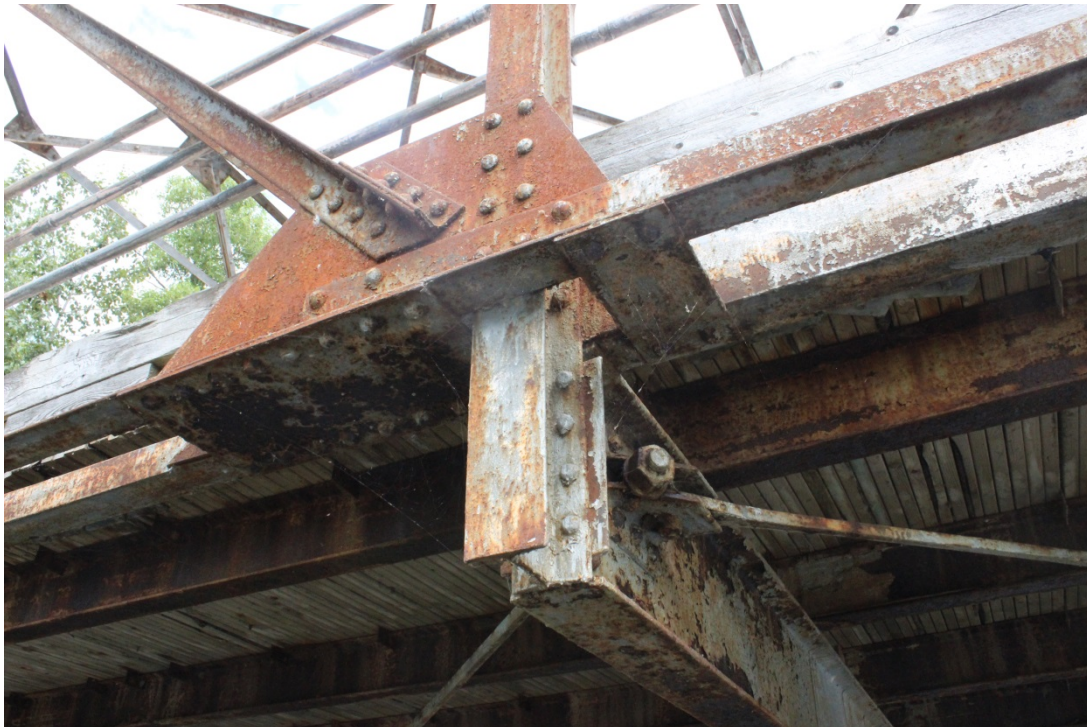
The truss bottom chords are visible from the bridge deck. Hence these were not inspected as closely as the stringers and floor beams. Nonetheless, the underside of the bottom chords was consistent with the top side condition. The bottom chords are in mostly fair to good condition with no significant section loss noted.

Image 24. South bottom chord between Bays 6 and 7. (Typical condition)

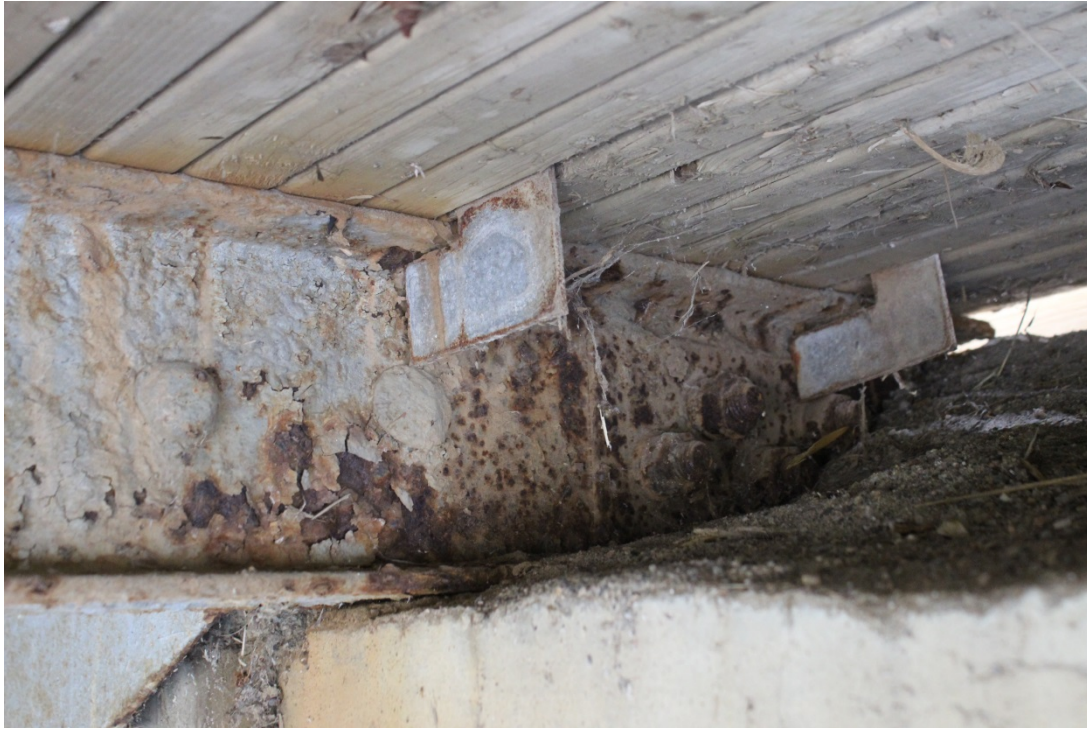
Image 25. Stringer 5 bearing area at east abutment

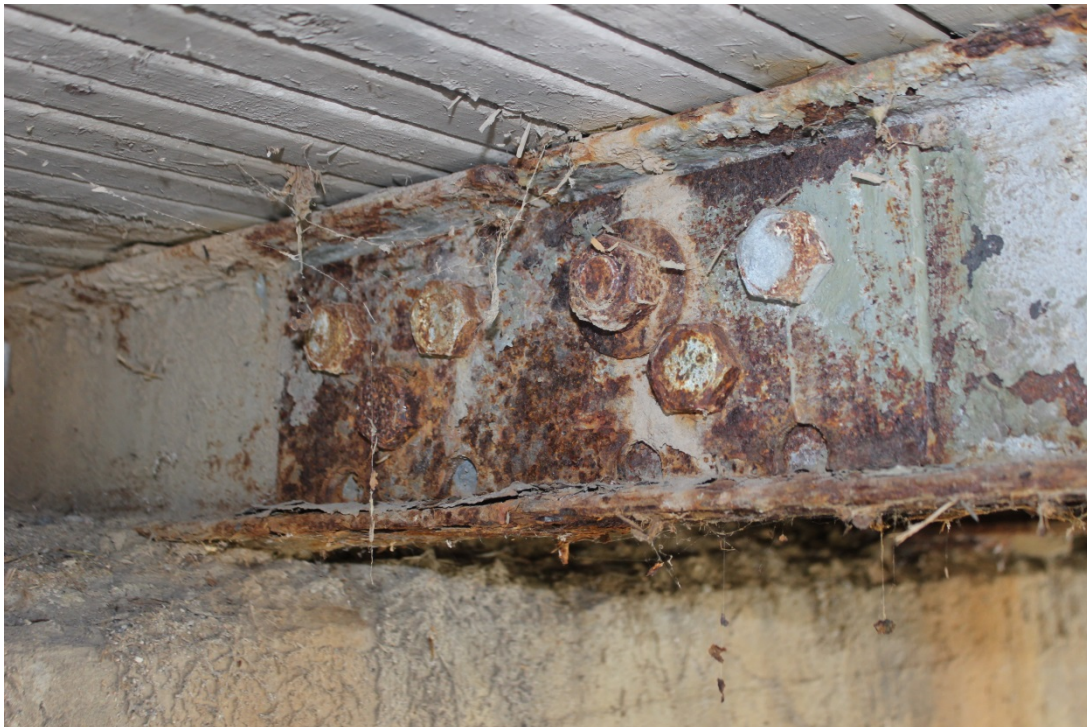
Image 26. Splice on Stringer 4 at east abutment

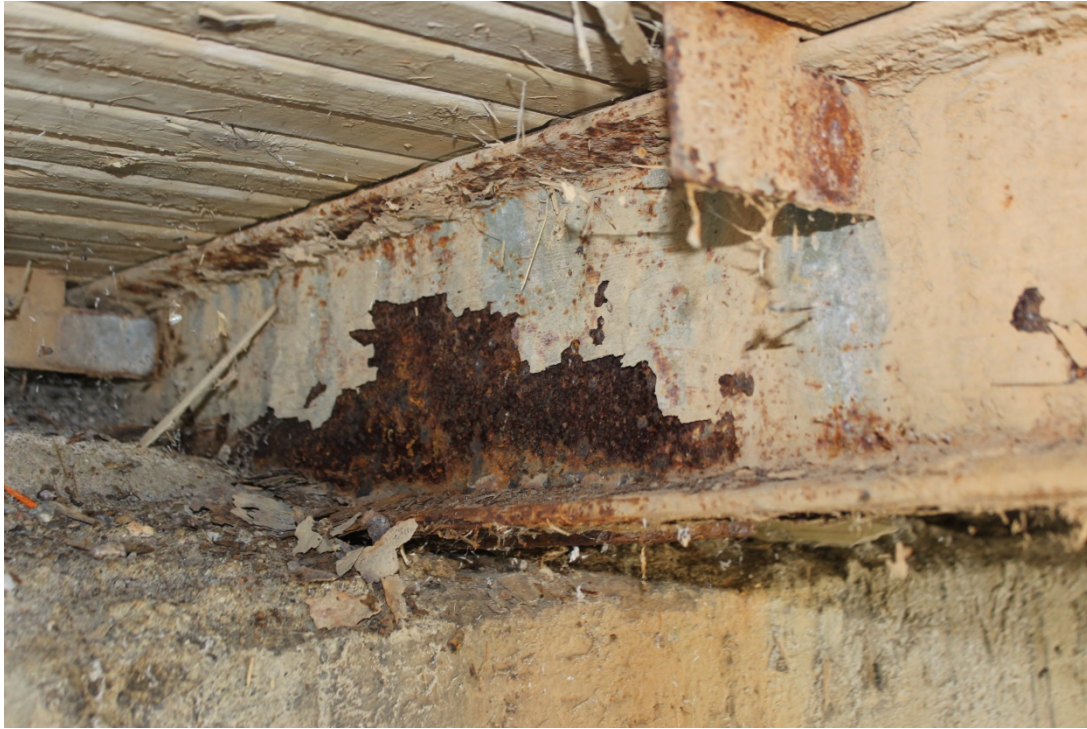
Image 27. Stringer 3 bearing area at east abutment

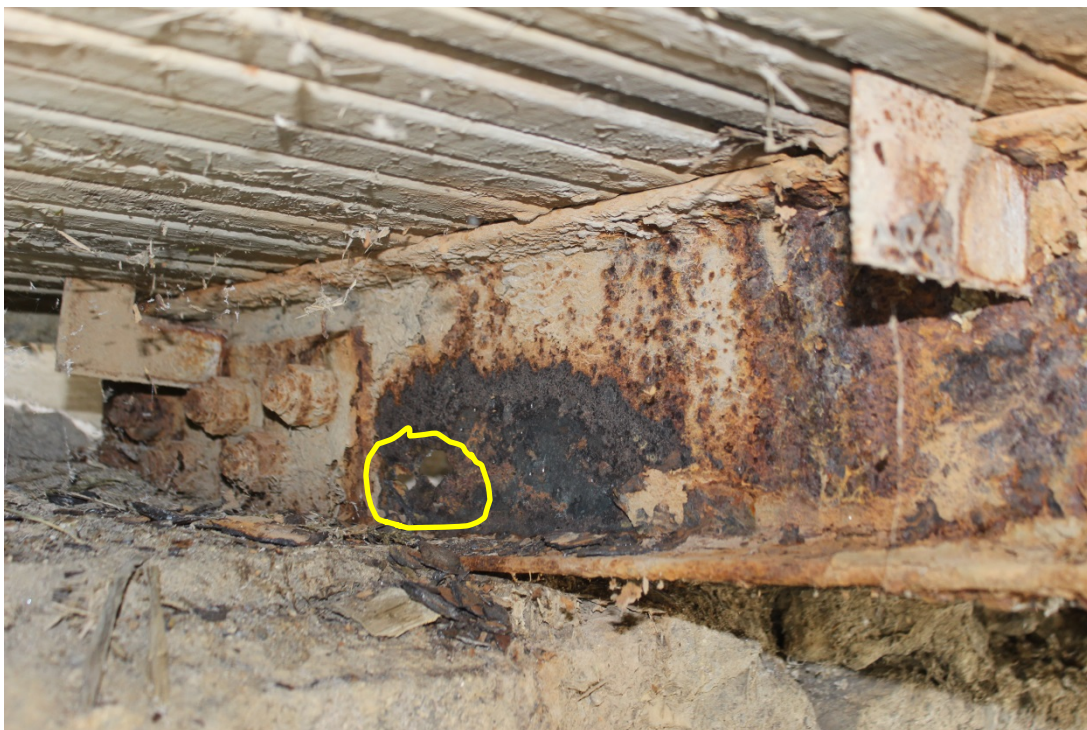
Image 28. Perforated Stringer 2 at east abutment bearing
