ANDREWSVILLE BRIDGE: OPTIONS FOR THE FUTURE

Re: Andrewsville Bridge

Andrewsville Bridge Wading Inspection

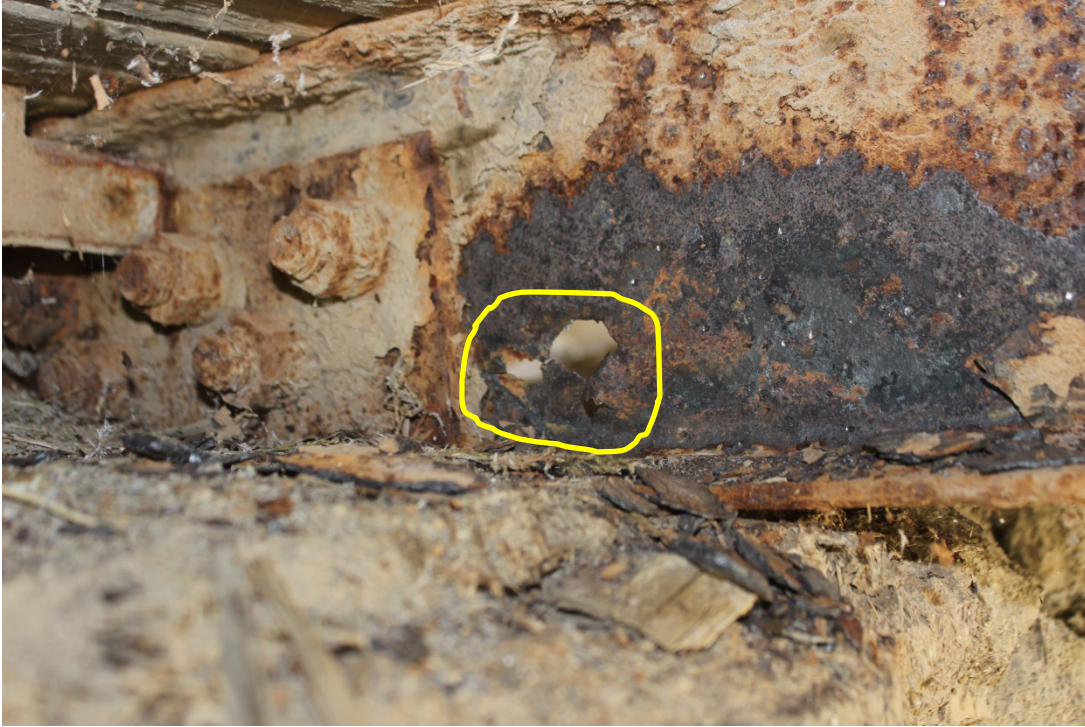
Image 29. Close up of perforated Stringer 2 at east abutment

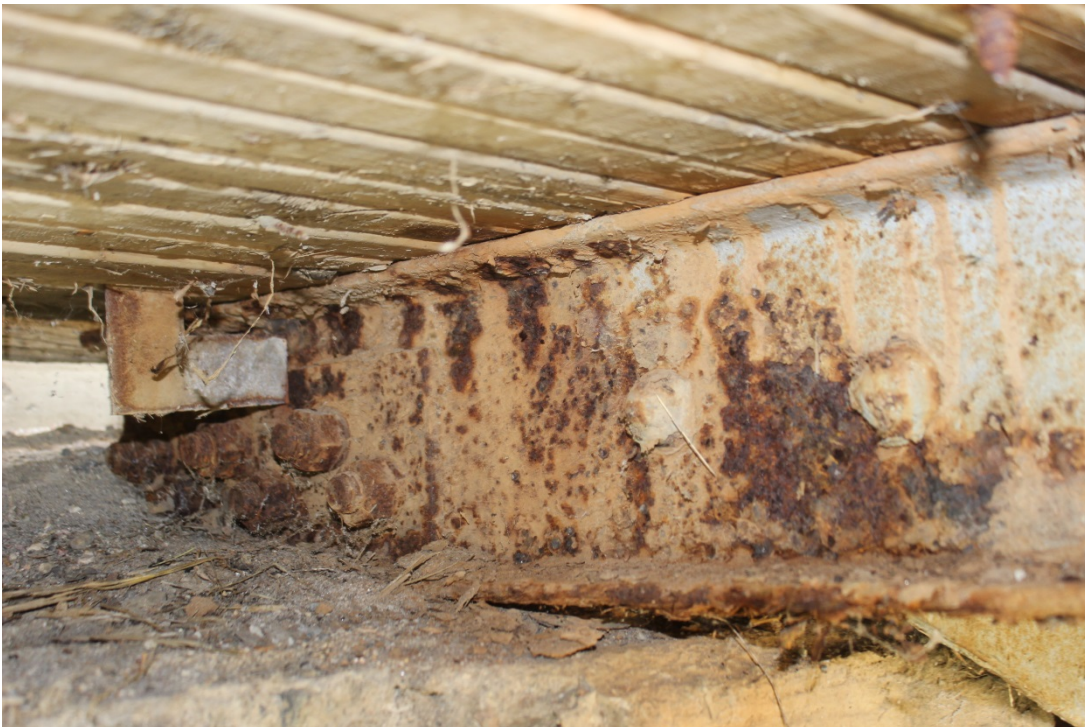
Image 30. Stringer 1 bearing area at east abutment

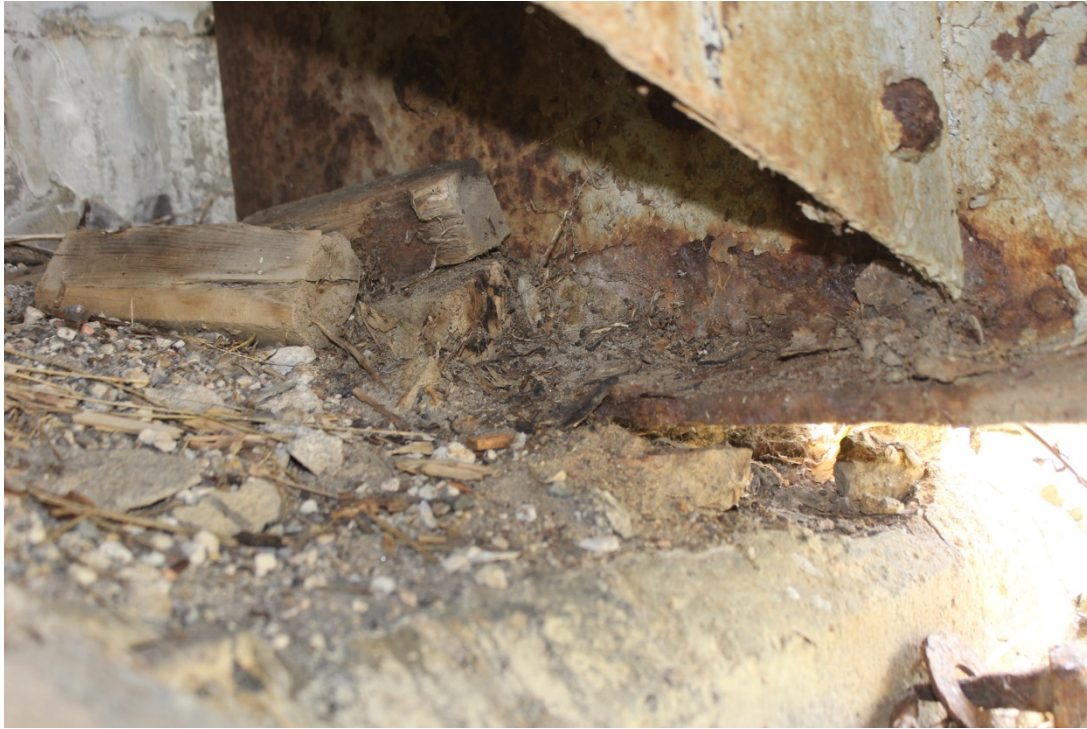
The girders of the east approach span exhibit the most corrosion at their bearings. Debris at the bearings and difficult access precluded a thorough assessment. However, it can be stated that these girders remain structurally sound for the current load limit on the bridge.

Image 31. South girder interior side bearing area at east abutment

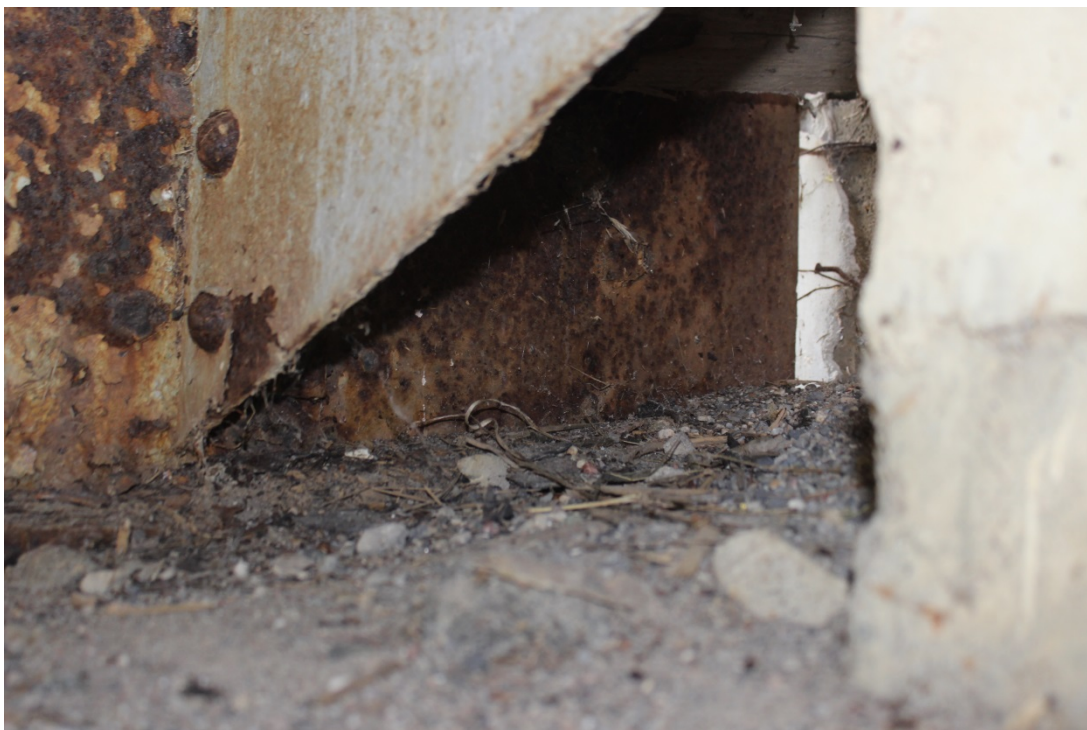
Image 32. North girder interior side bearing area at east abutment

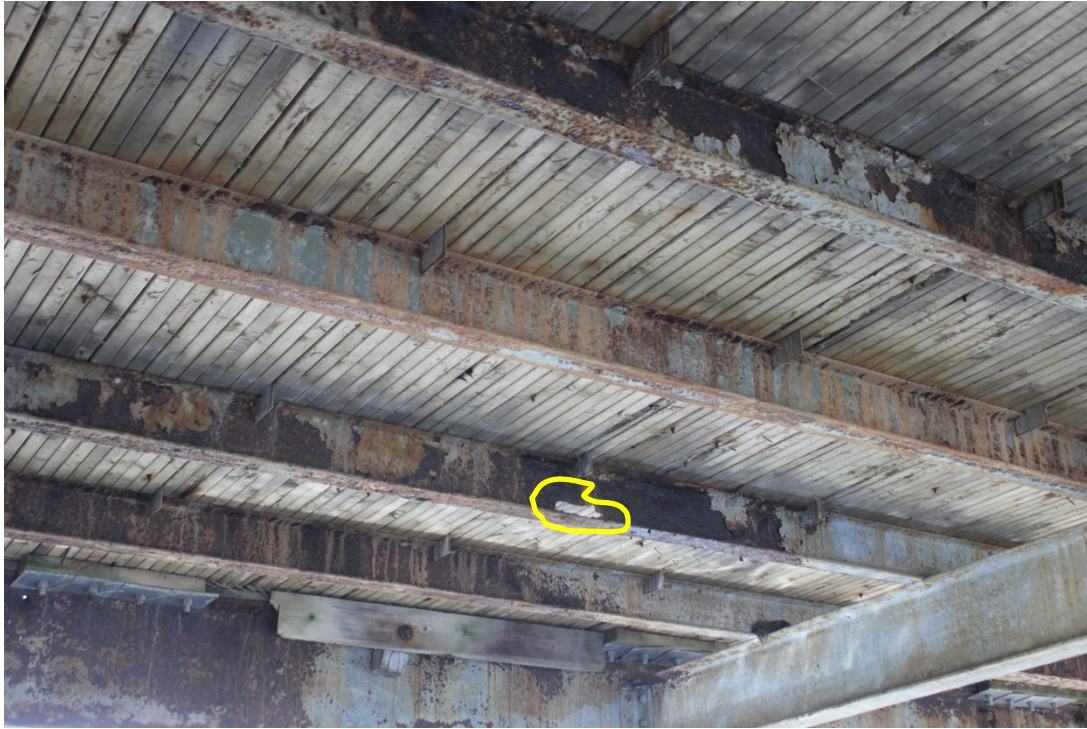
The stringers of the approach span are very similar in condition as the main truss, with the exception of Stringer 2. This stringer has four perforations of its web. The largest perforation involves the entire depth of the web. This stringer has very conservatively an average of 10 to 15% section loss.

Image 33. East bay of east approach span with perforation in Stringer 2

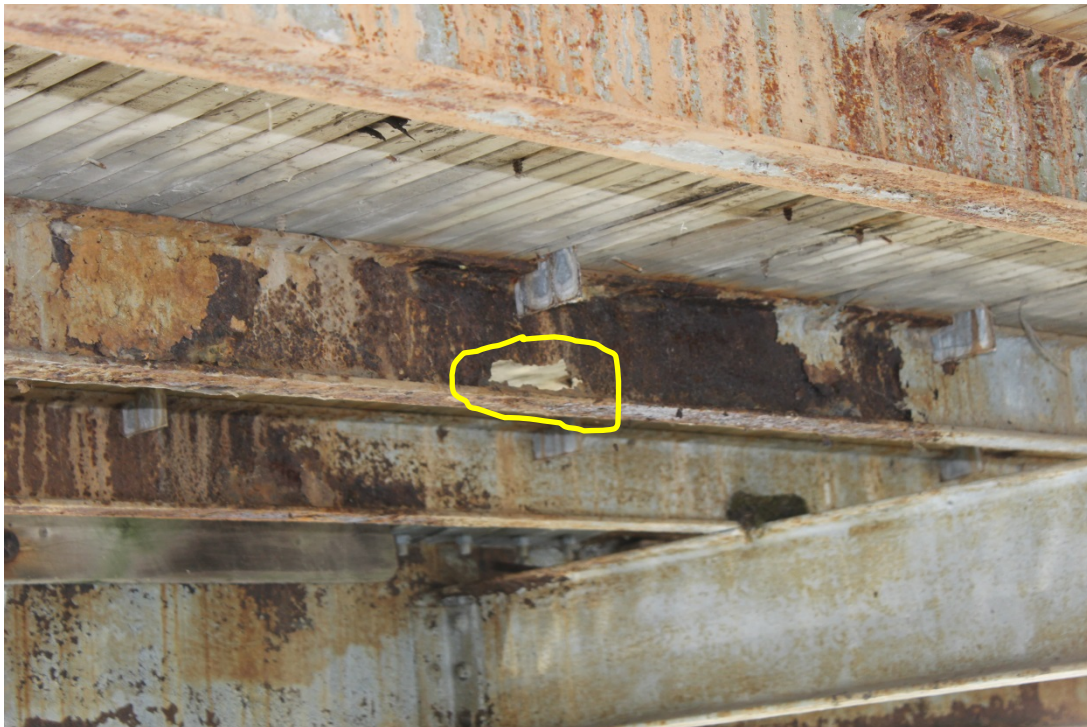
Image 34. Close-up of perforation shown in Image 33
