# Bridge Inspection Report

## Andrewsville Bridge

Road Name: *Andrewsville Main St*  
Site ID: *B40*  
Structure Type: *Truss-Through*  
Owner: *County of Lanark*  
Built: *1915*  
Length: *47.7 m*  
Width: *5.1 m*  
Spans: *1*  
Spans Arrange: *38.5 (truss) 9.2 (girder)*  
Feature Under: *Water*  
Crossing: *Rideau River*  
Location: *500m west of County Rd 23*

Inspection Date: *September-18-17*  
Inspector: *Harold Kleywegt, P.Eng.*  
Assistant: *Milena Tresnak*

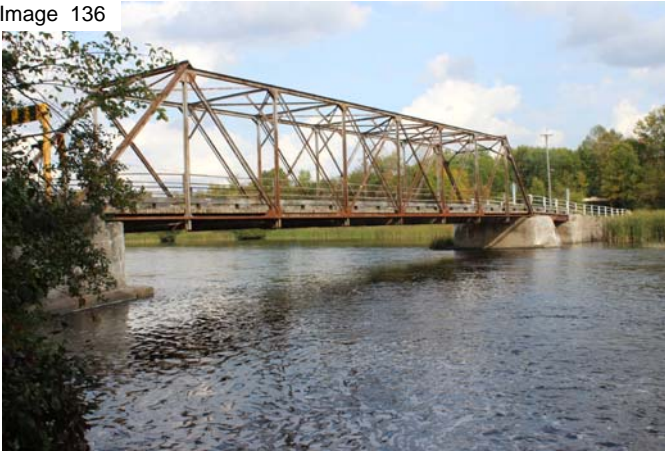
Image 136

West elevation

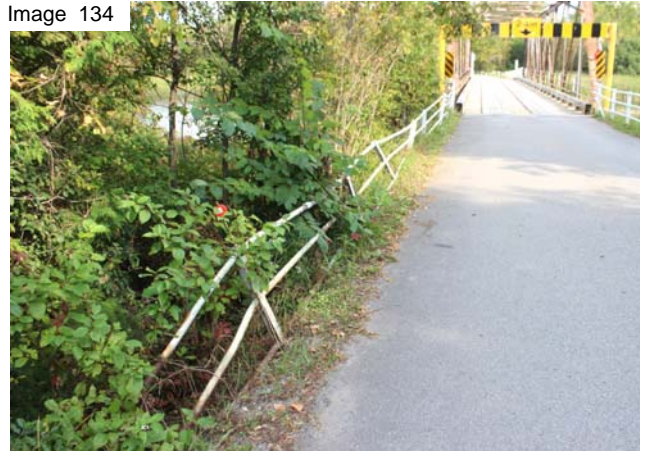
Image 134

| <b>Steel Pipe Ped Barrier (2)</b><br><b>Approach Barrier</b> | Defects <b>0.0%</b><br>Damage <b>20.0%</b> <b>Major Deformation, Moderate Impact</b><br>Maintenance <b>Repair Minor Damage</b><br>Capital Rec. <b>None</b><br><b>Perf Def: Weakened</b><br><i>Significant damage and settlement on north approach, east side. Settlement and tilting on south side.</i> |

Damaged pipe railing NE quadrant

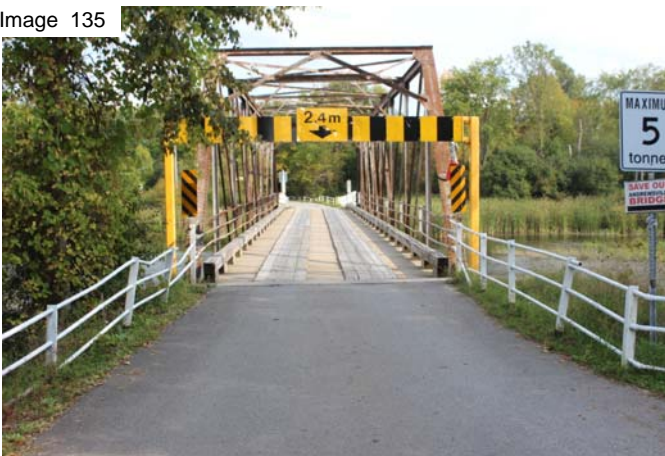
Image 135

North approach

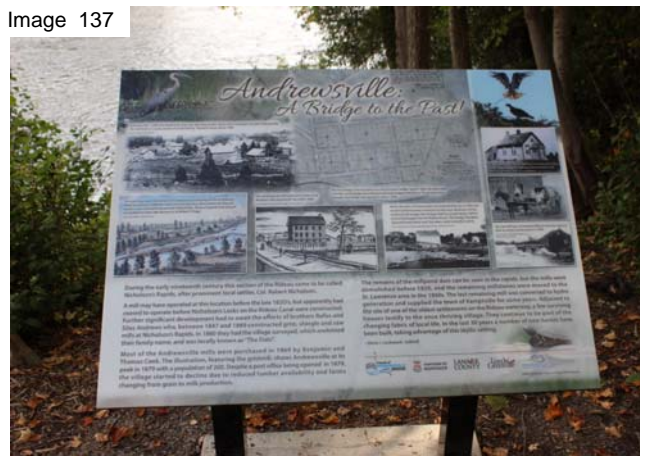
Image 137

Plaque in NW quadrant added in 2017

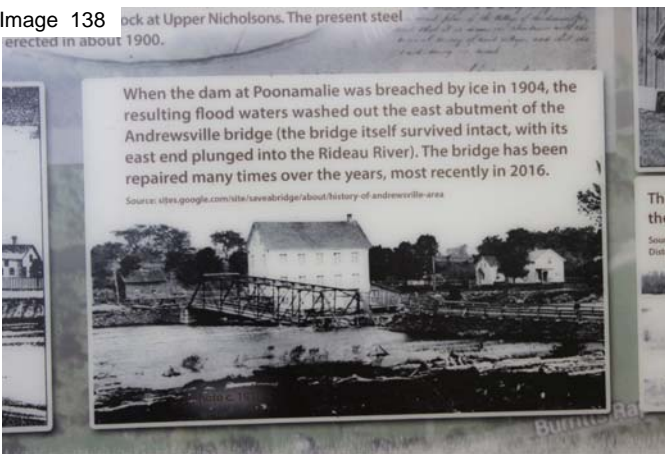
Image 138

Plaque detail

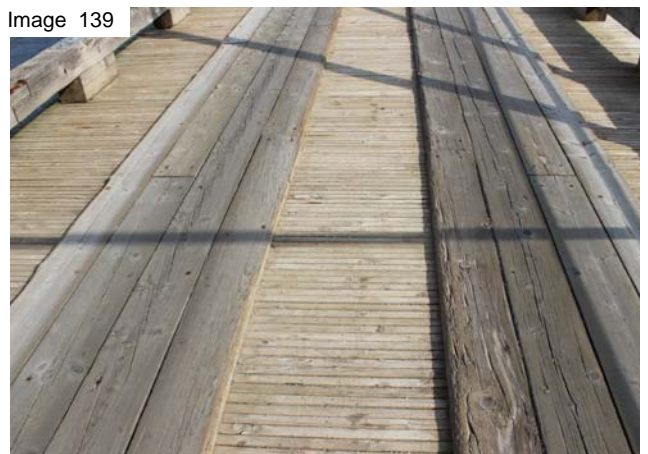
Image 139

| <b>Timber-Sawn ()</b><br><b>Running boards</b> | Defects <b>20.0%</b> <b>Moderate UV Weathering, Moderate Checking</b><br>Damage <b>2.0%</b> <b>Moderate Breakage</b><br>Maintenance <b>Local repair</b><br>Capital Rec. <b>None</b><br><i>The running boards at the pier have sustained some minor damage. Well secured.</i> |

Running boards and deck on truss

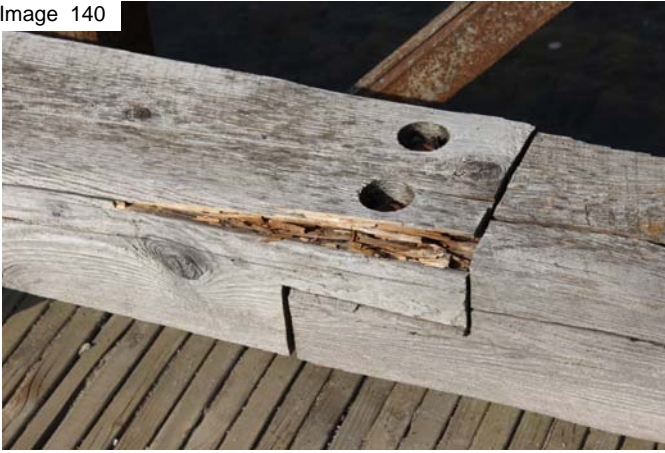
Image 140

| <b>Timber Curb (2)</b><br><b>Curbs</b> | Defects <b>0.0%</b><br>Damage <b>10.0%</b> <b>Major Decay</b><br>Maintenance <b>Local repair</b><br>Capital Rec. <b>Replace in 2 years</b><br><i>Significant decay noted in several areas in 2017. Some curb timbers completely decayed and require replacement. Entire curb system will require replacement in a few years.</i> |

Decay in curb timber

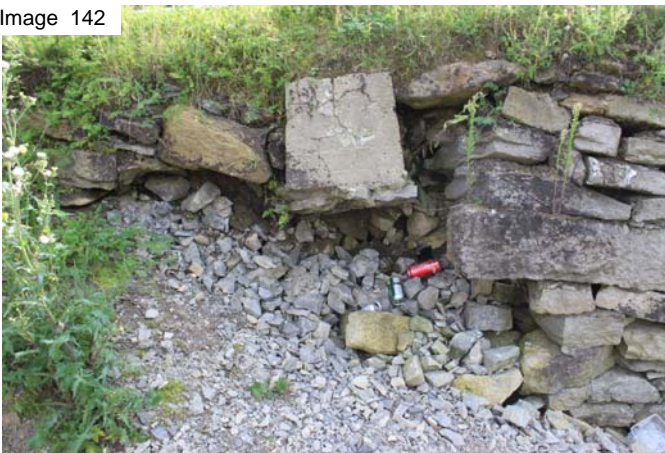
Image 142

Under-cut rail post foundation SE quadrant

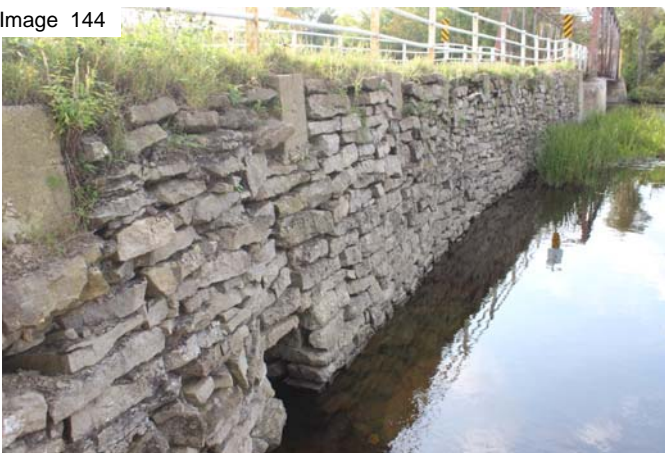
Image 144

| <i>There is significant flow penetrating through the causeway on the south approach. The dry stone walls on the sides of the embankment have bulged on the east side. Frost action has loosened and disintegrated some of the stonework to a depth of 0.3 m. There is a strong possibility of partial collapse of in particular the east side of the causeway. This collapse could occur with little or no warning. Severe bulging of dry stone wall at NE quadrant, and is in serious condition. Water has partly undercut portions of wall on south approach. See images.</i> | | |

Dry stone embankment wall SE quadrant

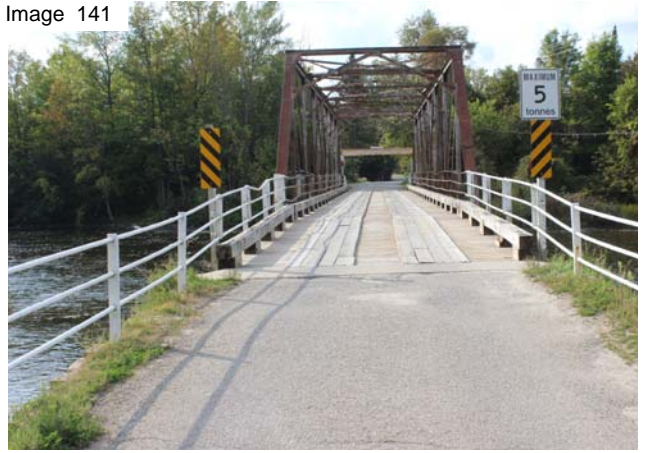
Image 141

South approach

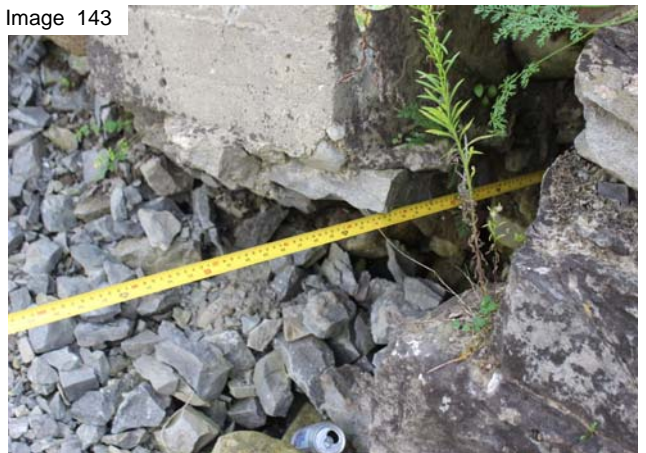
Image 143

600 mm under-cut SE quadrant

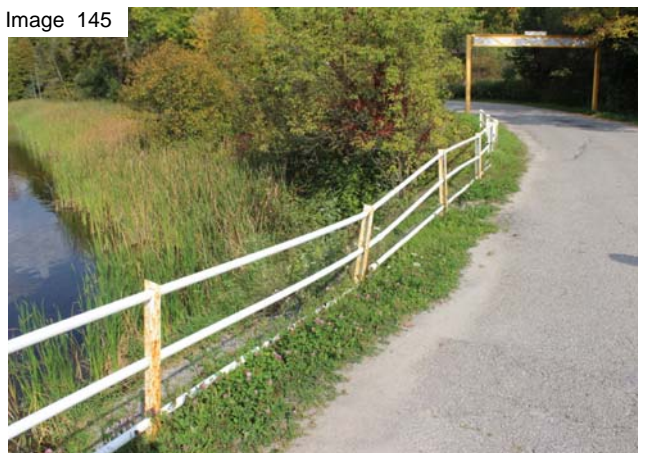
Image 145

Sagged rail at under-cut location

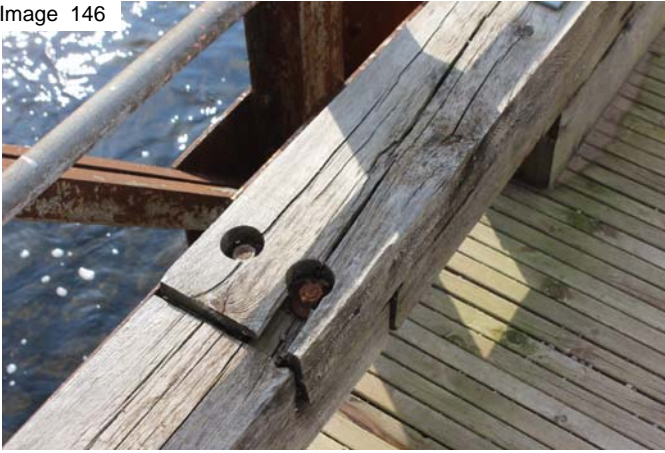
Image 146

Curb timber decay on truss

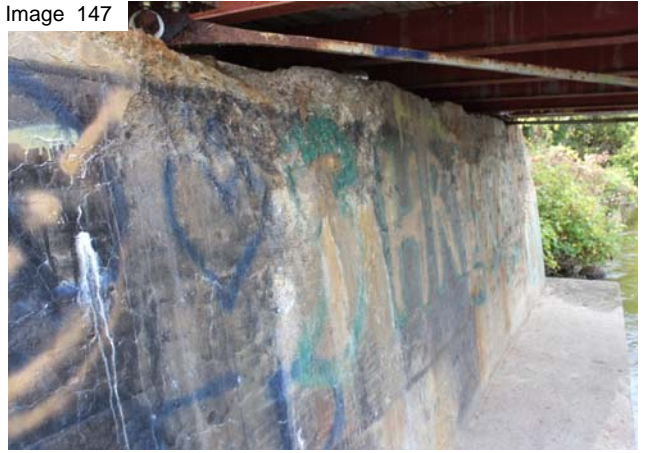
Image 147

North abutment wall

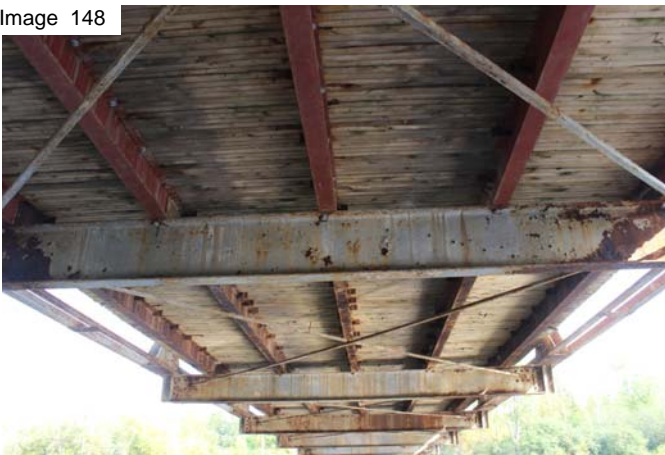
Image 148

Truss soffit looking south

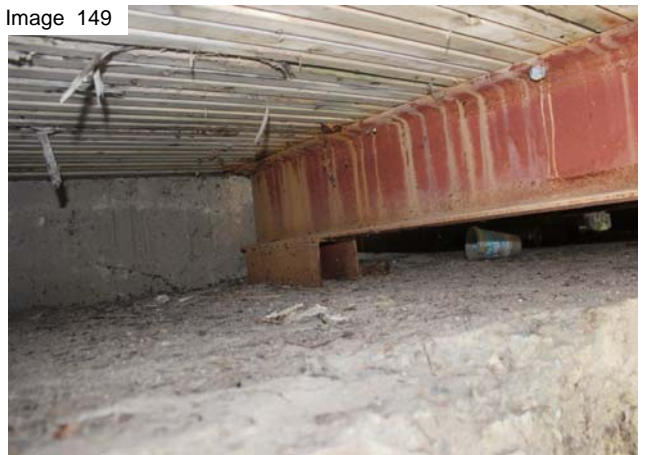
Image 149

New stringer at north abutment

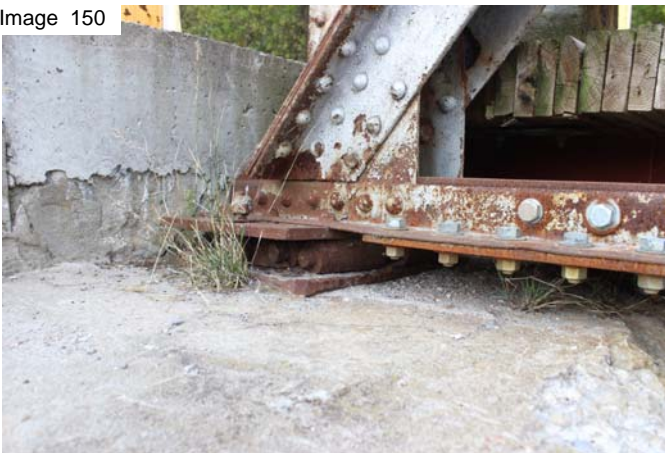
Image 150

| Height: | | <i>Bearings are covered in debris at pier and should be power washed. Nested roller bearings at north abutment are heavily rusted.</i> | |

Nested roller bearing NW truss corner

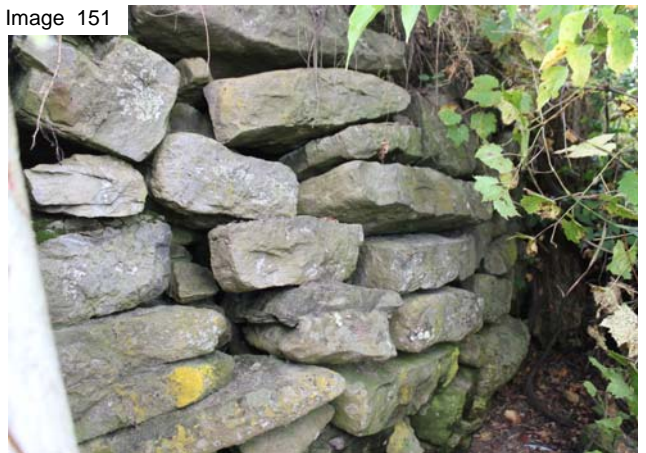
Image 151

Bulging dry stone embankment wall NE quadrant

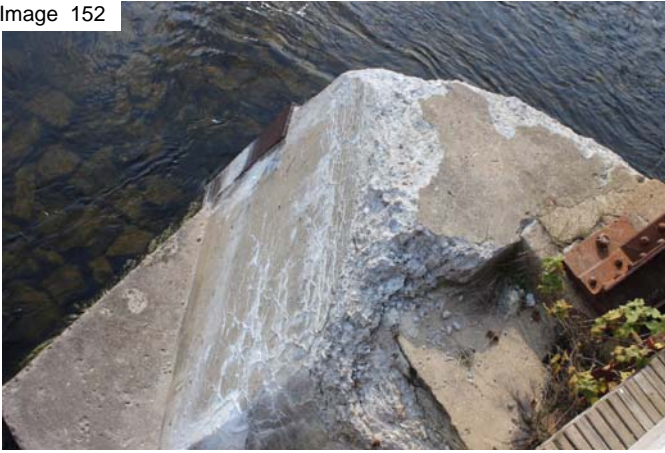
Image 152

| Height: | 2.2 m | <i>Not possible to inspect most surfaces. Top is experiencing severe disintegration especially at nosing.</i> | |

Disintegrating pier nosing

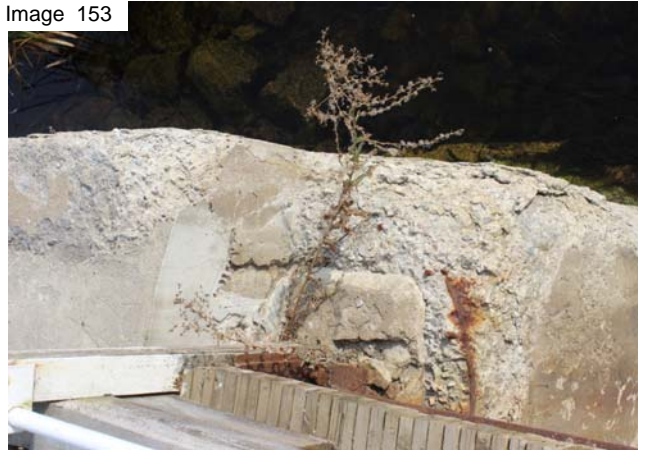
Image 153

| Height: <b>2.2 m</b> | <i>AAR related disintegration with leach staining and scaling.</i> | |

Disintegrating south abutment west side

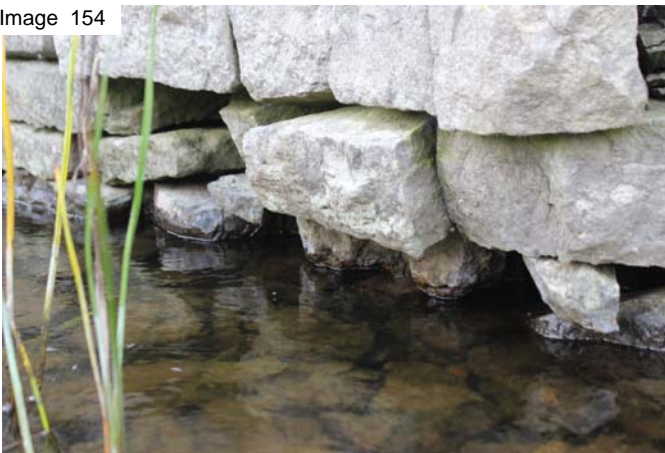
Image 154

Under-cut dry stone wall SE quadrant

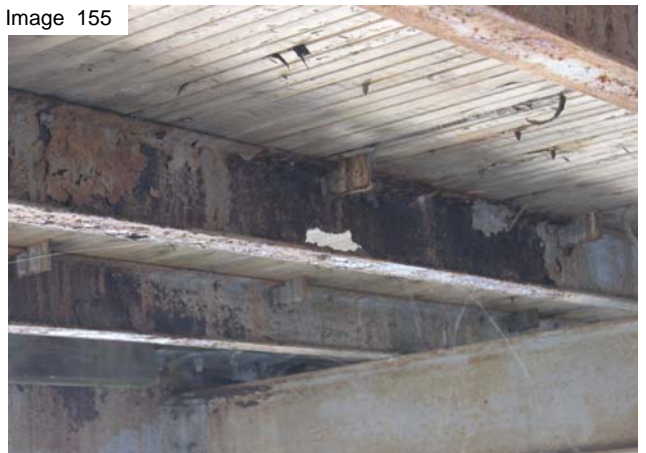
Image 155

| Height: <b>0.3 m</b> | <i>Some stringer ends have been repaired with bolted extensions. Stringers at the west abutment replaced in 2016. Large perforations in stringer 2 from west on south approach span and south end of truss.</i> | |

Peforation stringer 2 approach span south end

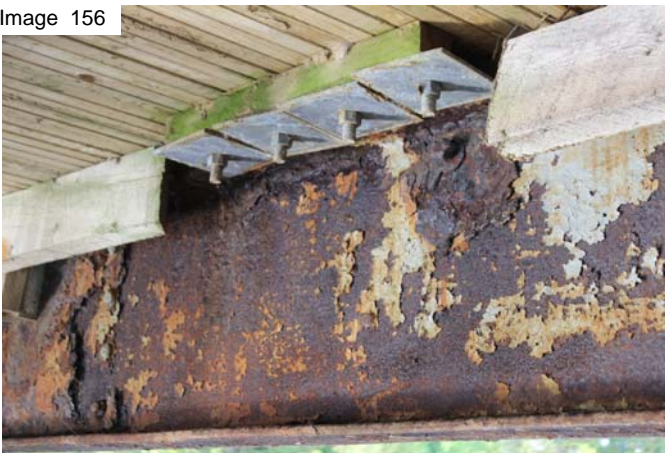
Image 156

| <b>Steel-Fabricated (2)</b><br><b>I-type - Girder</b> | Defects <b>20.0%</b> <b>Moderate Corrosion</b><br>Damage <b>5.0%</b> <b>Minor Section Loss</b><br>Maintenance <b>None</b><br>Capital Rec. <b>None</b><br><b>Partial Inspection</b><br><i>Much of coating is lost, with rust blisters on the lower flanges.</i> |

Slab rust on east girder of south approach span

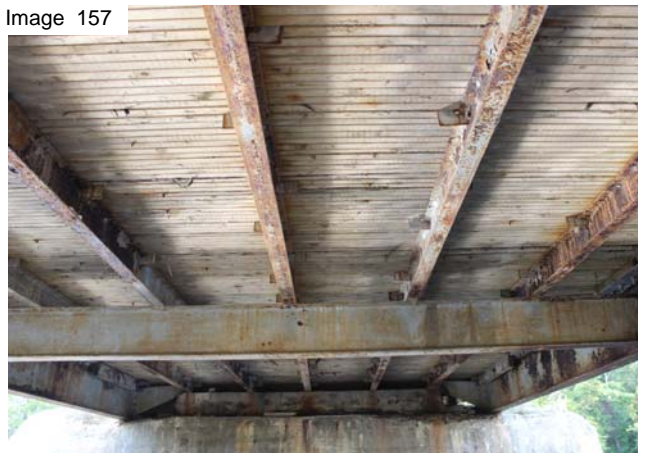
Image 157

South approach span soffit

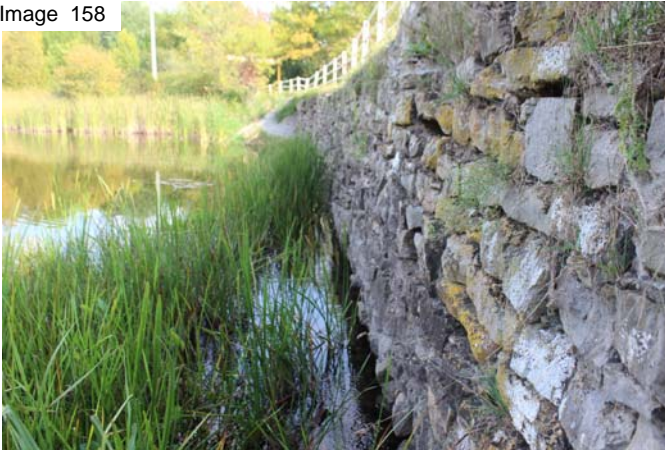
Image 158

Dry stone wall SE quadrant
