ANDREWSVILLE BRIDGE UPDATE

ANDREWSVILLE BRIDGE UPDATE AND CONSULTING ENGINEER'S 2018 WADING INSPECTION REPORT

Andrewsville Bridge 2018 Wading Inspection

Introduction

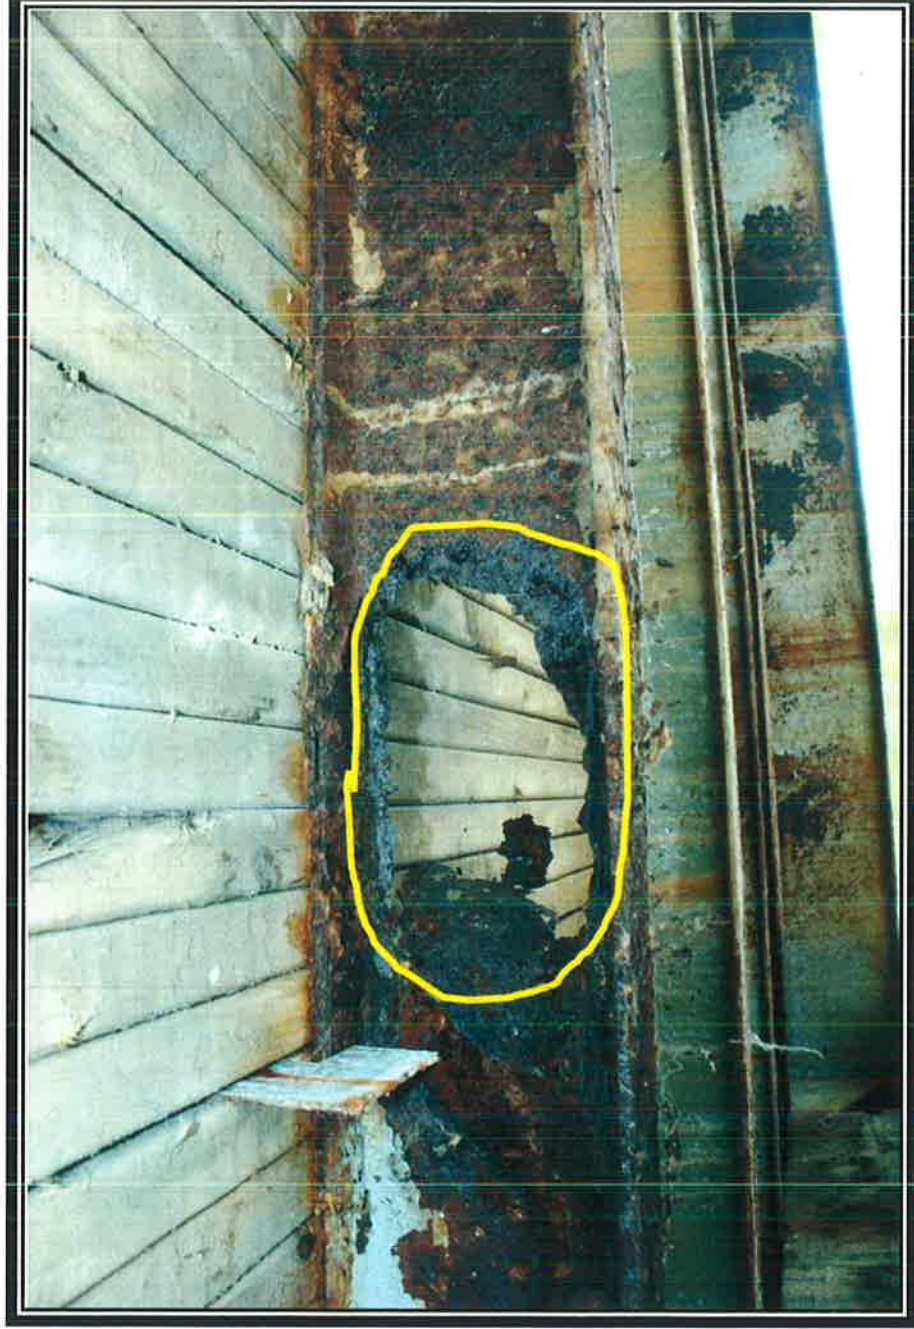
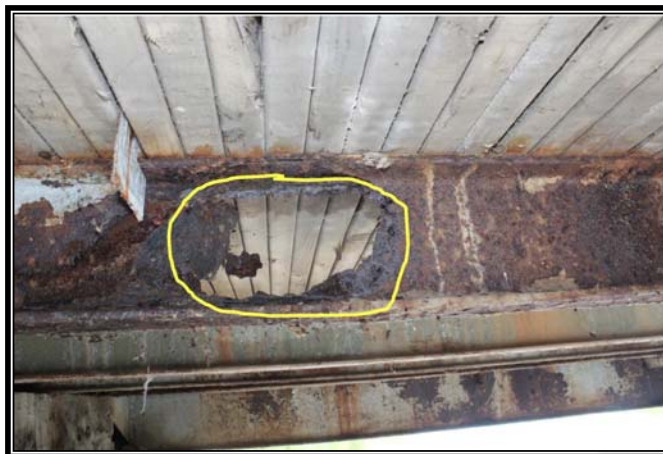
PERFORATION OF APPROACH STRINGER 2 AFTER PROBING

Stringer 2 of the east approach span is severely perforated both west and east of the intermediate supporting floor beam. This stringer has almost no remaining strength.

5. The stringers of the east approach span should be replaced at this time.
6. The timber deck curbs should be replaced at this time.

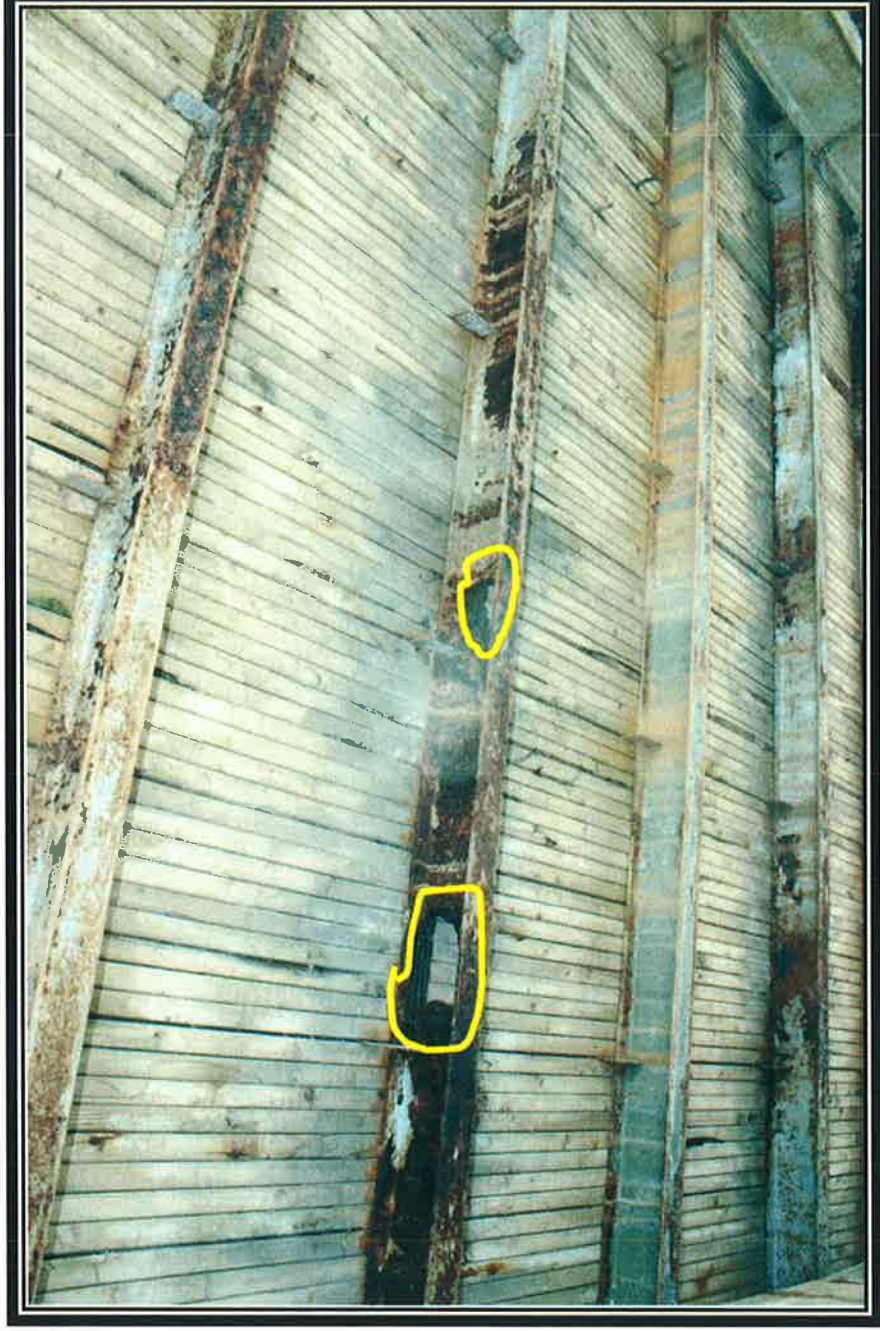
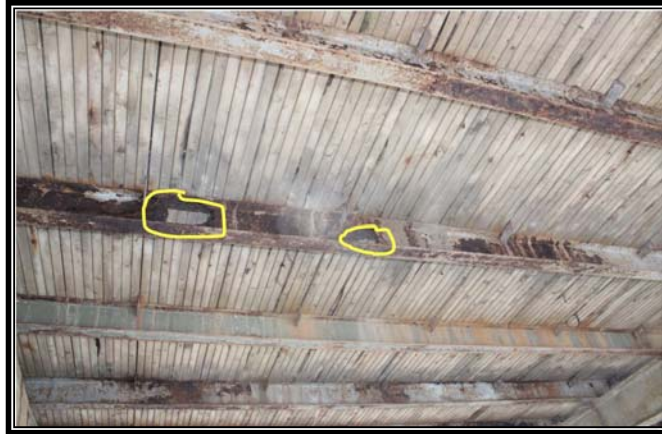
GENERAL VIEW OF WEST BAY OF
APPROACH SPAN LOOKING DOWNSTREAM.
PERFORATIONS CIRCLED.

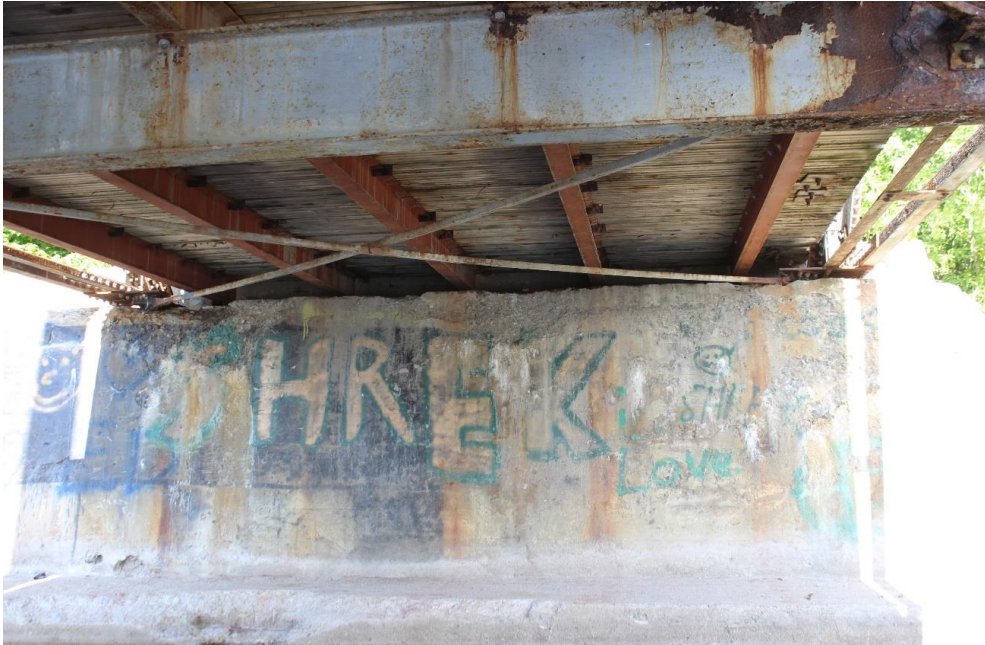
The Bay 1 stringers were not inspected as they were replaced in late 2016.

Image 1. West abutment and replaced Bay 1 stringers, Floor Beam 1 in foreground.

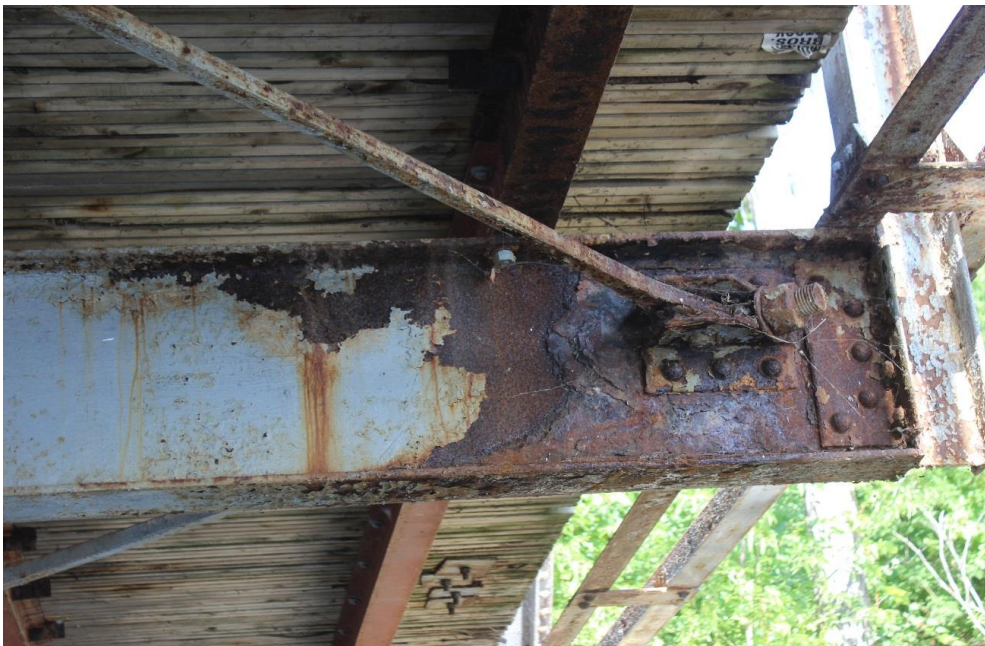
The ends of the floor beams are most heavily involved in corrosion. Slab rust is evident on the webs and flanges of the floor beam ends. There is still residual paint on the centre sections of the floor beams. Although the floor beams are slightly weakened by corrosion, they are more than adequate for the present load limit on the bridge.

Image 2. North end of Floor Beam 1 (FB 1) with slab rust evident

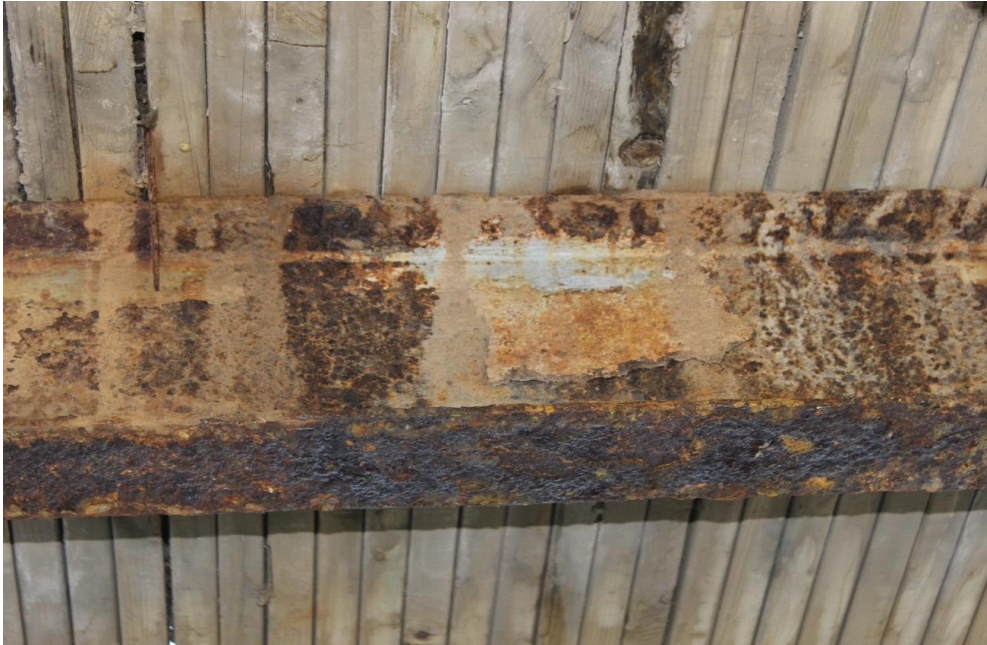
Image 3. Stringer 4 north side adjacent FB 2, slab rust, severe corrosion

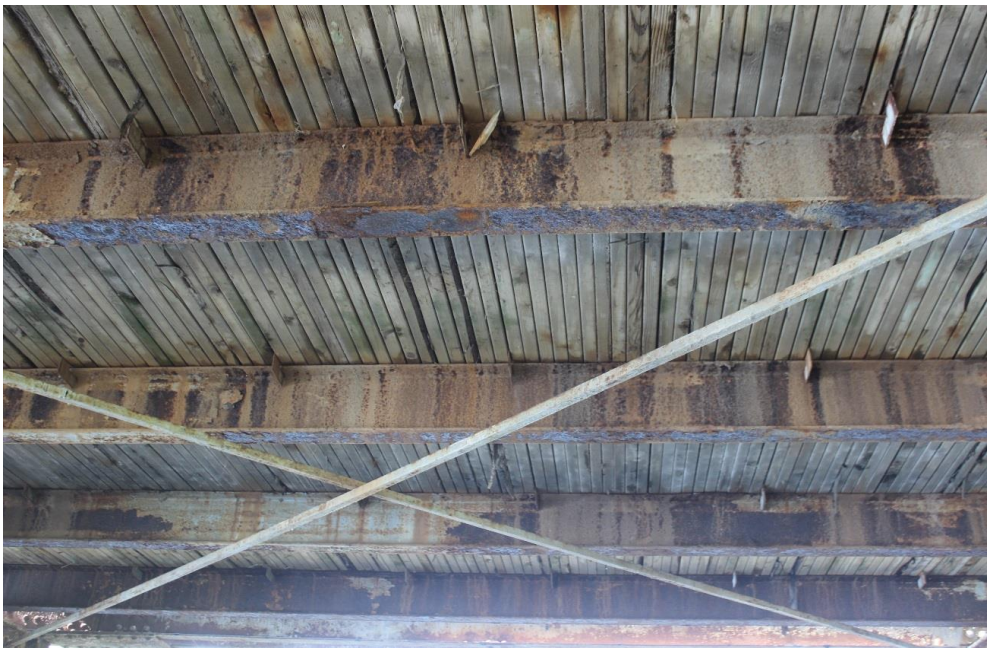
Image 4. Bay 3 looking south, Stringers 4,3,2,1 visible

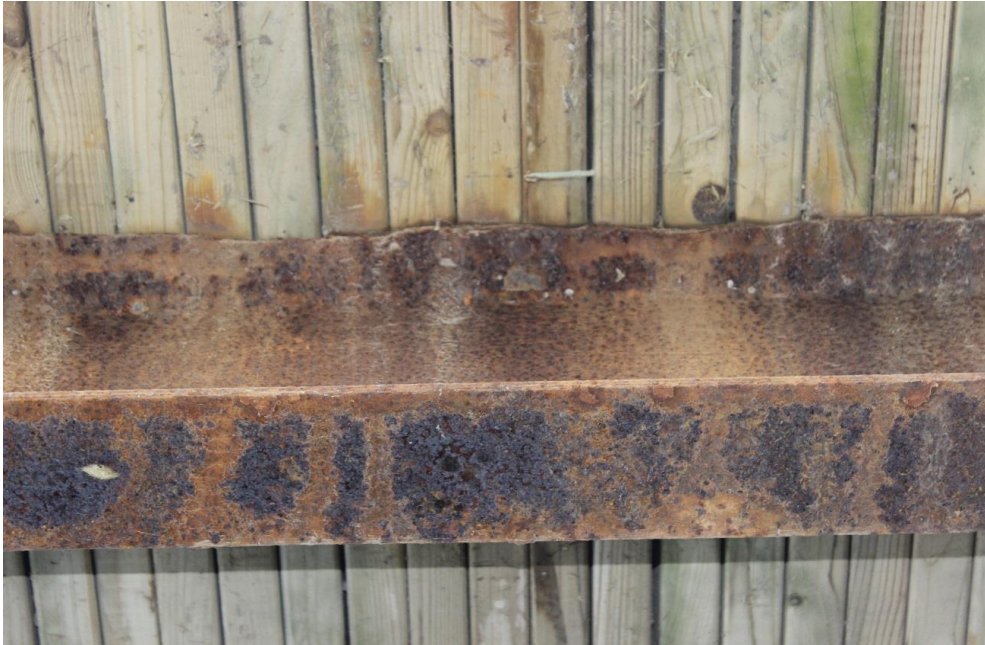
Image 5. Stringer 5, Bay 3 with top flange thinning

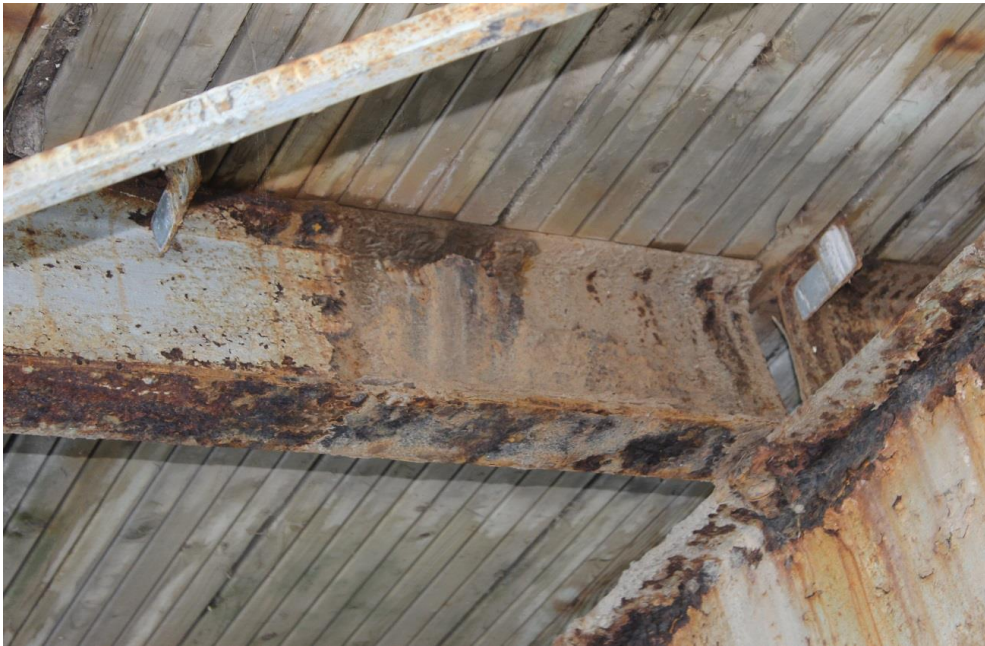
Image 6. Slab rust on north face of web of Stringer 4 adjacent FB 3

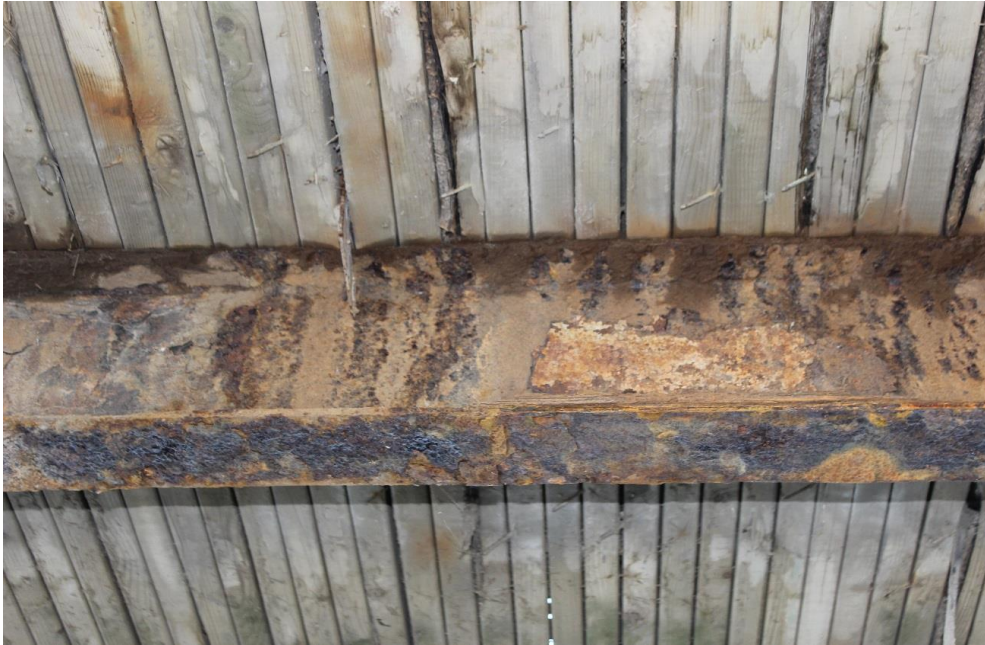
Image 7. North face Stringer 4 between FB 4 & 5, flange& web thinning, slab rust present

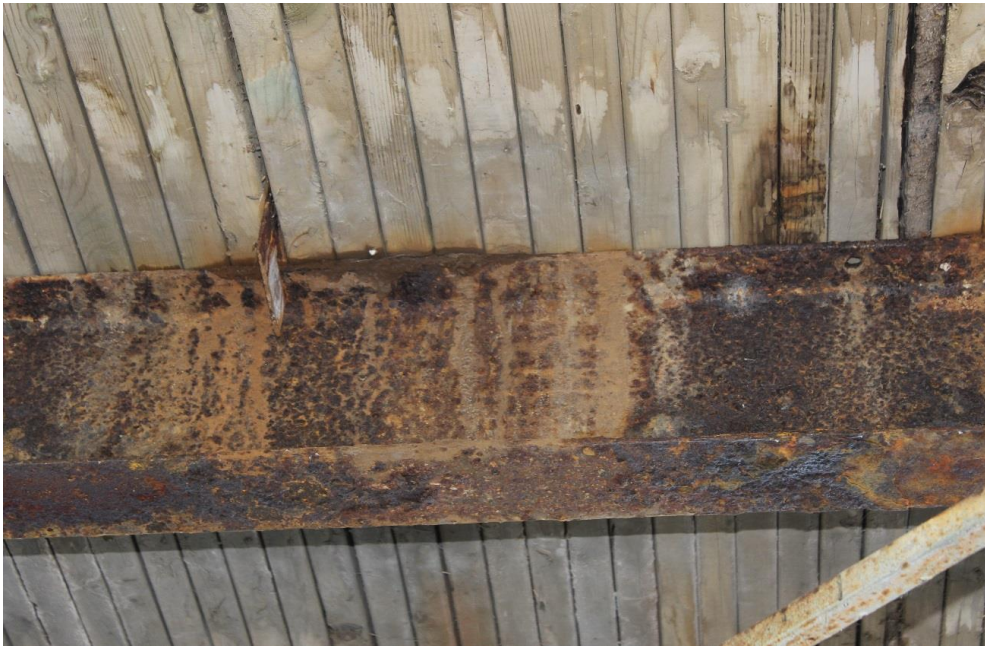
The principal concern is the condition of the stringers. The stringers exhibit areas of severe corrosion with slab rust and severe thinning of the webs and flanges. In some localized areas the stringers may have lost an estimated 40% of their design strength due to section loss caused by corrosion.

Image 8. South face Stringer 2 between FB 5 & 6, representative corrosion for most stringers

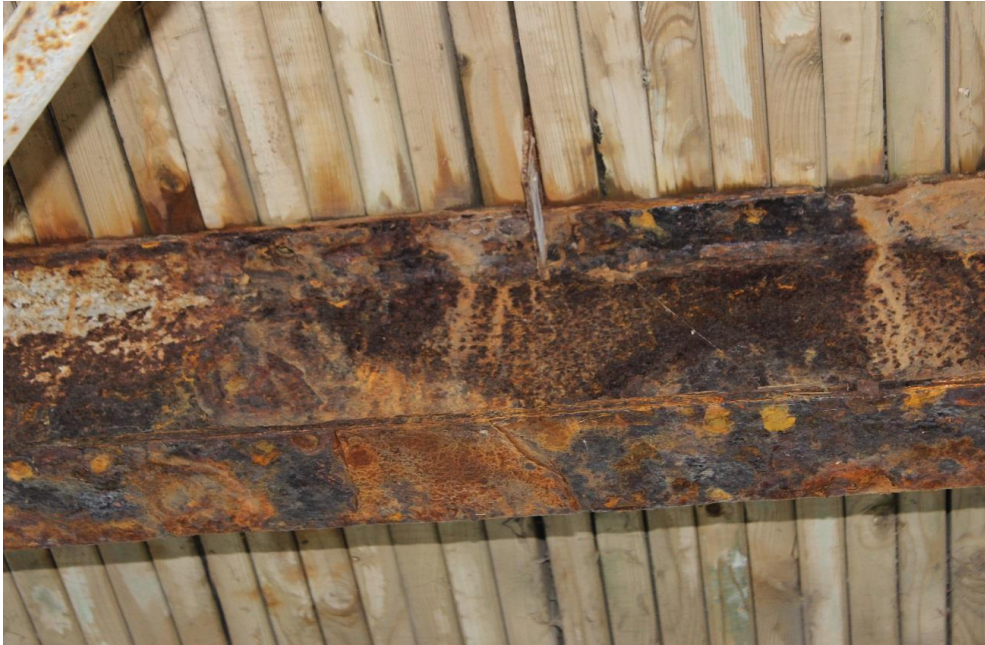
Image 9. South face of Stringer 3 between FB 7 & pier, slab rust and general section loss

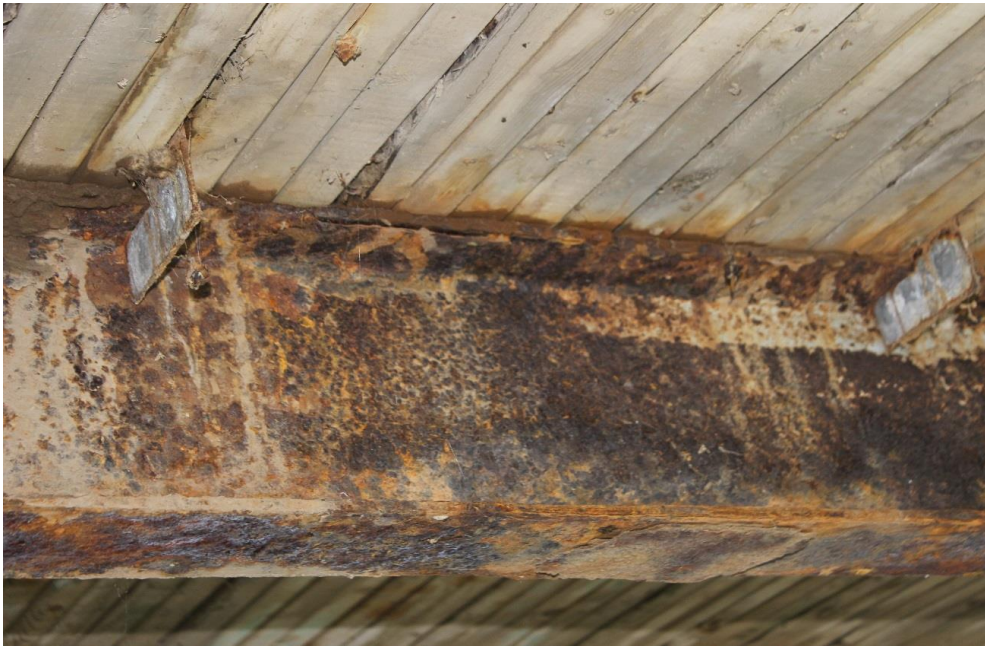
Image 10. North face of Stringer 4 between FB 7 & pier, severe thinning of top flange

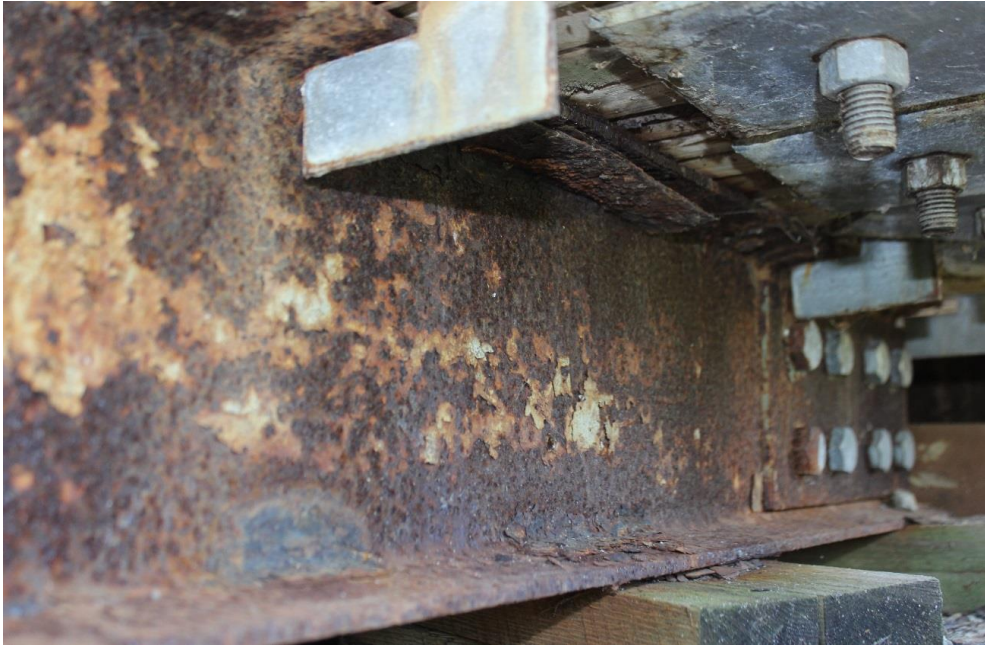
Image 11. South face of main truss Stringer 5 at pier bearing

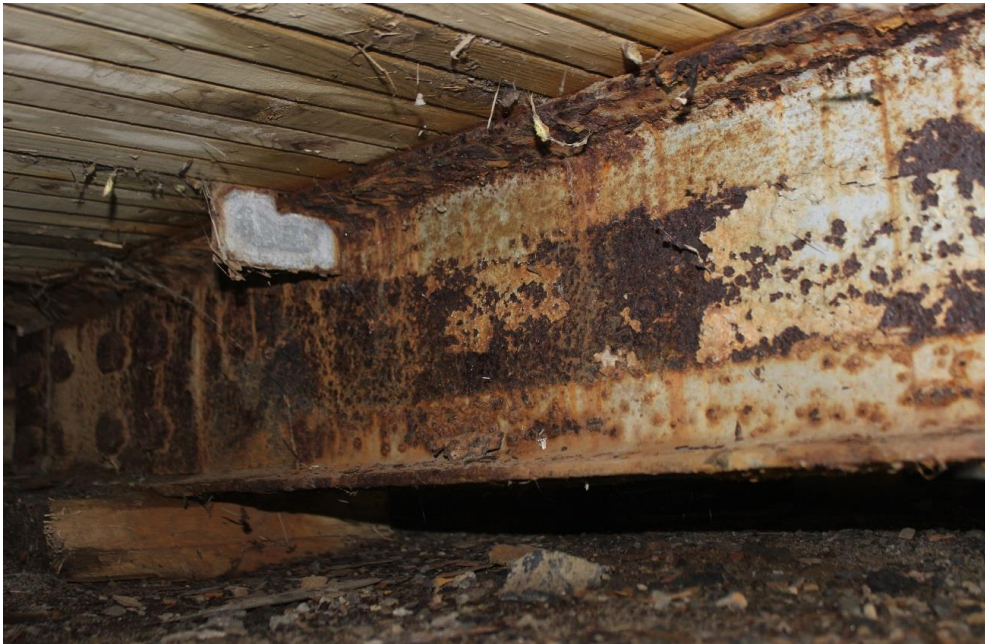
Image 12. North face of truss Stringer 3 at pier bearing

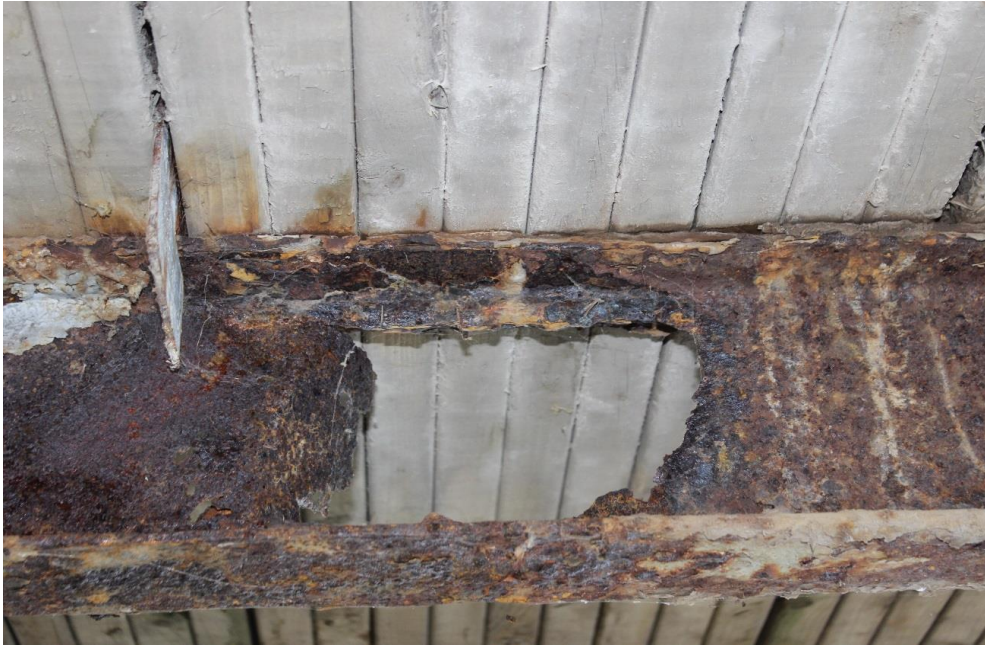
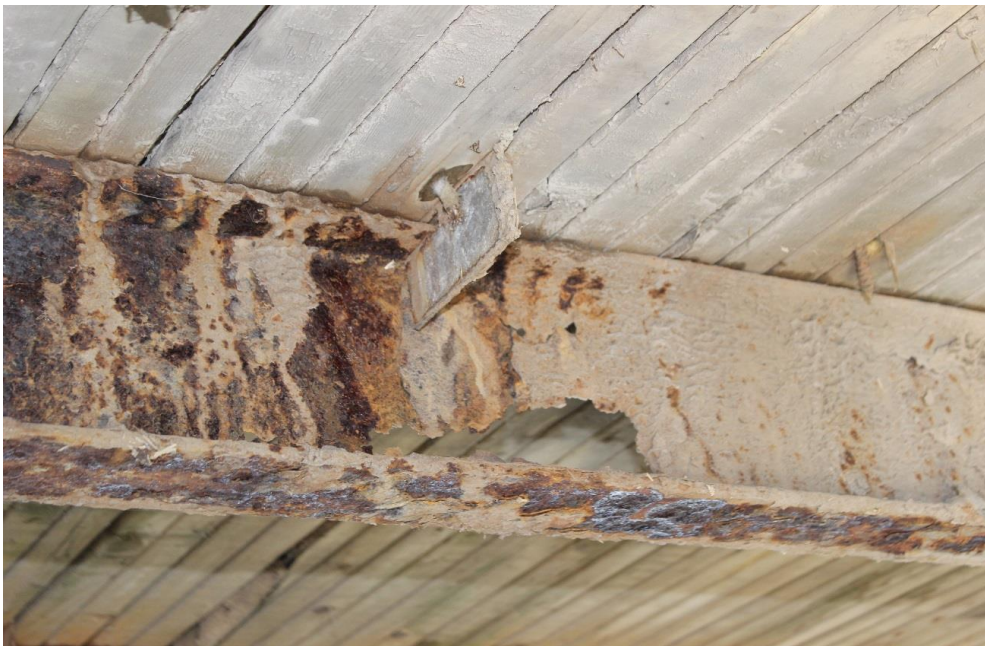
Image 13. Perforated Stringer 2 west end approach span, looking north

Image 14. Perforated Stringer 2 west end approach span, looking north

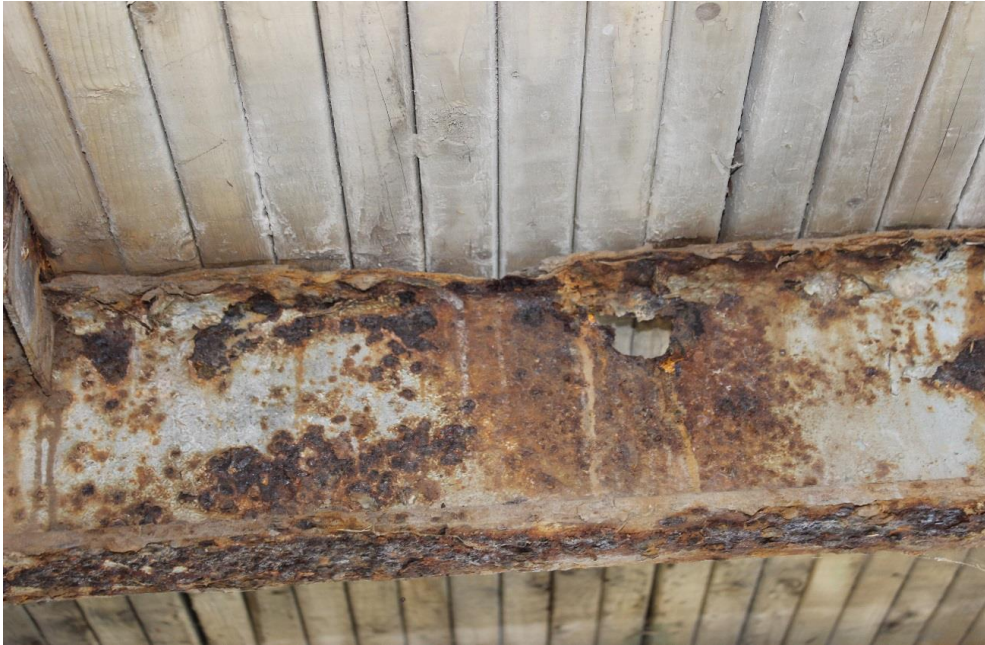
Stringer 4 of the east approach span has one perforation and is otherwise heavily corroded.

Image 15. Perforated Stringer 4 west end approach span, looking north, severe flange thinning

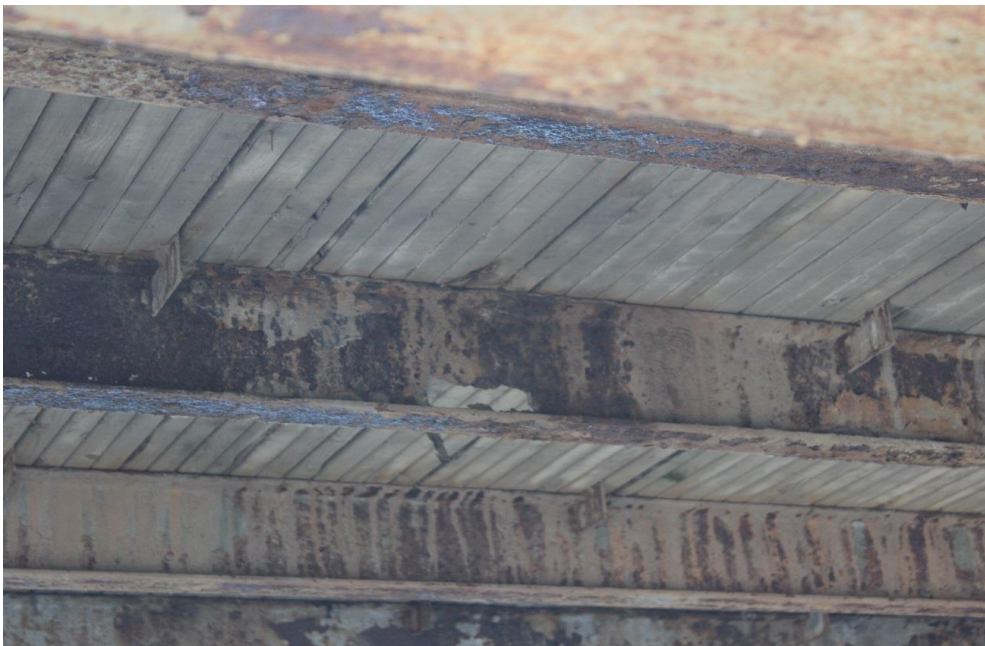
Image 16. Perforated Stringer 2 east end approach span, looking north

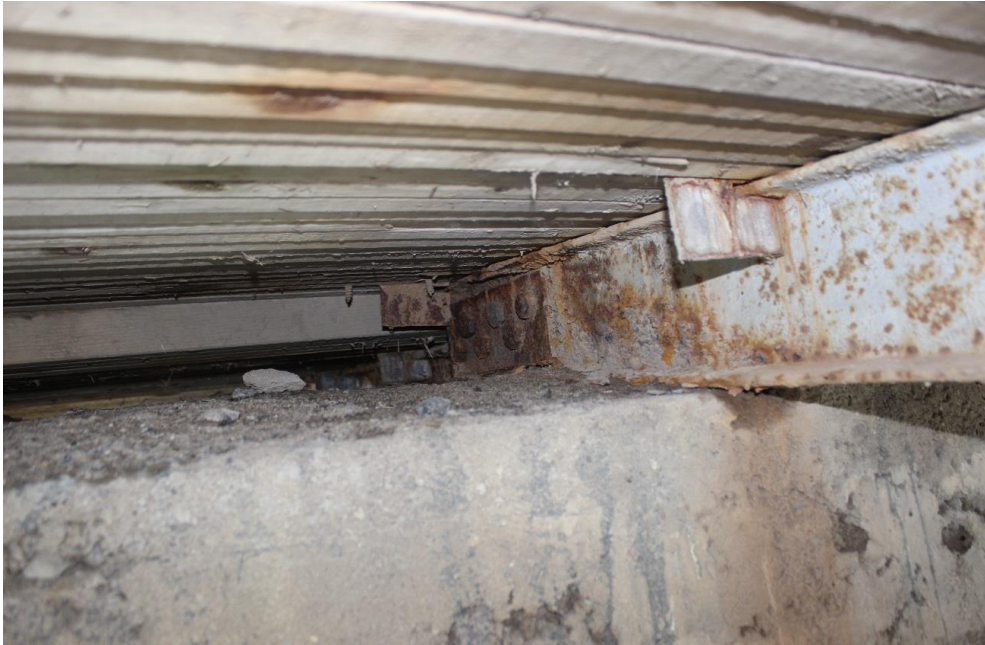
The stringers have more severe local corrosion and section loss where they bear on the pier and east abutment. Difficult access and the presence of debris hindered a more thorough examination.

Image 17. Approach span stringer resting on east abutment

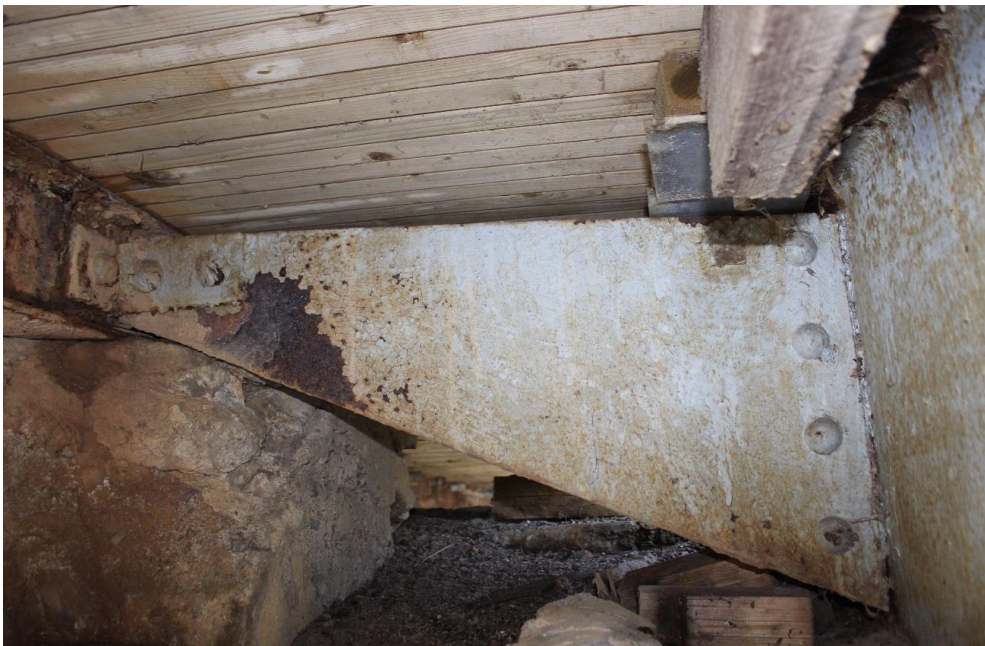
Image 18. Outrigger attached to approach girder supporting Stringer 5 at pier

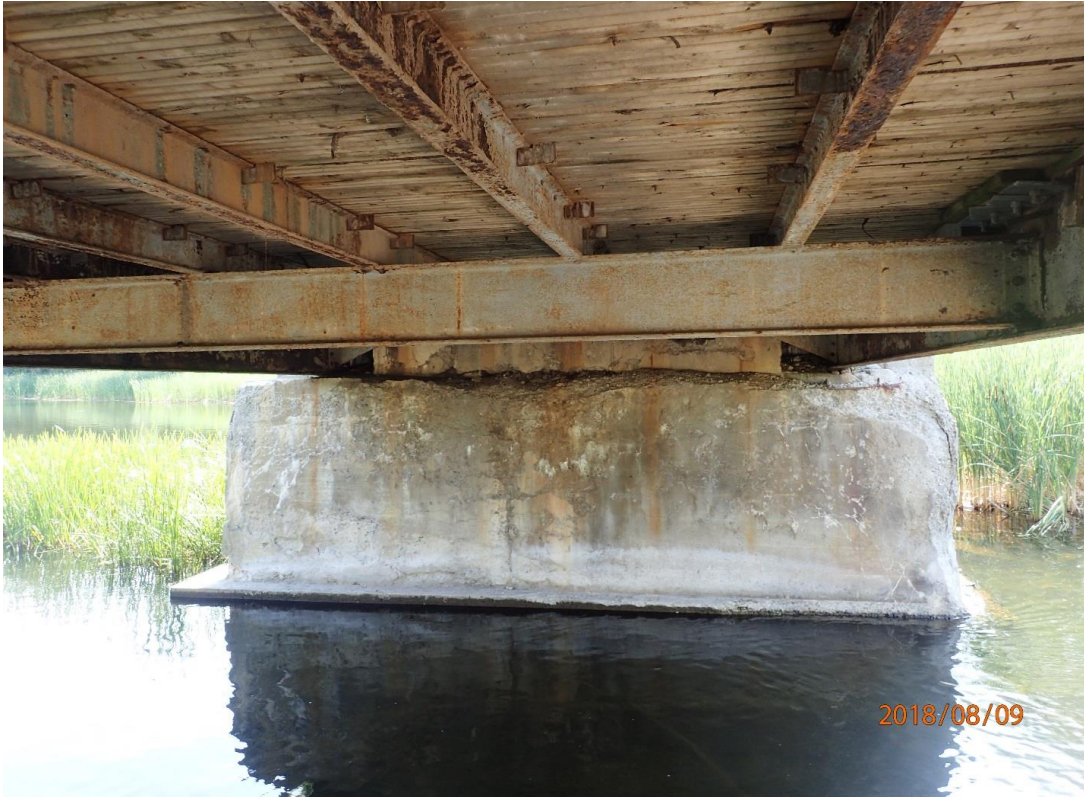
Image 19. Floor beam, stringers and east abutment at east approach span.

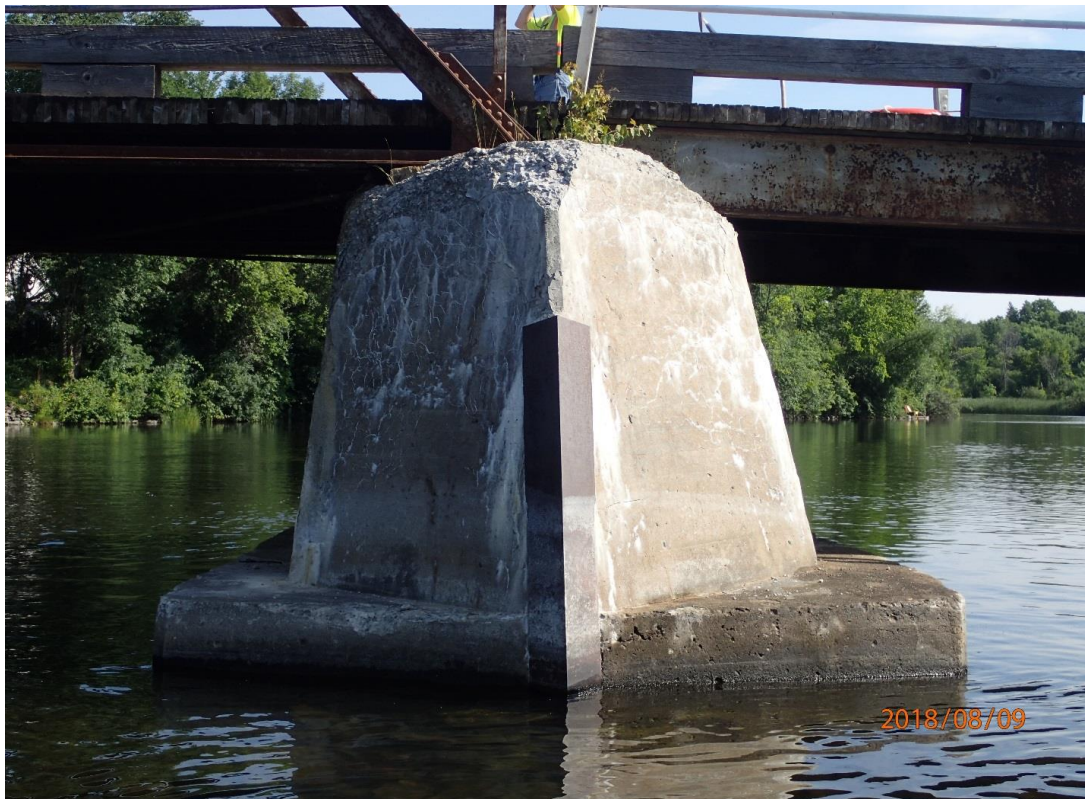
The concrete in the pier and abutments lacks air entrainment, exhibits alkali aggregate reactivity and this has resulted in localized severe disintegration. The substructure concrete is adequate for the structural loading but would benefit from preservation repairs.

Image 20. Upstream face of pier between truss and east approach span
