Bridge Inspection Report

Andrewsville Bridge

Inspection Date: *September-05-19*

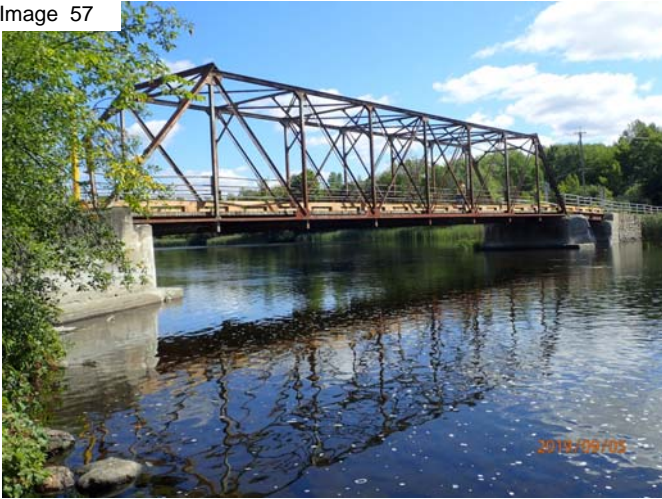
Image 57

West elevation

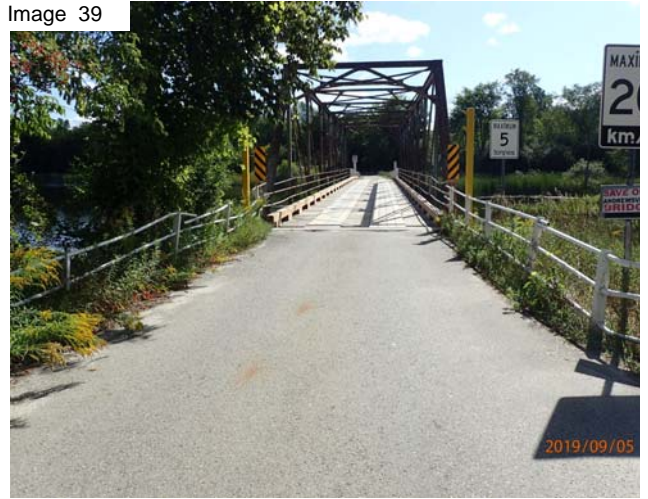
Image 39

North approach

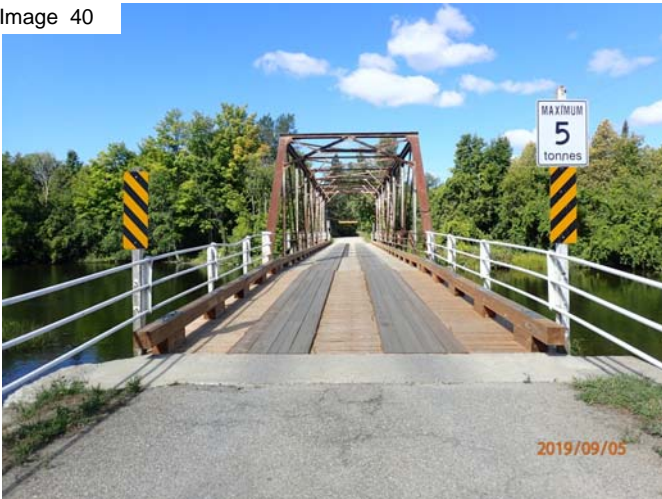
Image 40

South approach

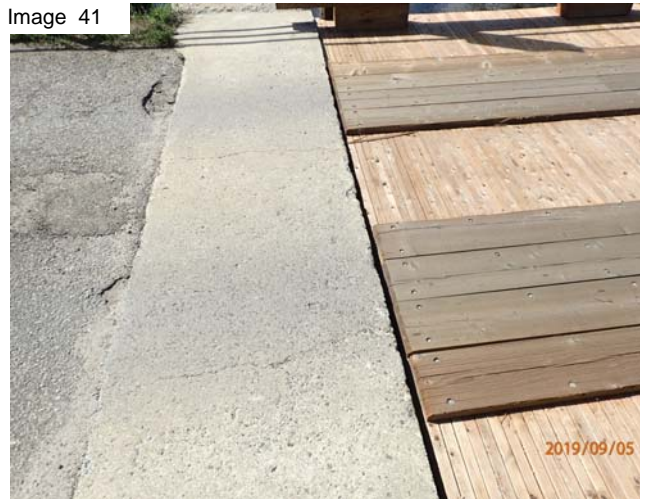
Image 41

End of south approach span

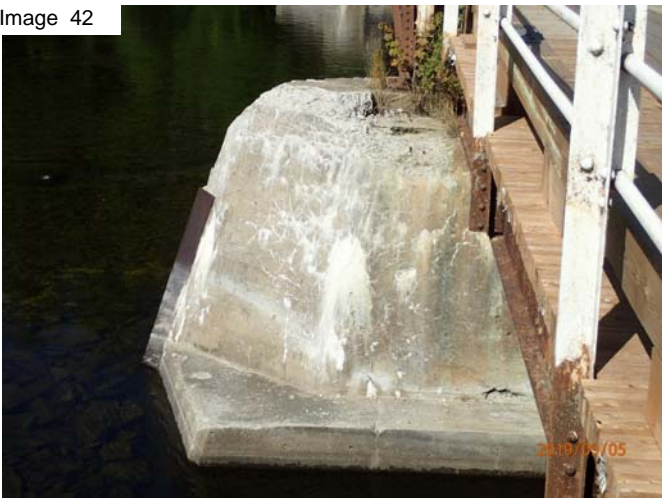
Image 42

SW end of pier

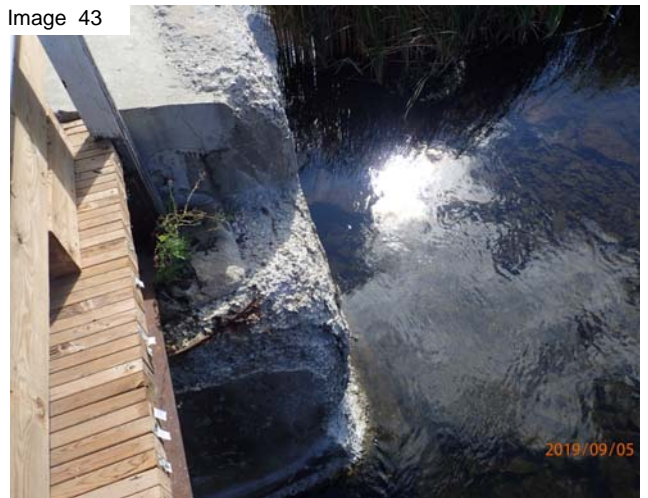
Image 43

South abutment west corner disintegration

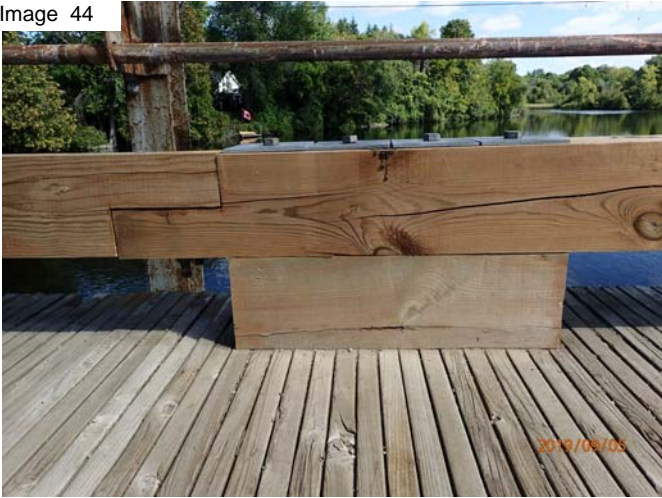
Image 44

Curb splice typ

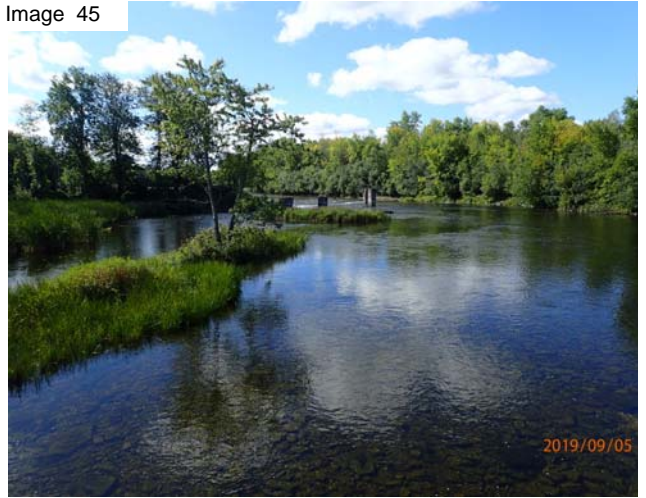
Image 45

West channel

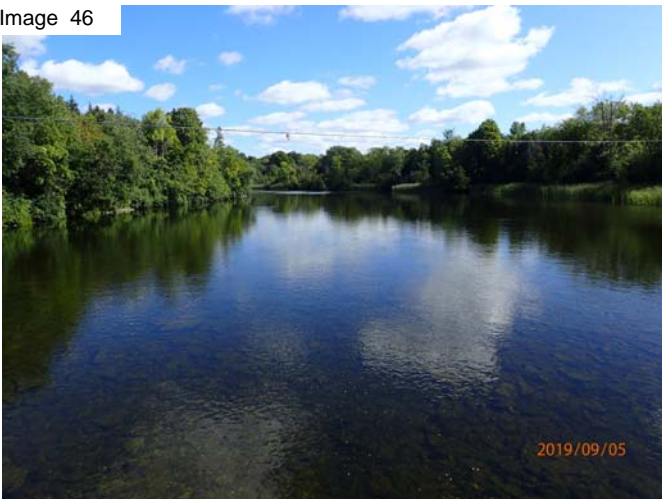
Image 46

East channel

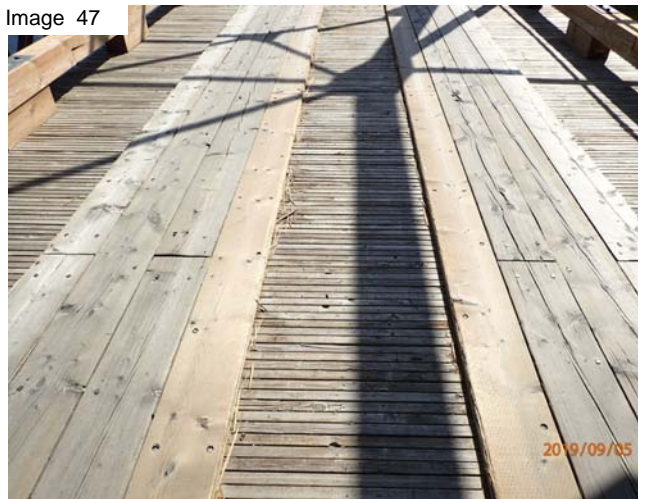
Image 47

Deck surface

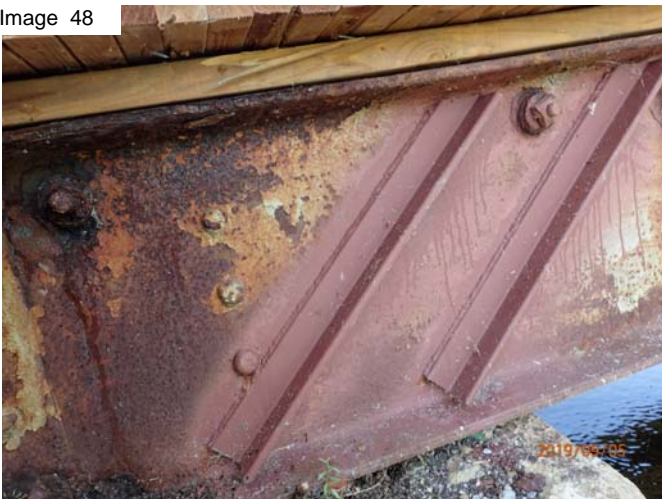
Image 48

Approach Barrier	Damage 40.0% Major Deformation, Moderate Impact	
Length: 100 m	Maintenance Repair Minor Damage	
Width:	Capital Rec. None	Perf Def: Weakened
Height:	Significant damage and settlement on north approach, east side. West approach railing recently damaged and in poor condition.	
Steel-Fabricated (2)	Defects 20.0% Moderate Corrosion	
I-type - Girder	Damage 5.0% Minor Section Loss	
Length: 9.2 m	Maintenance None	Partial Inspection
Width: 0.2 m	Capital Rec. None	
Height: 0.46 m	Much of coating is lost, with rust blisters on the lower flanges. Web strengthened in NE corner in 2019, see image.

SE girder end web strengthening (2019)

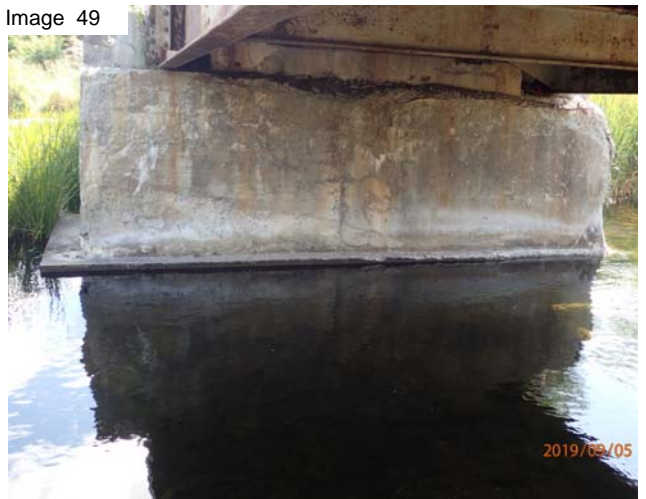
Image 49

East abutment wall

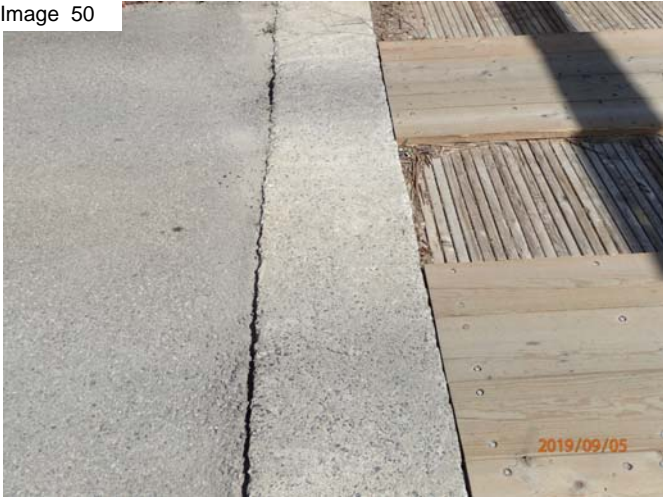
Image 50

West end of deck

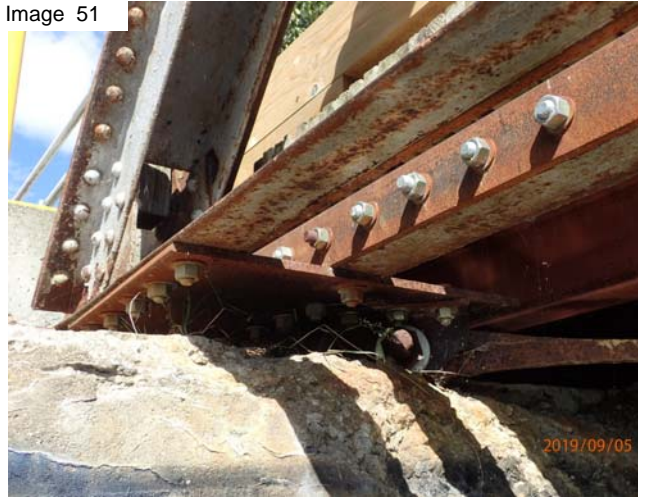
Image 51

Damage	20.0%	Moderate Seizing
	Maintenance	Power Wash	
	Capital Rec.	Replace in 1 year	Perf Def: Seizing
	Bearings are covered in debris at pier and should be power washed. Nested roller bearings at north abutment are heavily rusted.		
Headwall (2) Dry Stone Walls Length: 100 m Width: Height: 2.5 m	Defects	0.0%	
	Damage	20.0%	
	Maintenance	None	
	Capital Rec.	Repair in 5 years	Perf Def: Bulging
	See embankment comments.

NE bearing

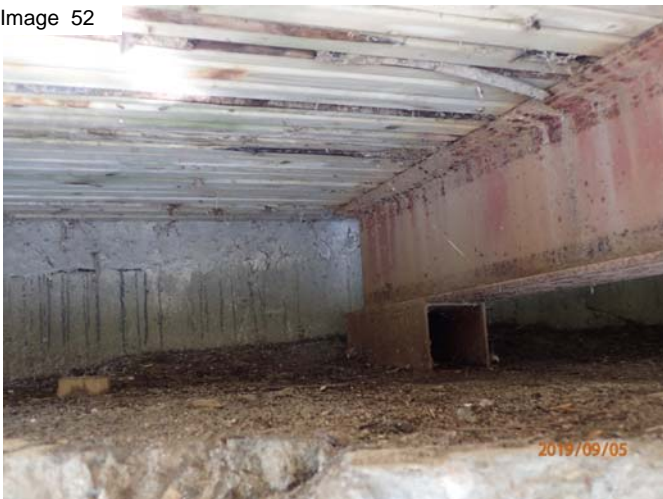
Image 52

West end ballast wall & stringer

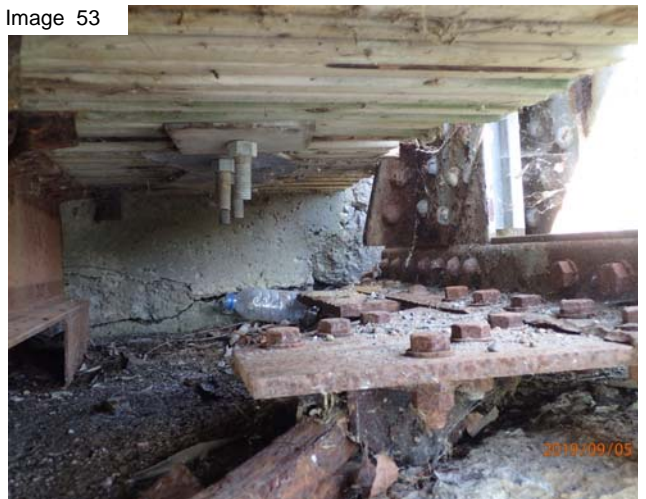
Image 53

NW corner bearing

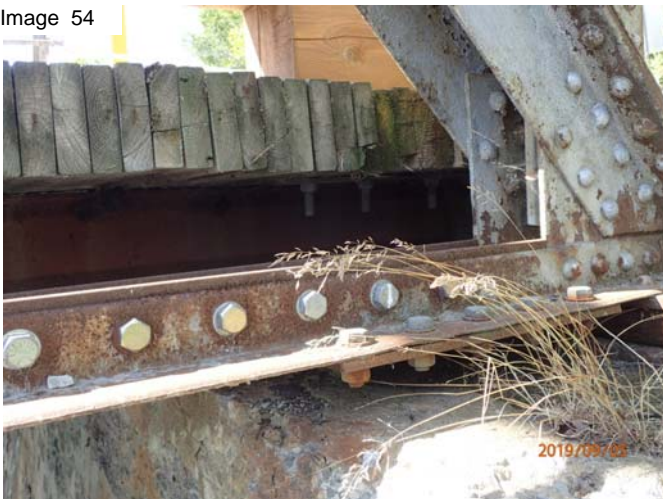
Image 54

NE corner detail

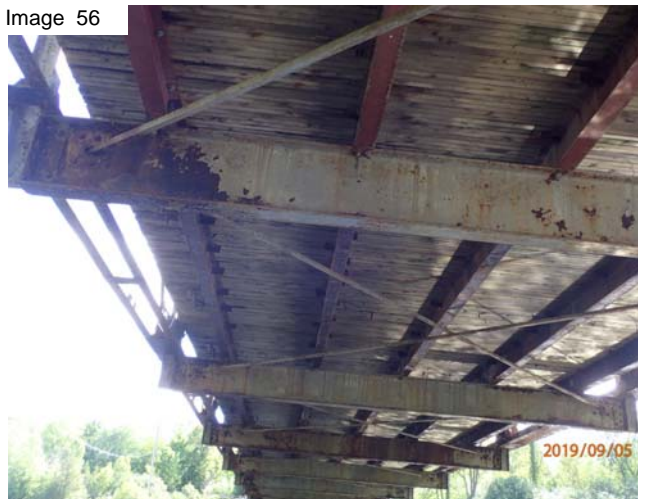
Image 56

Soffit
