ANDREWSVILLE BRIDGE WADING INSPECTION REPORT- JULY 2021

Lanark County, United Counties Leeds & Grenville

Keystone Bridge Management Corp.
Your Bridge Asset Management Specialist

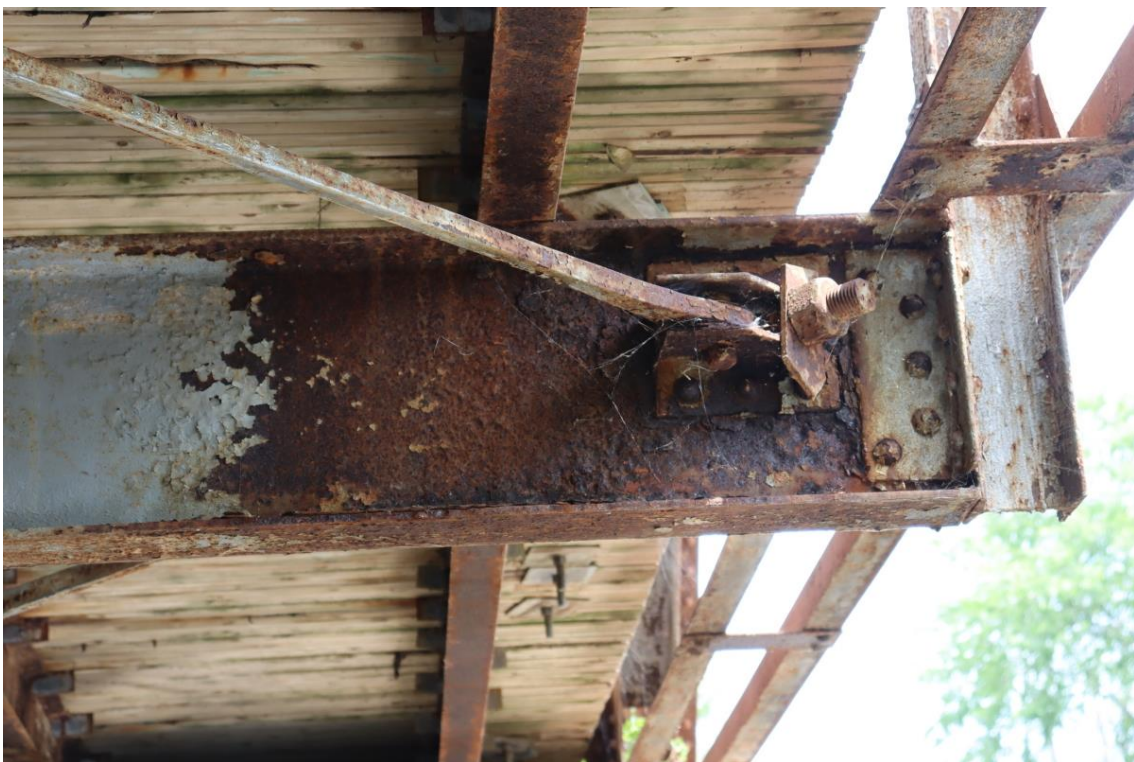
has changed very little in the past seven years. The upstream and downstream ends of each of the seven floor beams are generally more heavily corroded than the middle sections. None of the corrosion on the floor beams is of a critical nature. That is, the load capacity of the truss is not governed by the floor beam condition.

Figure 11: Floor beam 7 north end

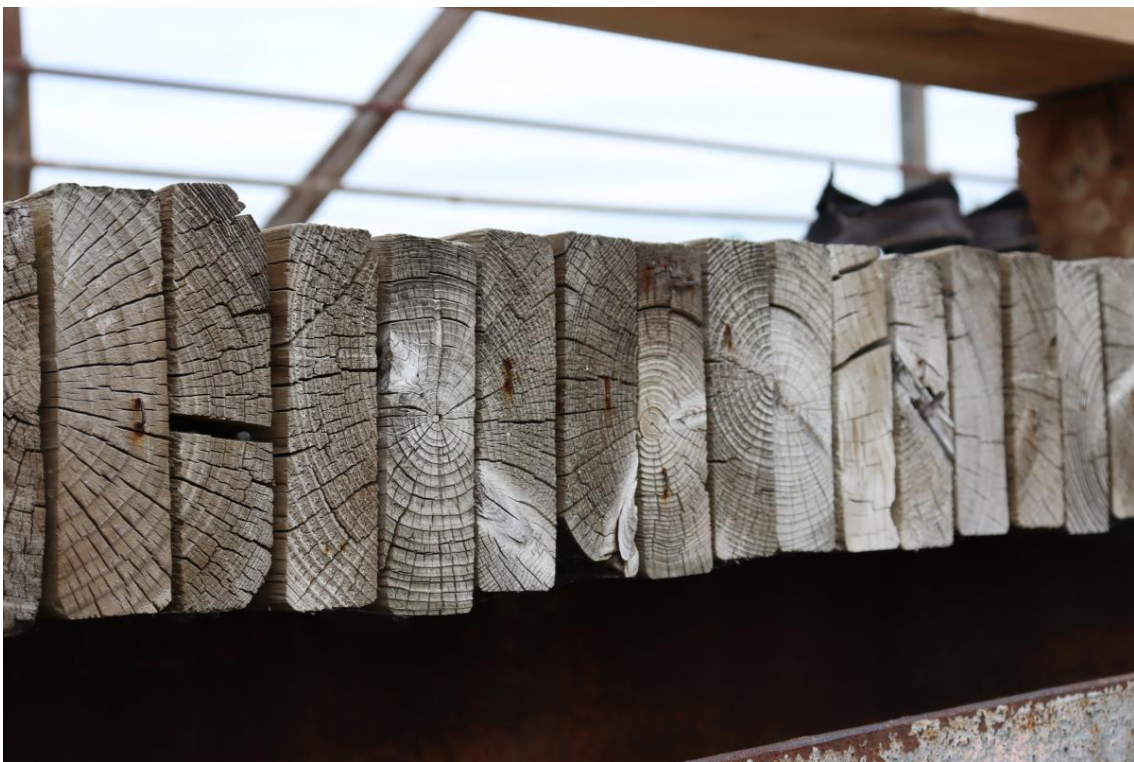
Figure 35: External stringer 1 condition Bay 6

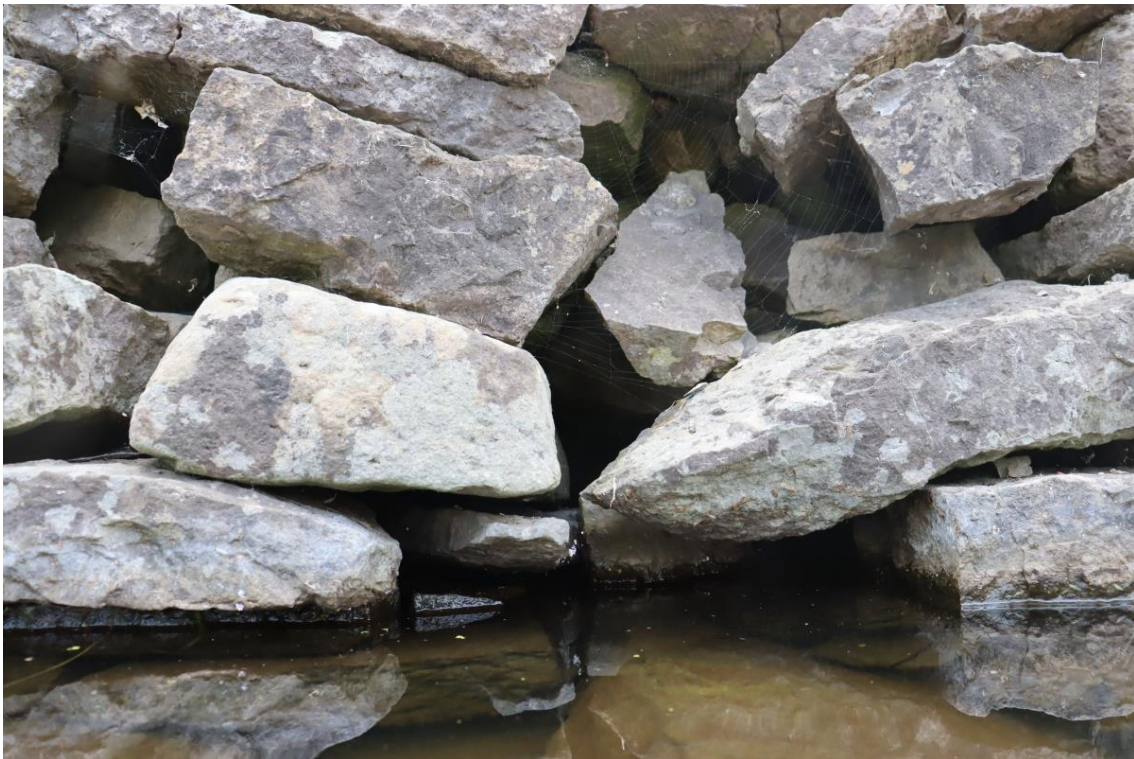
It is not anticipated that the dry-stone walls make the approaches vulnerable to catastrophic loss. That is to say, the slow deterioration of the walls will not cause a large collapse and full loss of the road platform. However, an extreme flood event or a seismic event could produce large scale failure of the walls and loss of the road. Certainly, a portion of the wall could collapse unexpectedly at any time and compromise the road surface.

Figure 48: Bulging retaining wall north-east quadrant

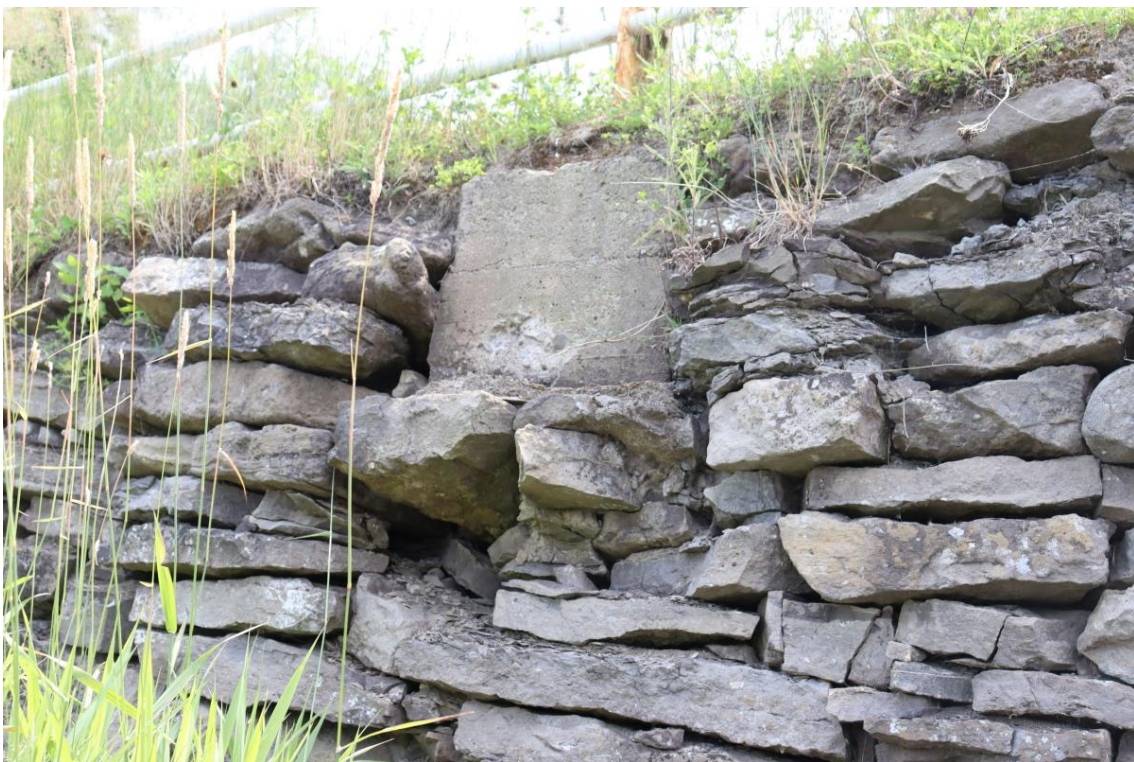
Figure 49: Blocked drainage opening through causeway

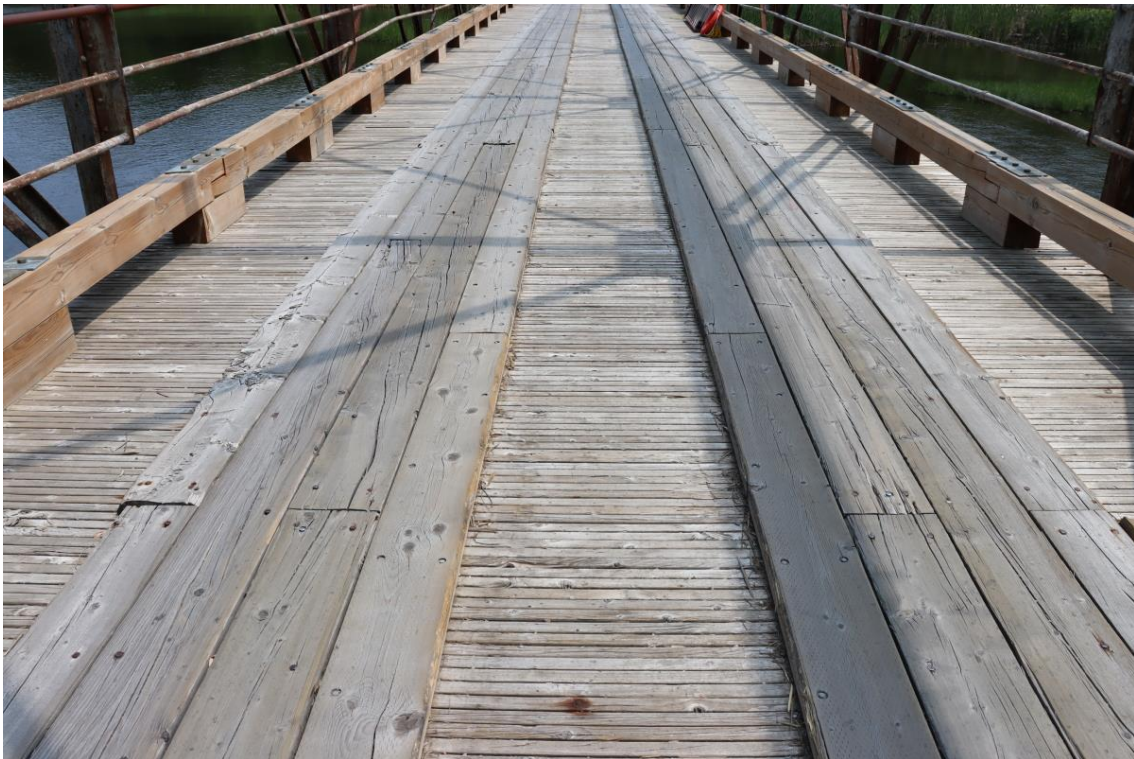
Figure 60: Damaged running boards

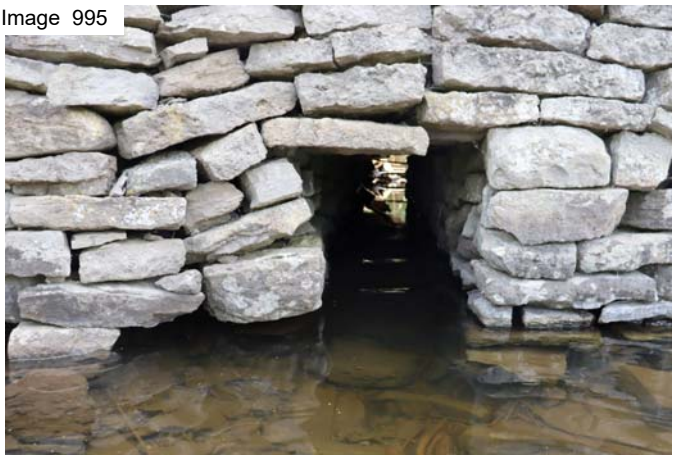
Railing bottom undercutting in north retaining wall
