# MEMO

September 5, 2025

**Re: Douglas Landing Subdivision Aquatic Habitat Assessment**

**Douglas Landing Subdivision Fish Habitat Assessment**  
Douglas Landing Developments

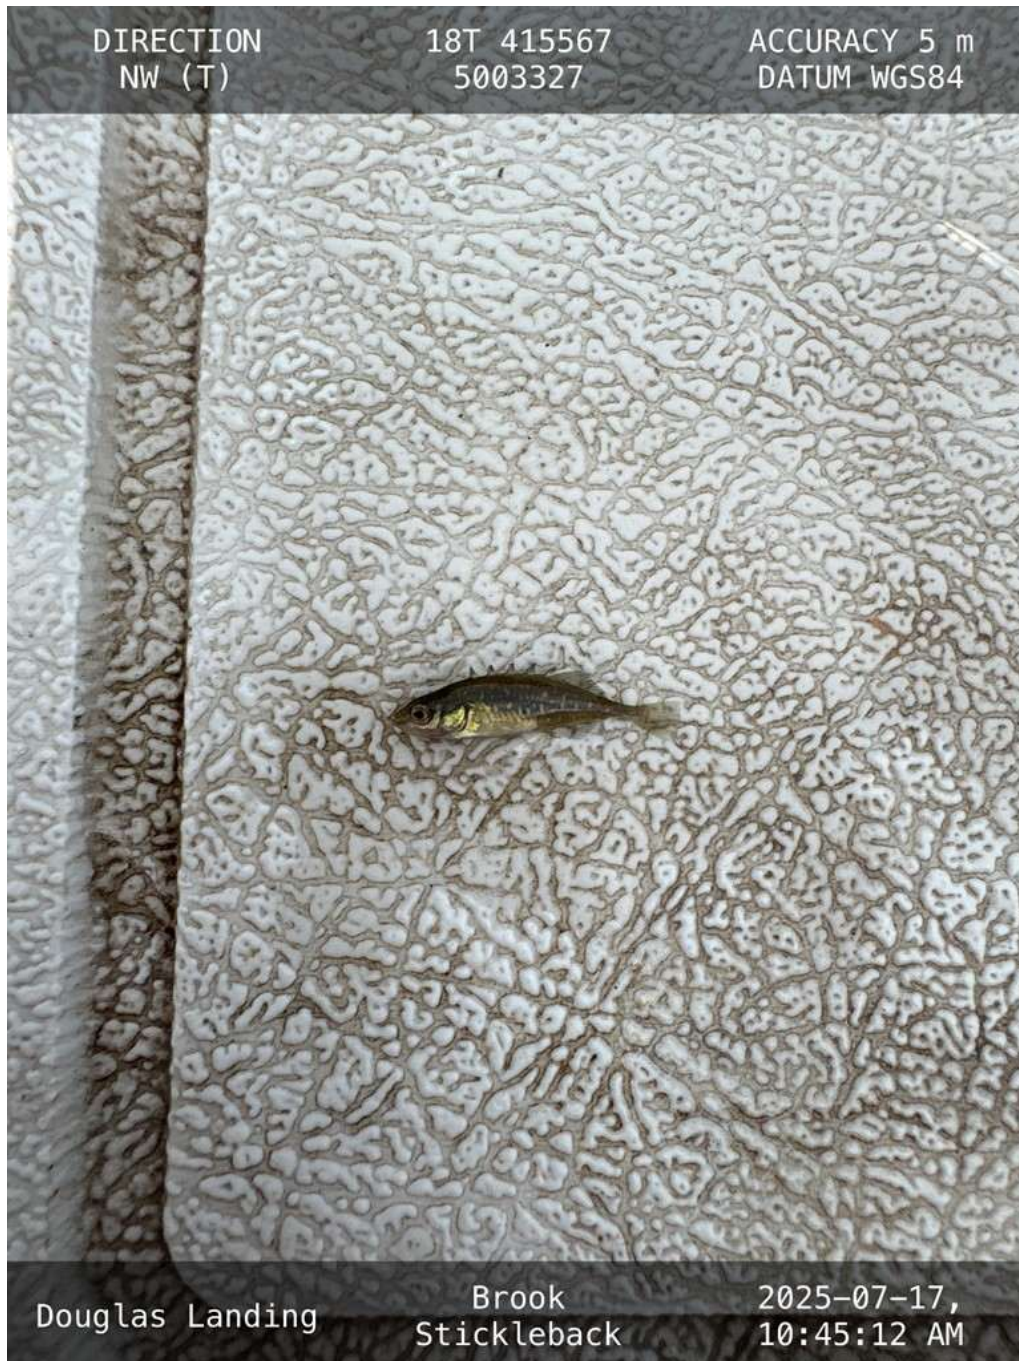
Electrofishing resulted in three species being captured, totalling 25 fish. Two brook sticklebacks (*Culaea inconstans*), seven central mudminnows (*Umbra limi*), and sixteen creek chubs (*Semotilus atromaculatus*) were captured during 235 seconds of electrofishing effort, with a mean catch per unit effort of 0.04 fish caught / second of fishing effort (Photos 1 to 3, Table 1).

Photo 1: Brook Stickleback (*Culaea inconstans*), MMD2, July 2025

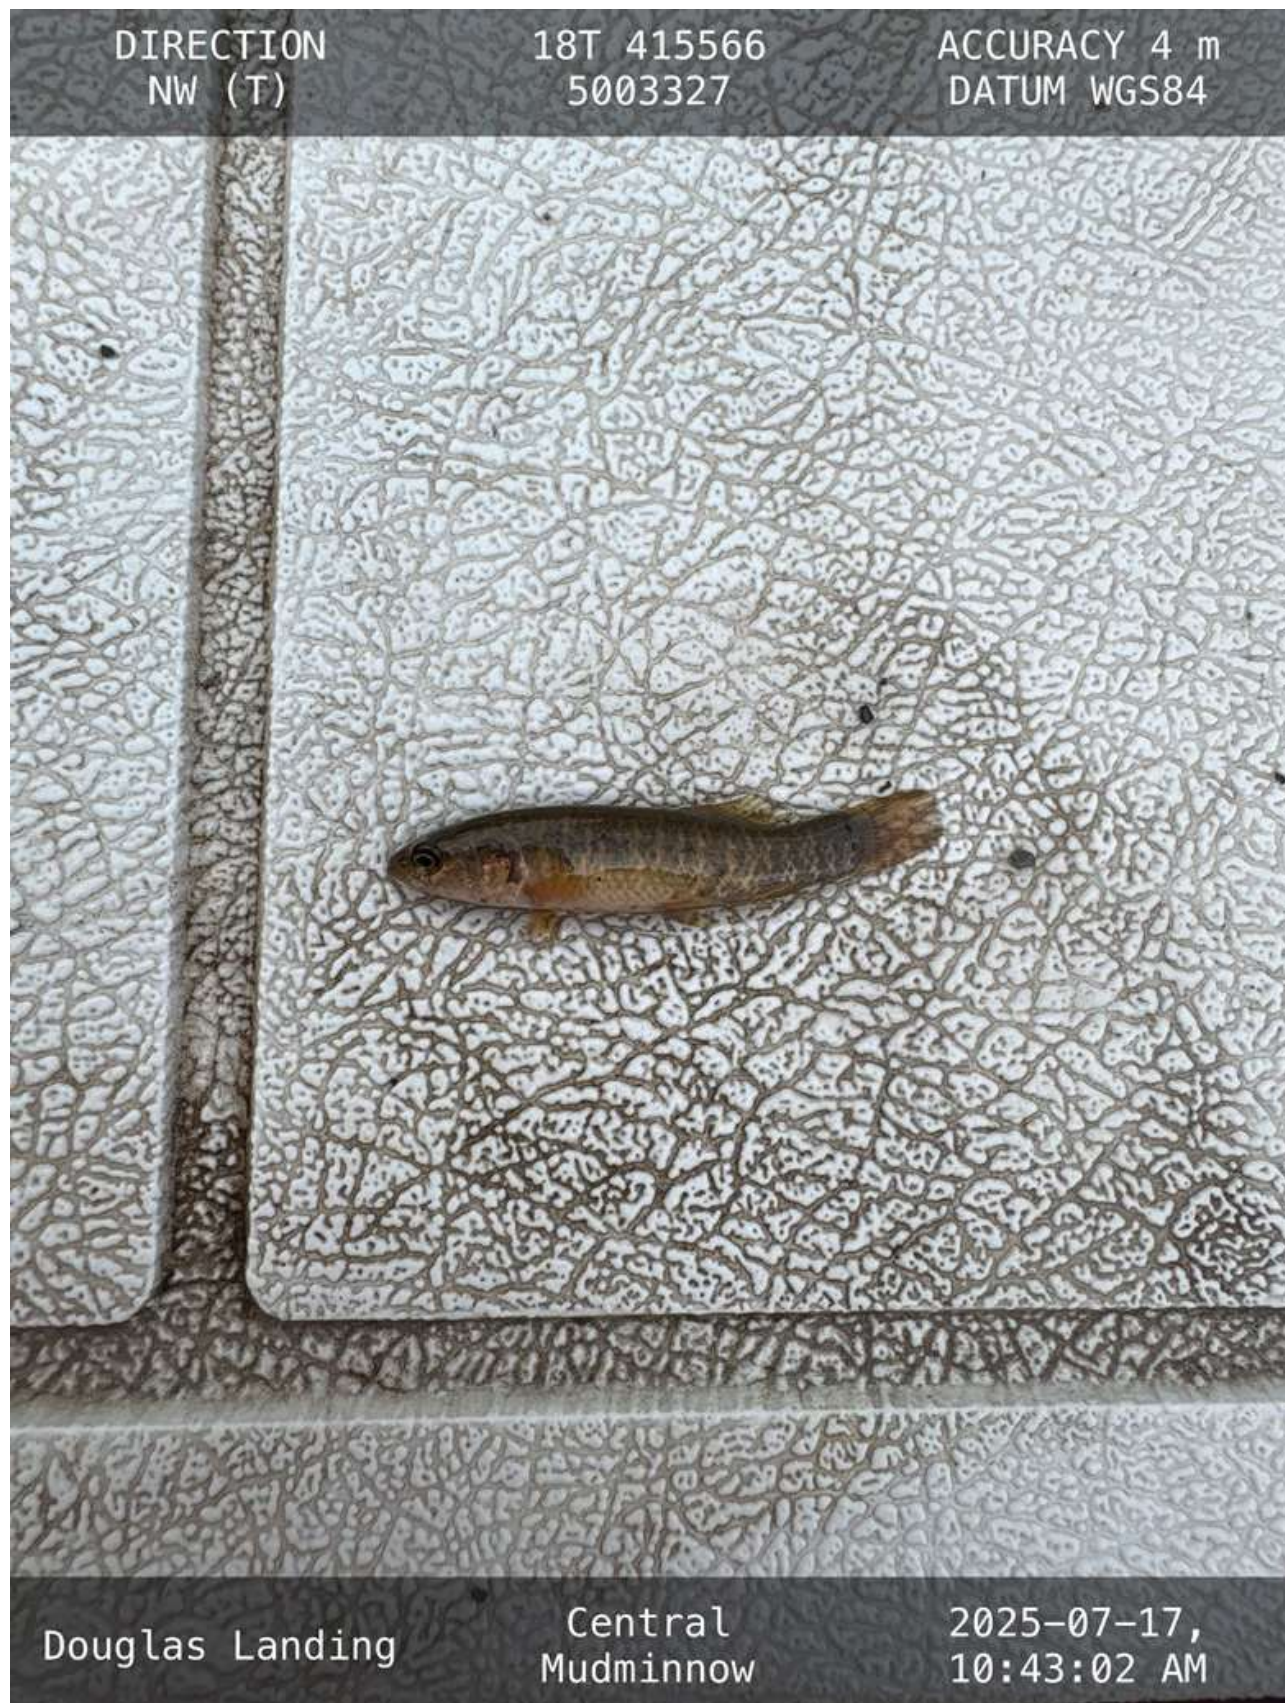
Photo 2: Central Mudminnow (*Umbra limi*), MMD2, July 2025

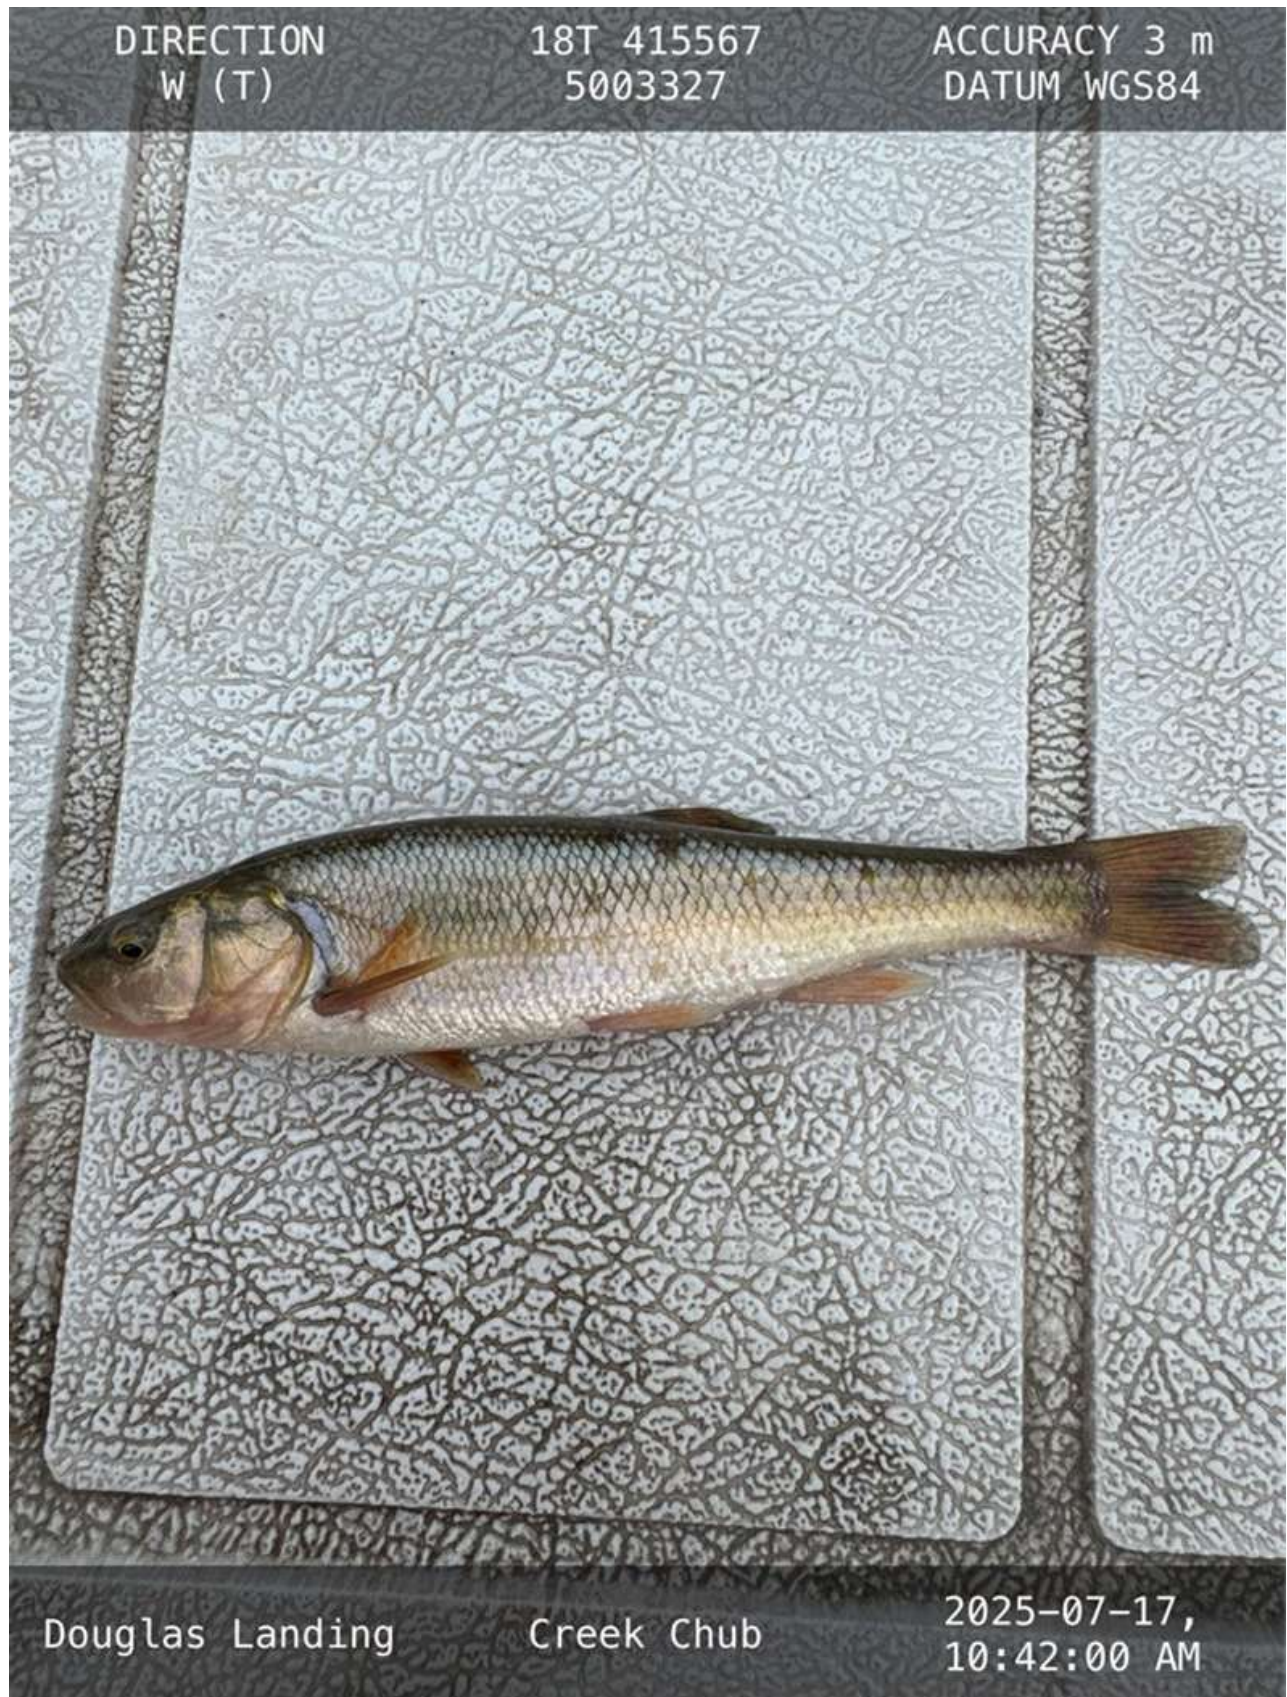
Photo 3: Creek Chub (*Semotilus atromaculatus*), MMD2, July 2025

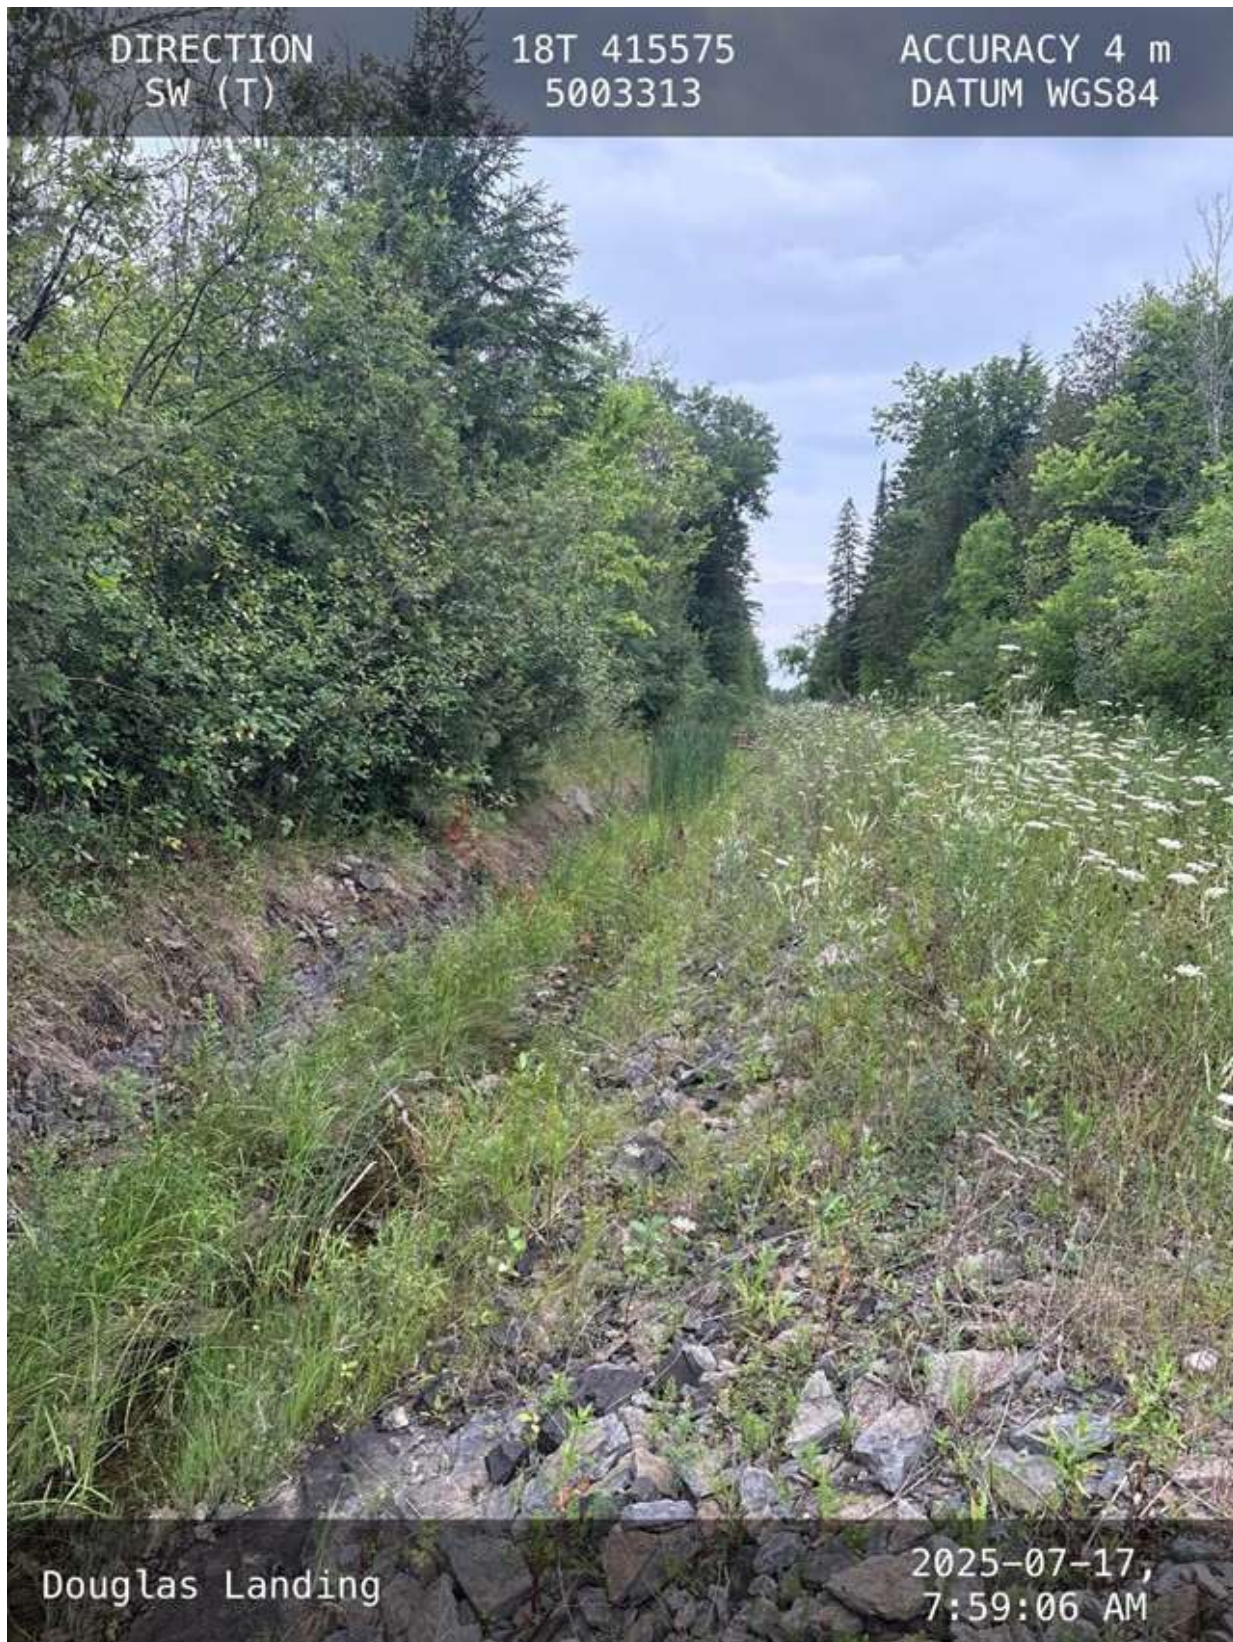
The channel conveys flow along a straightened municipal drain corridor in a southwesterly direction, originating in a wetland area to the east of the Subject Property (Map 1; Photo 4). Dry sections at the time of the assessment fragmented the watercourse, limiting opportunity for migration and access to refuge habitat. The MMD2's average bankfull width is 4.89 m, ranging from 3.5 m to 6.4 m, and the average wetted width is 1.02 m, ranging from 0.3 m to 1.9m. Maximum wetted depth was 0.25m, but most of the channel was less than 0.1 m deep. Bankfull depth ranges from 0.5 to 1.0m. The channel has a low gradient with areas of standing water.

Photo 4: Munro Municipal Drain Branch 2, July 2025

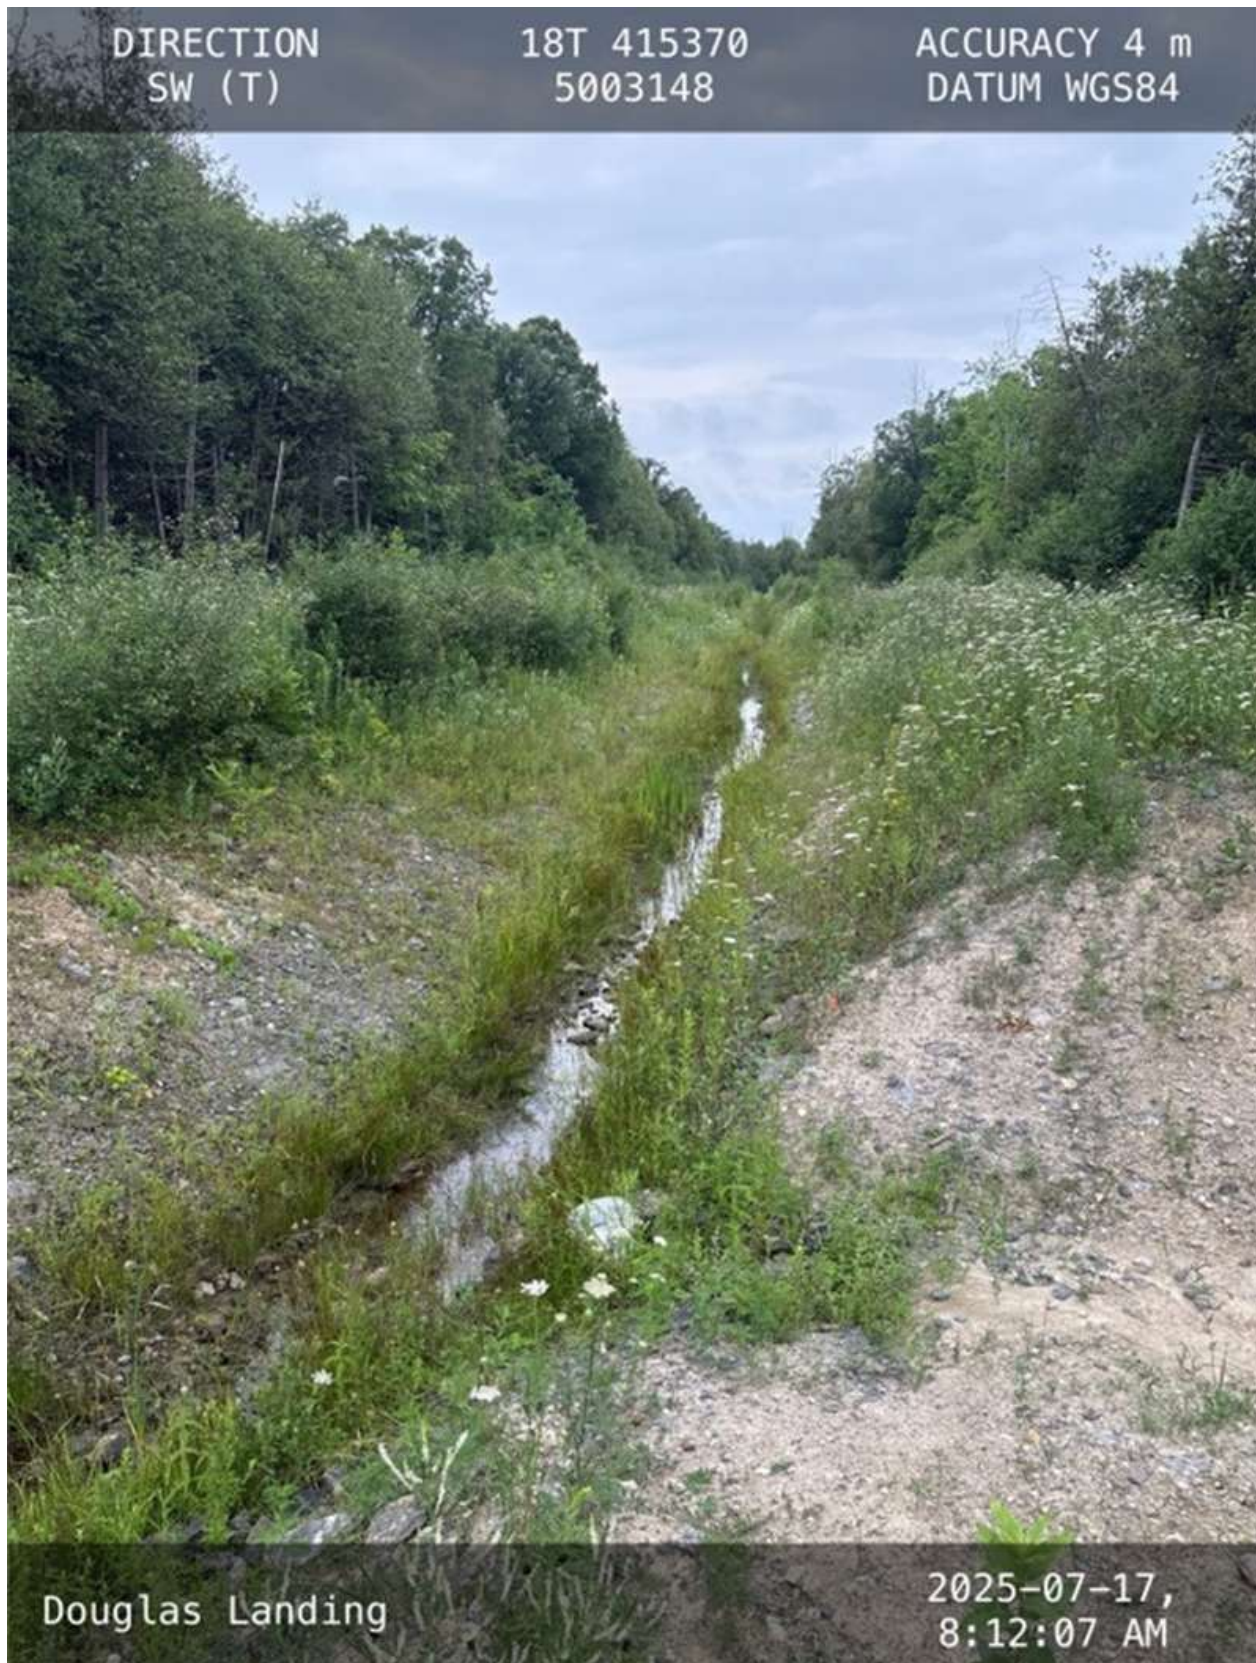
The left bank is mostly stable, with 75% of the channel being protected from erosion, and the remaining 25% is considered vulnerable. The right bank is 50% protected and 50% vulnerable to erosion. Stability is provided by coarse rocky substrate and rooted vegetation growing along the banks. Instability occurred at areas with bare erodible soils and steep bank angles (Photo 5).

Photo 5: Vegetated Banks with Coarse Rocky Material, MMD2, July 2025

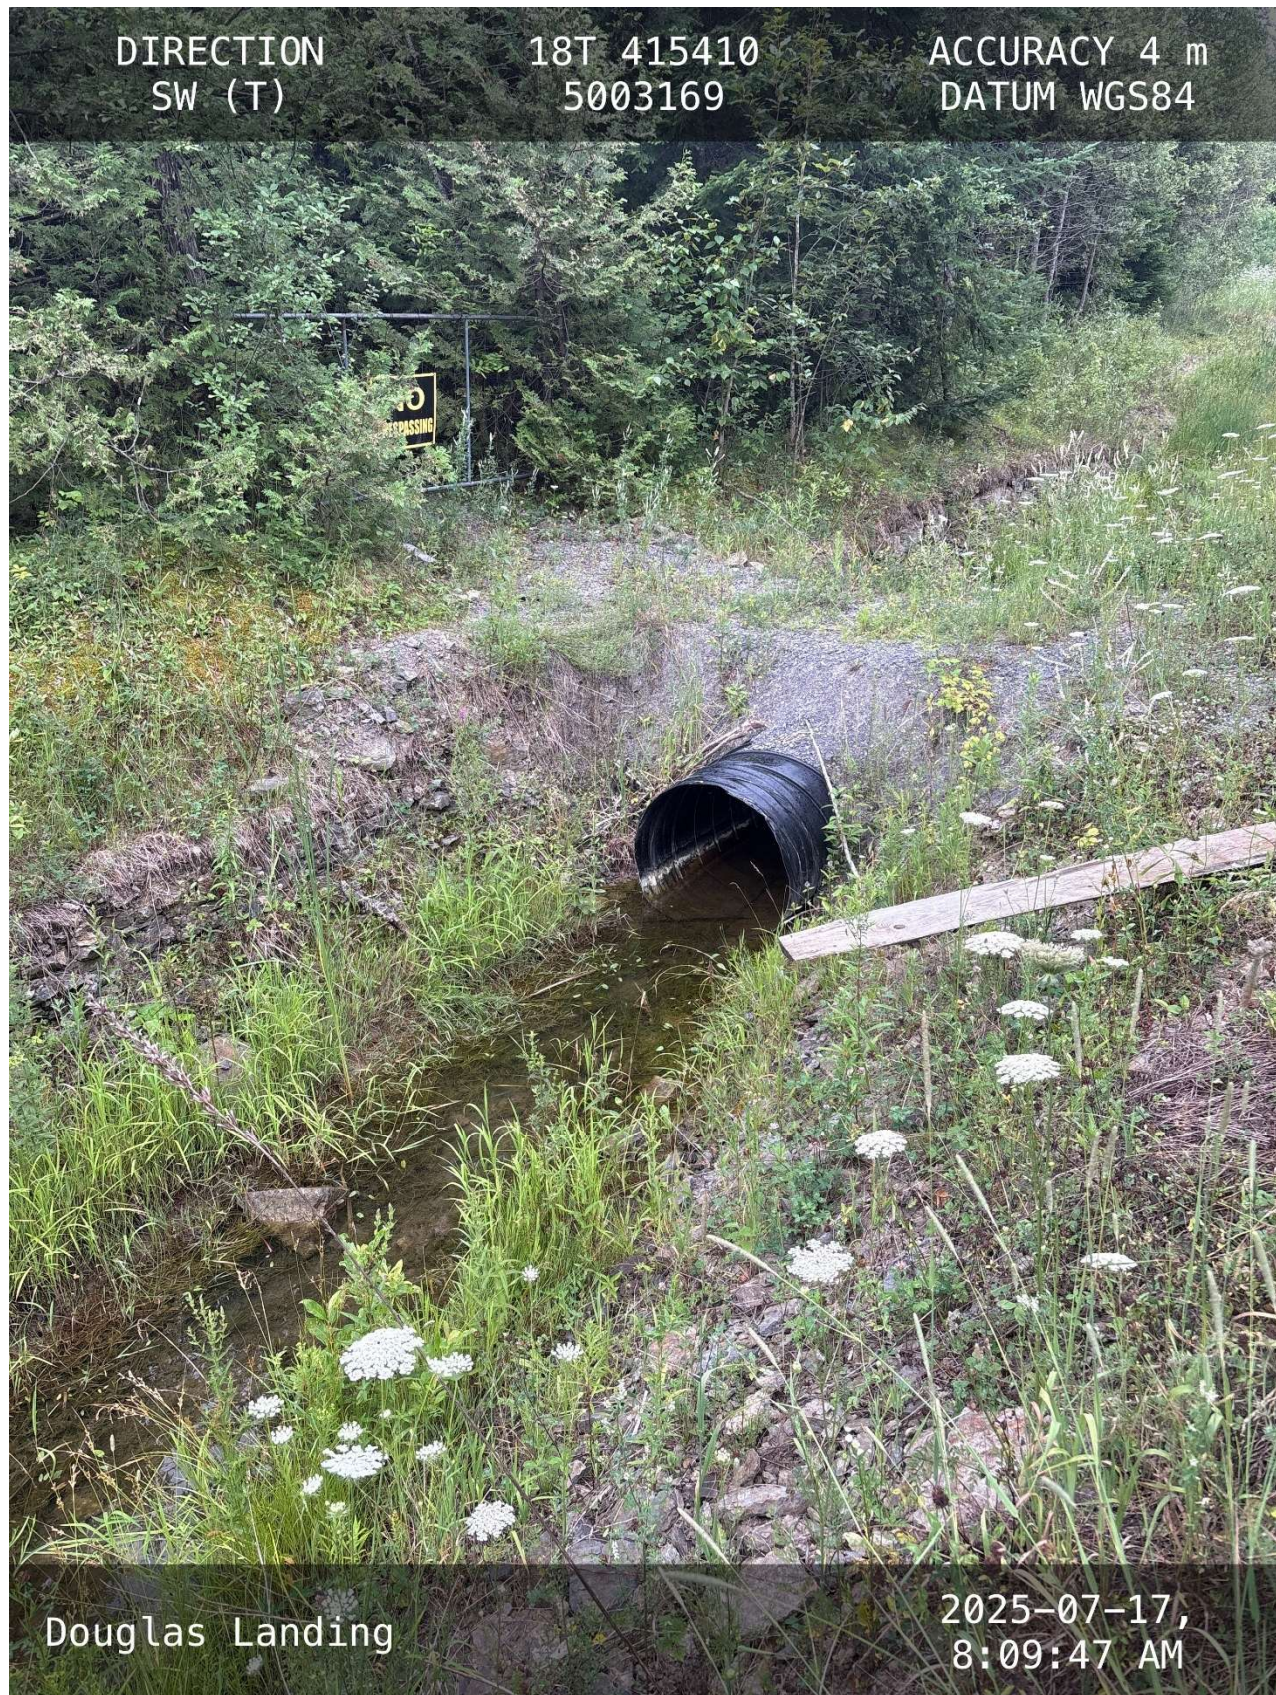
A single steel culvert with a diameter of 0.85 m and a length of 4.2 m is present (Photo 6). The culvert sits flush with the channel bed and is projecting from a gravel berm spanning the channel, providing access to a gate onto a neighbouring property.

Photo 6: Steel Culvert and Gravel Berm, MMD2, July 2025

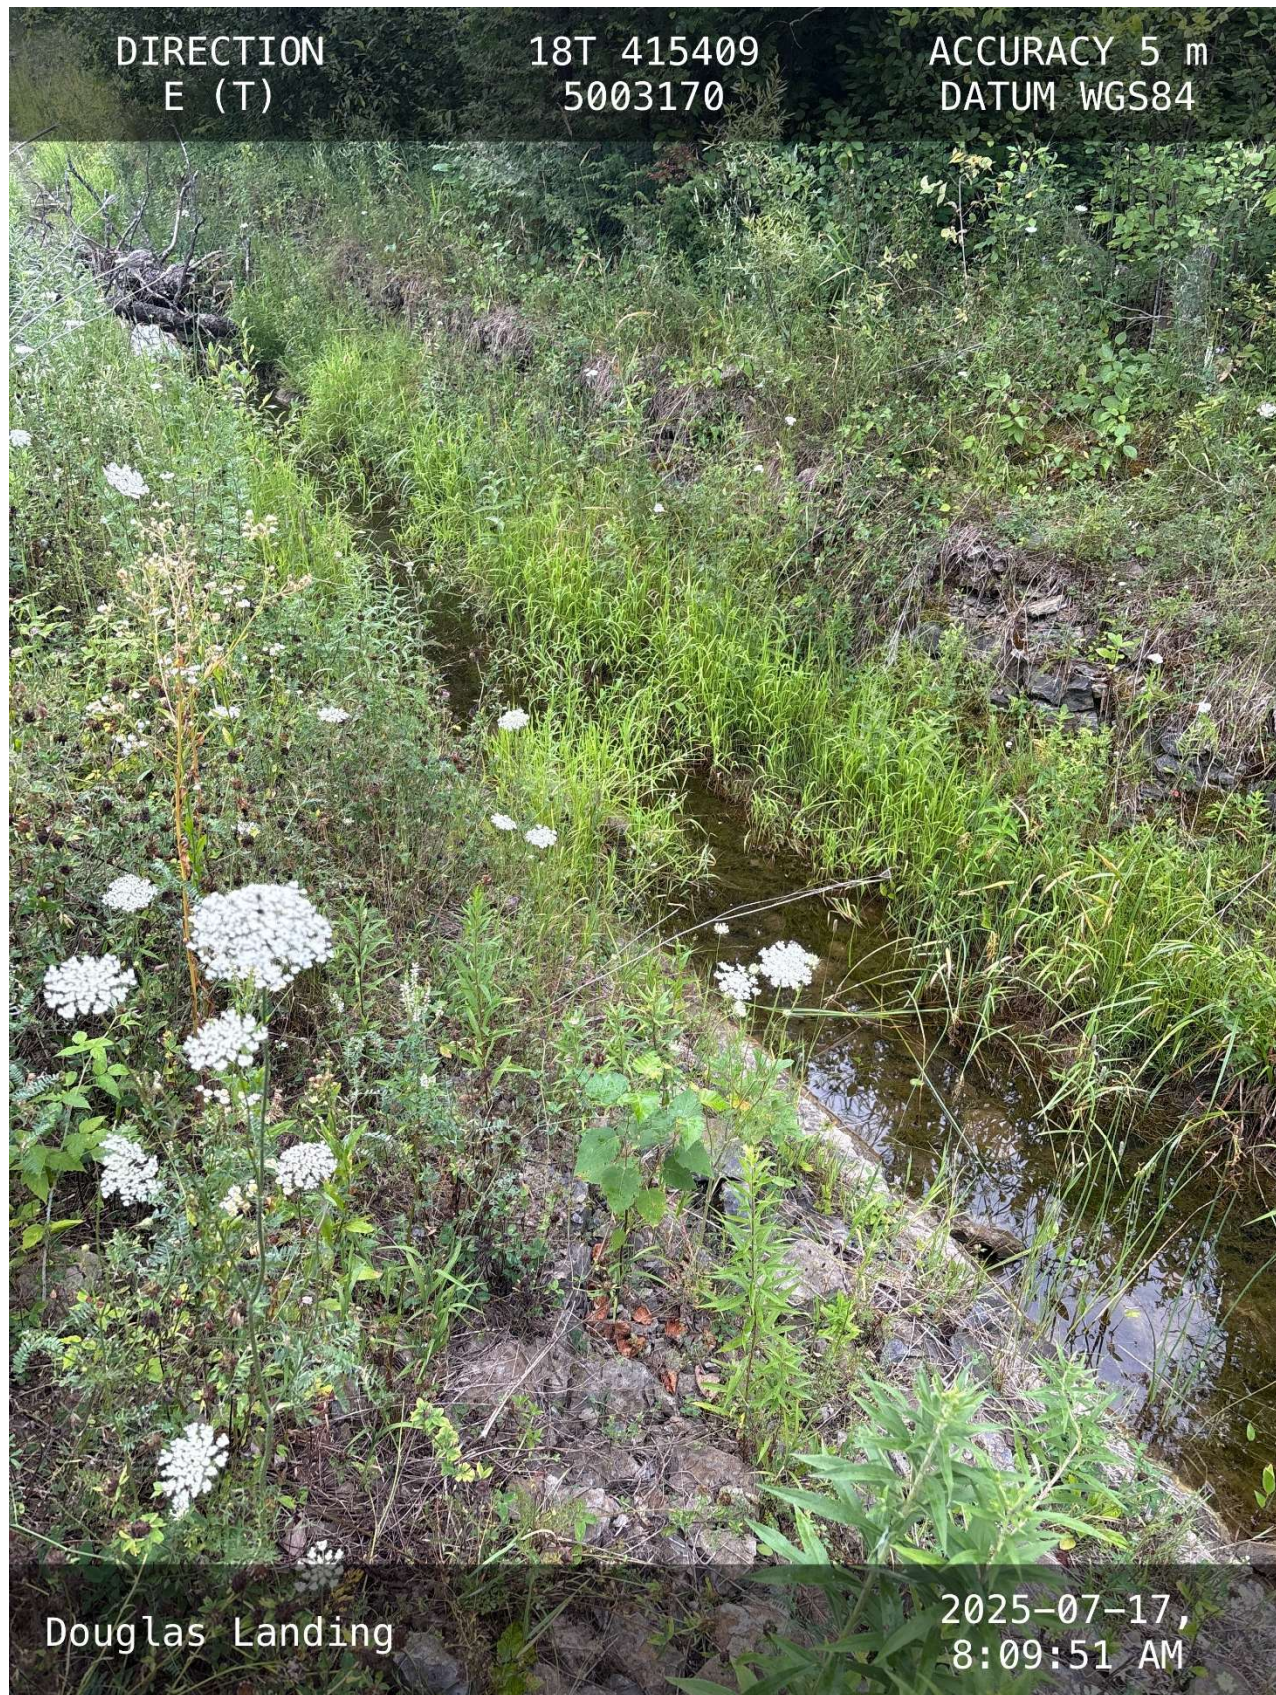
In the wetted channel, hardpan and bedrock sub-pavement provide limited media for rooted vegetation in the channel (Photo 7). Submerged and emergent macrophytes provide cover for the fish community present but are generally limited to the edges of the wetted channel.

Photo 7: Instream and Riparian Vegetation, MMD2, July 2025

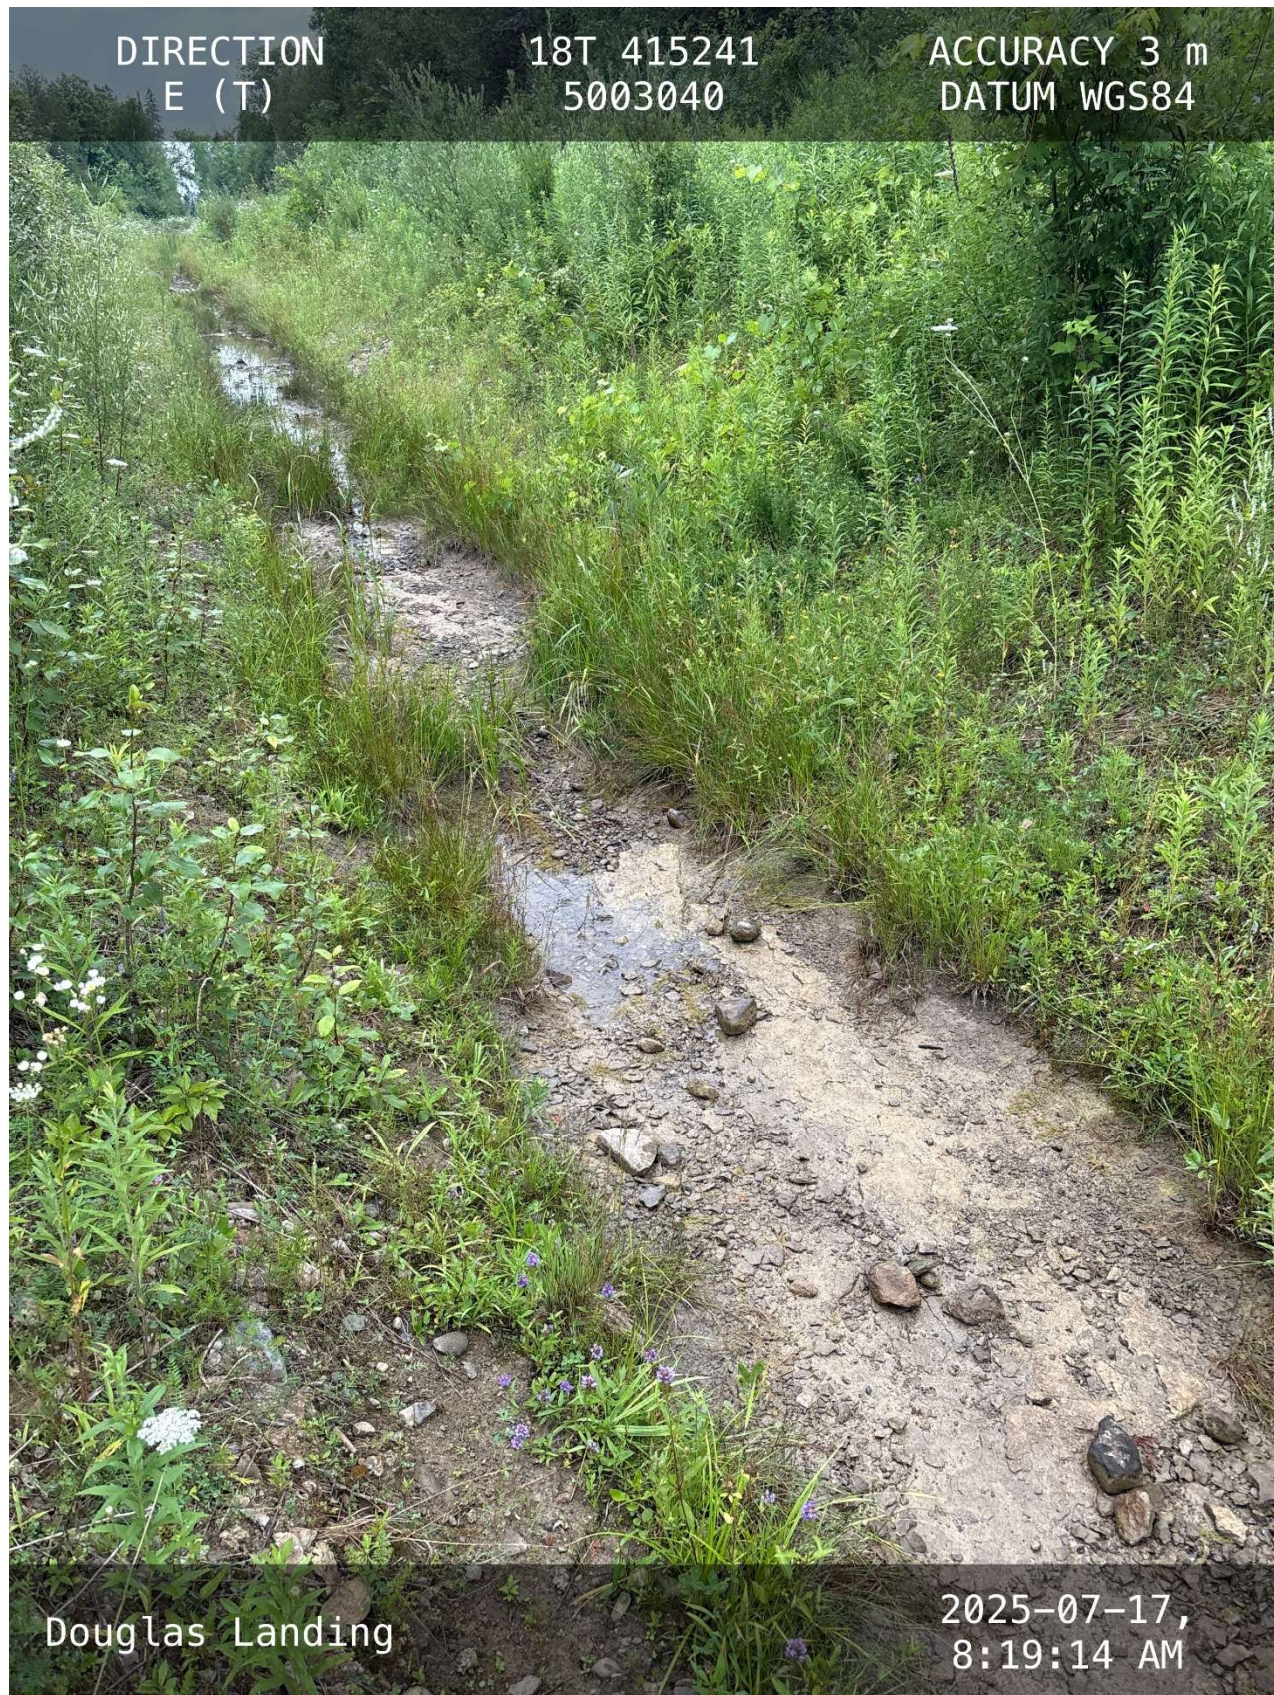
The channel runs dry approximately 160 m from the boundary of the property but is likely connected to downstream habitat during periods of high flow (Map 1; Photo 8). The wetted channel does not have any obvious barriers to fish passage at the time of survey. There are several natural log snags, but flow persists through and underneath these structures (Photo 9). Limited instream depth, sections of interstitial flow, and dry portions at the downstream extent limit upstream migration from during the summer months. Movement within the channel may be impacted by channel crossings (Photo 10). The culvert present in the channel is not perched and does not appear to pose a barrier to fish during the low water conditions observed.

Photo 8: Downstream Extent of Wetted Channel, MMD2, July 2025

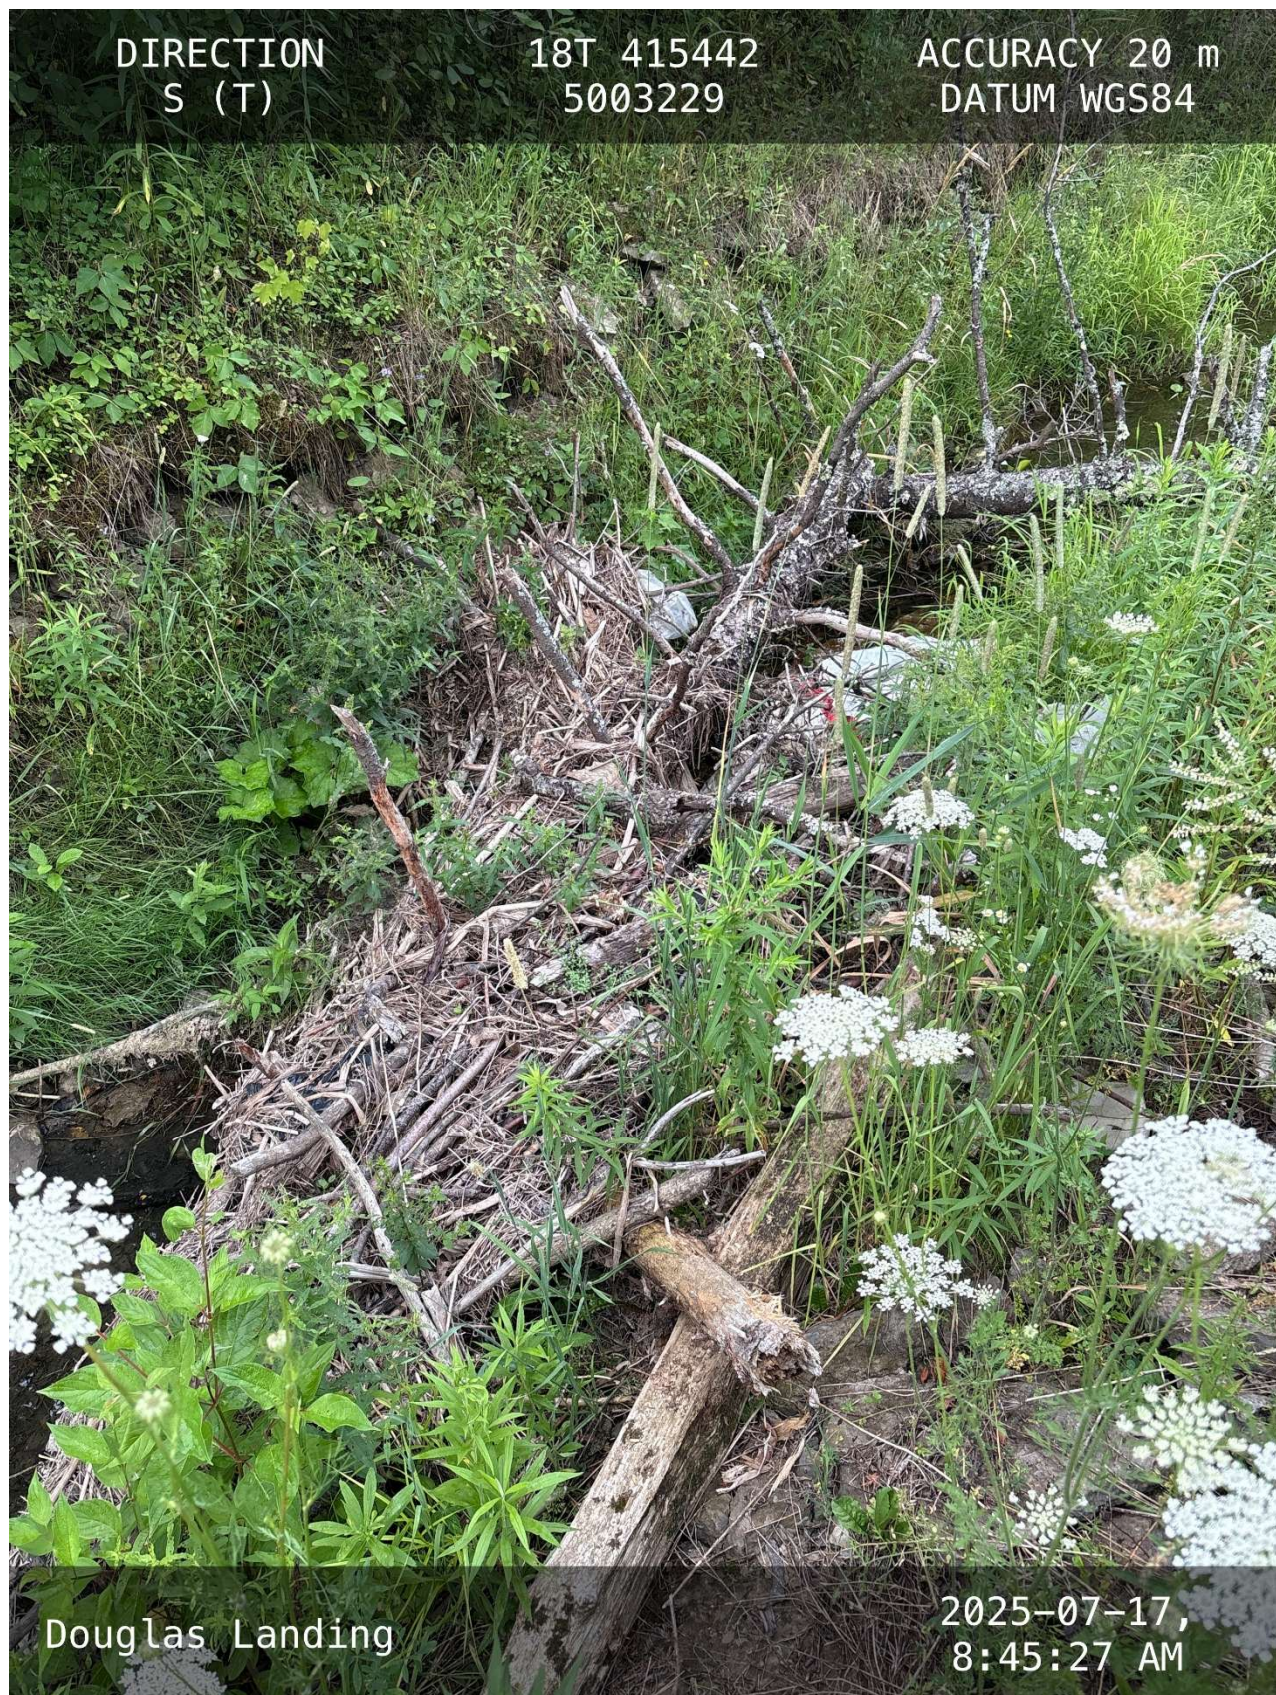
Photo 9: Log Snag With Flow Underneath, MMD2, July 2025

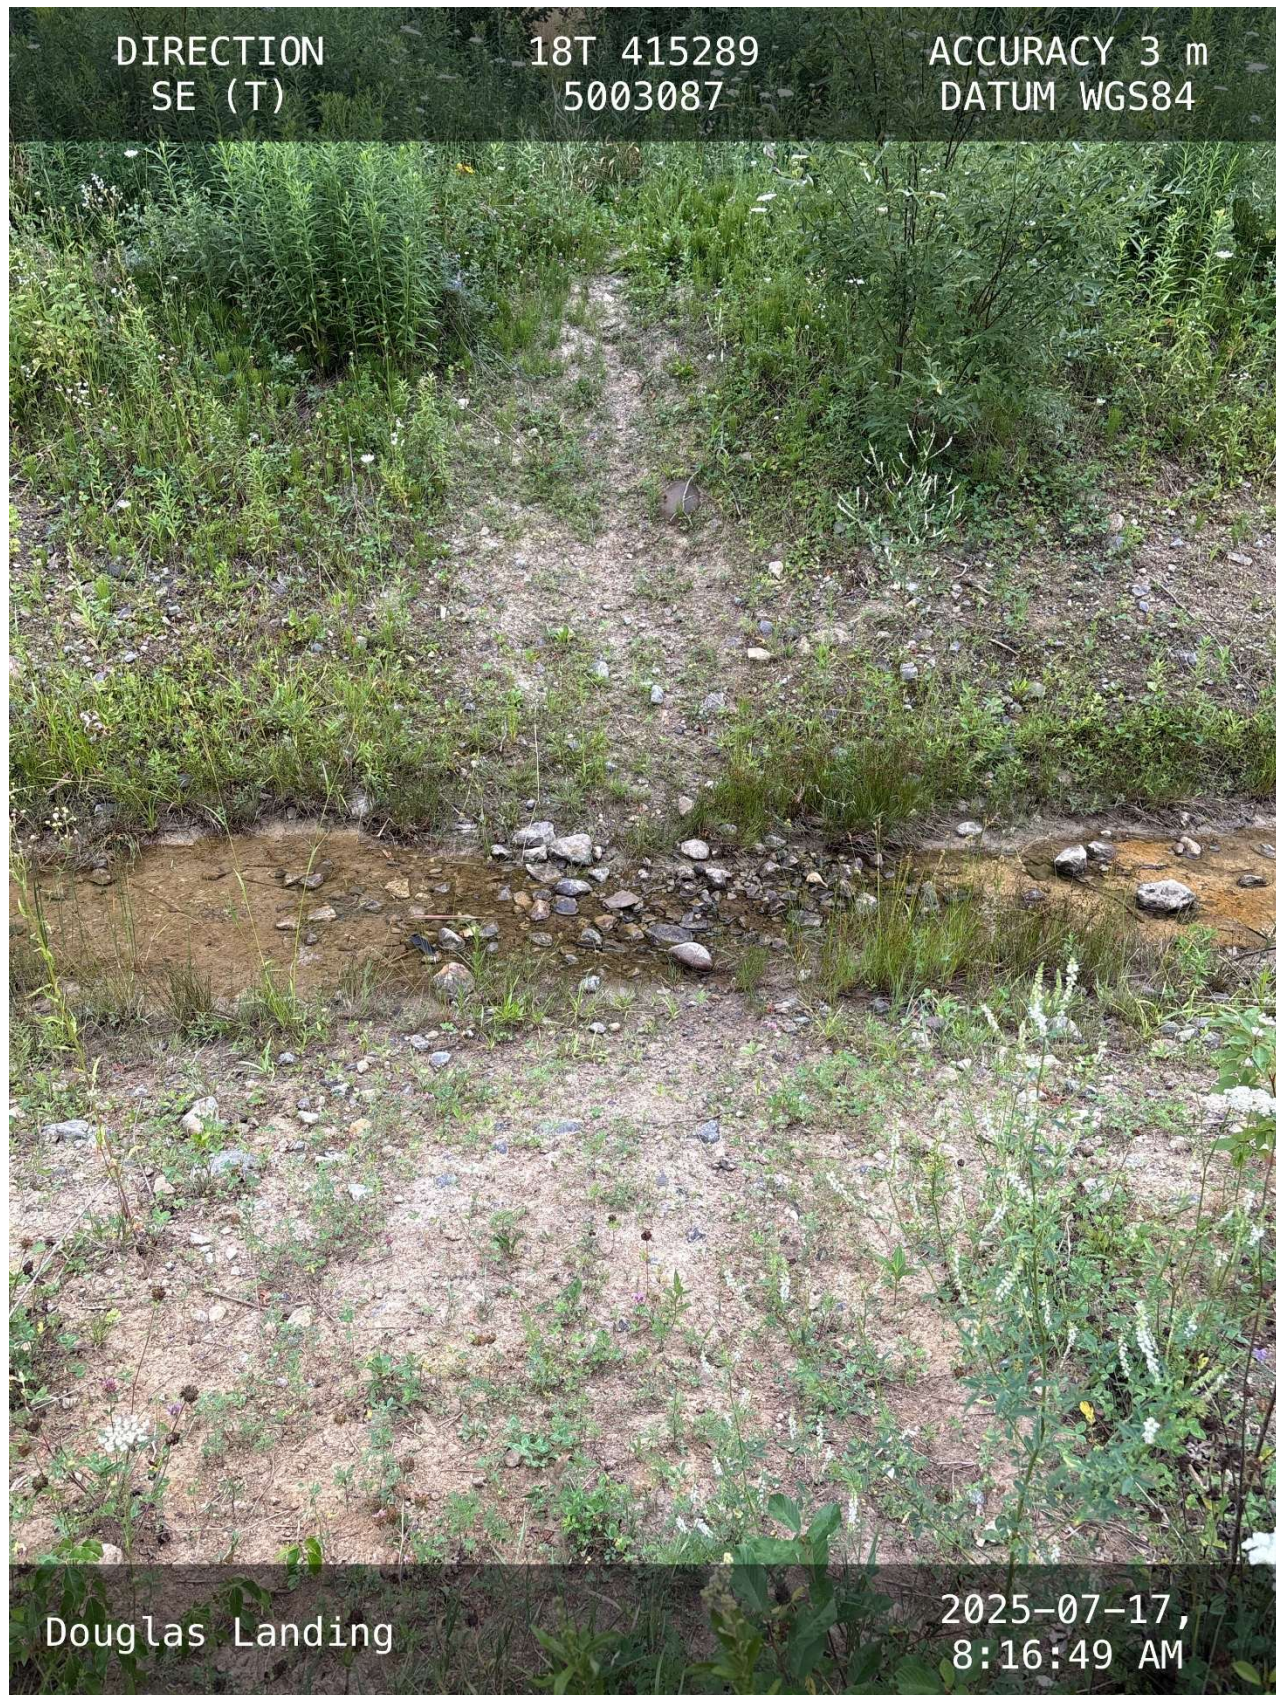
Photo 10: Channel Crossing, MMD2, July 2025
