RE: Verification of Complete Application for an Official Plan Amendment Lot 5, Concession 10, geographic Township of Lanark Highlands, County of Lanark County of Lanark File No. 0940-OP-23007

RE: County of Lanark Official Plan Amendment Township of Lanark Highlands Official Plan and Zoning By-Law Amendments McKinnon Pit Expansion (958 Highland Line Road) Part of Lot 5, Concession 10 Geographic Township of Dalhousie Township of Lanark Highlands Applicant: Arnott Brothers Construction Ltd.

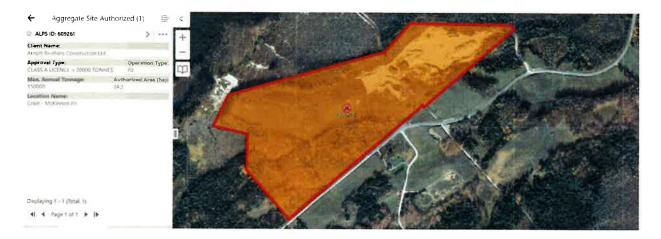
Figure 3 – Pits and Quarries Online Mapping for McKinnon Pit

tonnage of 150,000 tonnes. The information is correct; however, it is notable that the boundary of the Pit on the mapping is incorrect. The mapping shows the southern boundary of the Pit running along the edge of Highland Line before the road veers east (See Figure 3). The Existing Features Plan submitted with the ARA application shows the boundary is setback from the edge of Highland Line to maintain the 150 metre separation buffer to nearby residential uses (See Figure 4). The mapping confirms a license is already in place for McKinnon Pit.

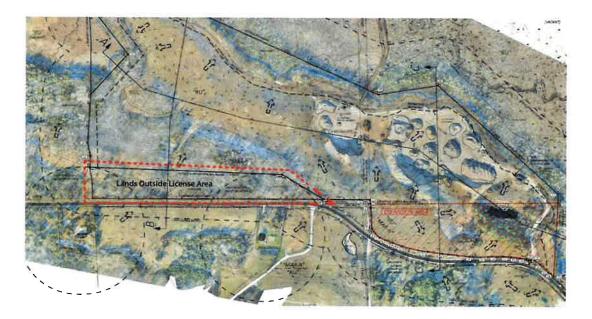
Figure 4 – Showing Lands Outside of Licensed Area abutting Highland Line

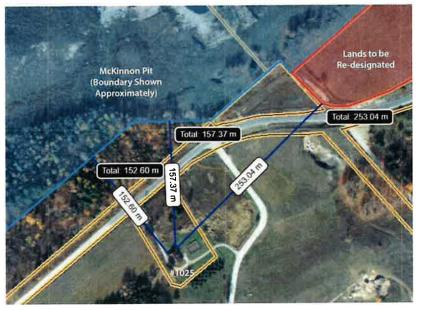
Figure 9 – Separation between 1025 Highland Line Road and the Re-Designated Lands

The re-designation to Mineral Aggregate Resource Policy Area will occur on lands within 300 metres of a residential use to the west at 1025 Highland Line Road. A second dwelling further west at 1121 Highland Line Road and the commercial Wheelers Pancake House would fall beyond 300m of the lands to be re-designated (See Figure 9). The new ARA Application is also seeking to expand extraction to 20 metres below the water table. A hydrogeological investigation has been completed by GRI Inc. which found no significant change or impact on groundwater recharge or flow on or around the property will occur from the re-designation of the subject property or extraction below water. Additional supporting studies like an Archaeology Study and a Natural Environment Technical Report have been completed to ensure the expanded area is compatible with surrounding development in accordance with Section 4.1.3.2 of the Official Plan.

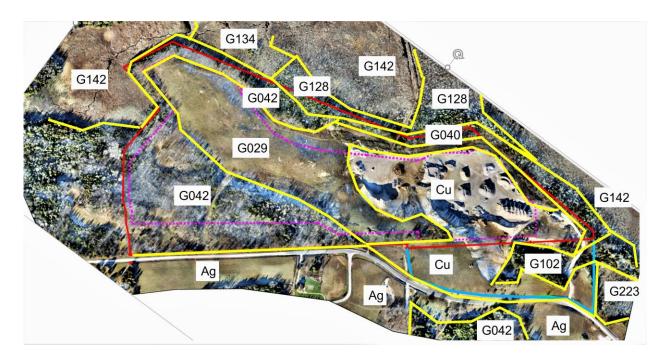
Figure 2. ELC mapping associated with existing licence boundary (red line) and proposed expansion boundary (blue line).

The Lanark County and Lanark Township OP's do not recognize provincially significant wetland on or within 120 m of the existing pit licence area or the proposed pit expansion areas. There is an approximate 129 ha. wetland that gets as close as 55 m to the north and west portions of the proposed extraction boundary of the existing licence area and is immediately east of the proposed expansion boundary. The following detail from the Mississippi Valley Conservation Authority (MVCA) shows an estimated boundary of "non-evaluated" wetland in green, the MVCA regulation limit of 30 m from the wetland in yellow, our inclusion of the expansion boundary in red, and a recommended further 15 m buffer in light blue. Other than a few minor changes, the MVCA wetland boundary mapping is very similar to the wetland mapping evident in Figure 2 of this report.

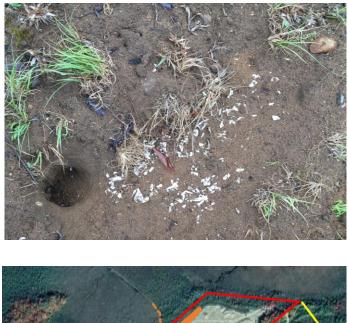
> The nests extended across an approximate 90 m length marked by the orange rectangle in the adjacent image. Turtles were observed basking on logs within the drainage ditches on either side of the snowmobile trail north of the existing licence area, and it is likely that they move south (see dashed orange line in adjacent image) through the easily passable snowmobile trail to access the nesting area.

excavation as it is our understanding that the pit has reached its floor depth here. However, inadvertent vehicle damage could occur, and it is recommended that turtle fencing be installed (see MNR 2013) at the edge of the unvegetated area to prevent this. This line is clearly visible in Google map images, and varies from 10 to 30 m from the northern tree line.

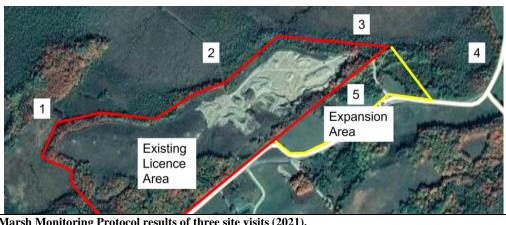
- Amphibian breeding habitat (wetland): Requires wetlands and pools $> 500 \text{ m}^2$. Four wetland sites were surveyed (see 1 to 4 in following image) and one pool (see 5 in following image) using the marsh monitoring protocol (BSC 2009). Field data are provided in Table 3. To be considered SWH, requires a Call Level Code 3 for indicator species or the presence of listed salamander species.

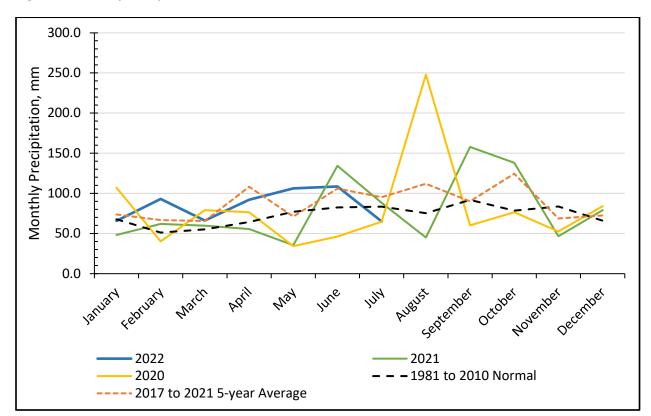
Figure 2: Monthly Precipitation, Drummond Centre Climate Station

Approximately 70 to 75% of the annual precipitation falls on the site when the pit will be active (assumed to be between May and December) according to the Normal and 5-year averages.

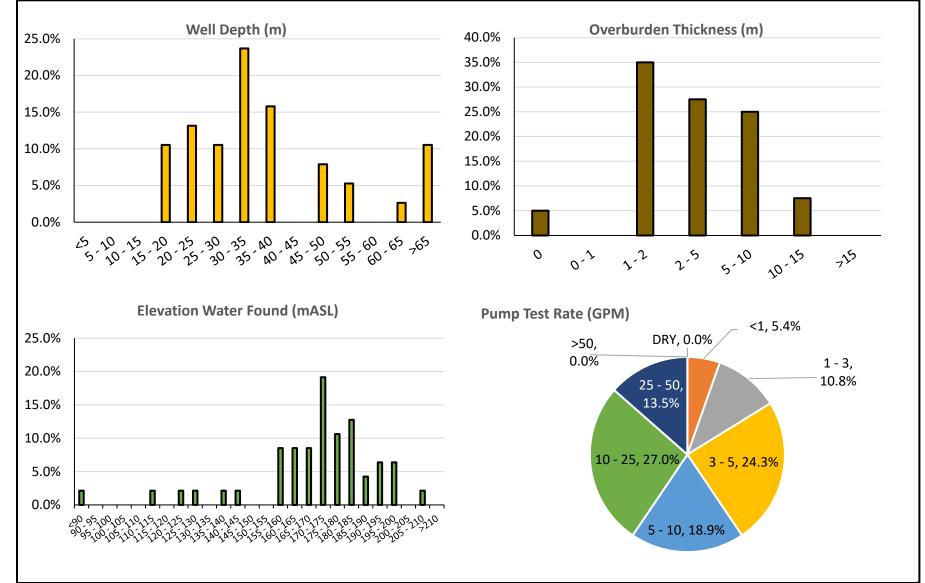
Figure 3: Well Record Analysis

The analysis show the wells in the area have reported moderate to high yields of good quality water (Figure 3). The RMRGS (Golder Associates Ltd. 2003) also indicates that the wells drilled in the area generally provide sufficient potable water to support a residence.

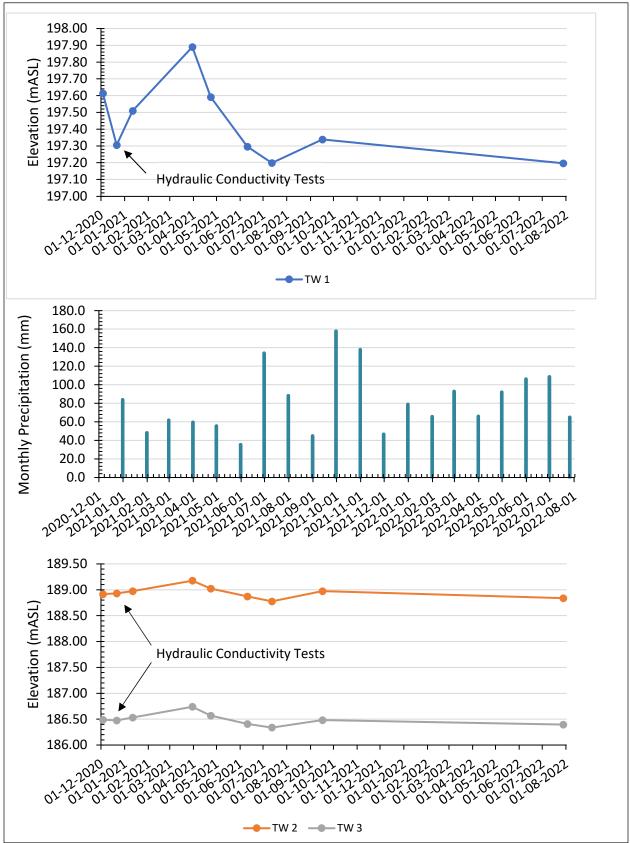
Figure 4: Variation in Groundwater Level, TW 1 to TW 3

GRI Inc. advanced three test holes on the site with piezometers installed. Hydraulic conductivity tests were completed and groundwater levels were measured from December 3 2020 to July 28, 2022. The study found no significant change or impact to the groundwater recharge or flow on or around the property will occur from the proposed operation. Recommendations included in Section 13 of the report propose a groundwater monitoring program, to be followed by data collection when the below water excavation begins.

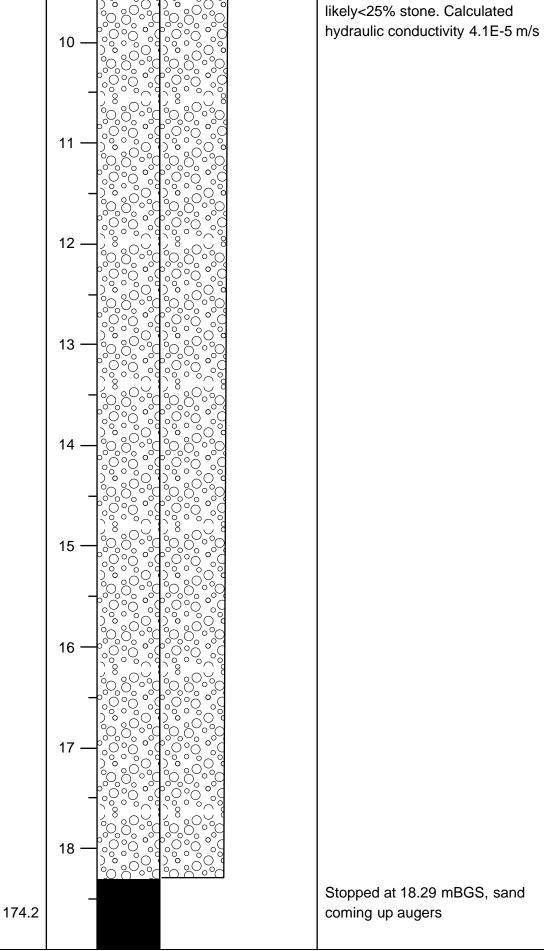
Arnott	- McDo	nalds Cor	ners TW 3 18T 037883	0 4976959	Ι	
ELEVATION (mASL)	SCALE (m)	ЛОПОСУ	MUD SANDGRAVEL MUD SANDGRAVEL		SAMPLE NO.	INSTALLATION
402.5				loose silty sand		
193.5	- 1 —					
	2 —					
	3 —					
	4 —					
188.9	5 —			medium coarse to very coarse sand , pea gravel, ALCS 1 to 2 cm, FM 3 to 3.5		
187.4	6 —			medium coarse to very coarse sand , pea gravel, ALCS 1 to 2 cm, FM 3 to 3.5. Calculated hydraulic conductivity was 5.8E-05 m/s	sa3 1-2-18-16	
	7 —					
	8 —					
	9 —

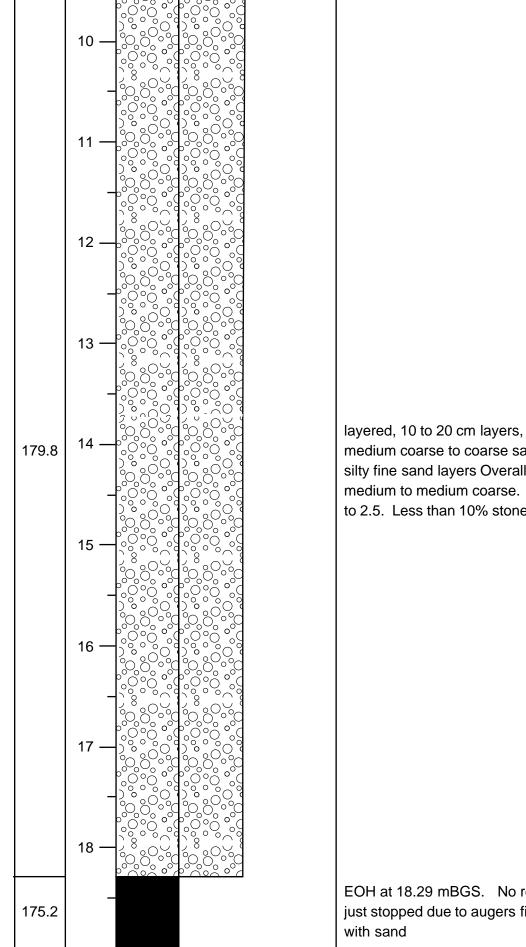
medium coarse to coarse sand to silty fine sand layers Overall, medium to medium coarse. FM 2 to 2.5. Less than 10% stone.

EOH at 18.29 mBGS. No refusal, just stopped due to augers filling

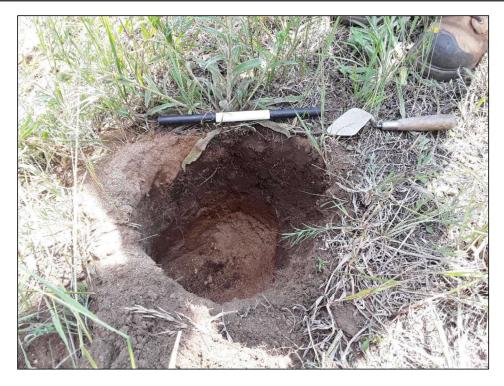
Image 15. Typical soil stratigraphy in the former pasture, facing east. (PR21-014D031)

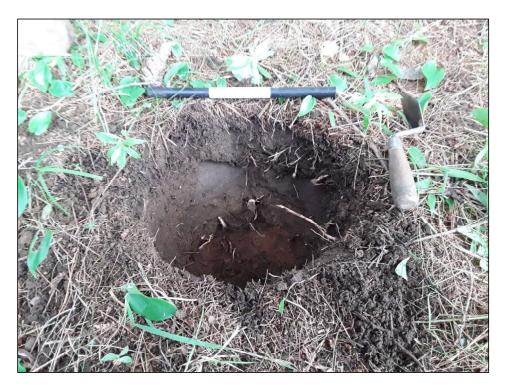
Image 16. Typical soil stratigraphy in the wooded area, facing north. (PR21-014D039)

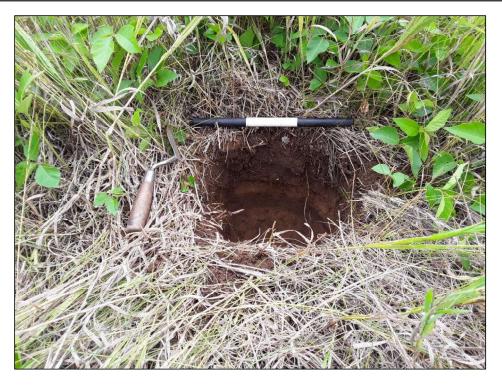
Image 17. Typical soil stratigraphy in the open area west of the gravel road, facing north. (PR21-014D060)
