Plan of Subdivision

Draft Plan of Subdivision and Stormwater Management Report: BURN'S FARM SUBDIVISION

**DRAFT PLAN OF SUBDIVISION**  
**PART OF EAST HALF OF LOT 7 CONCESSION 1**  
(GEOGRAPHIC TOWNSHIP OF DRUMMOND)  
**TOWNSHIP OF DRUMMOND / ELM斯LEY**  
COUNTY OF LANARK

**RE: Plan of Subdivision Application - Burns Farm  
Part of Lot 7, Concession 1, Geographic Drummond  
Township of Drummond/ North Elmsley  
Owner: 1394706 Ontario Inc (Crains' Construction)**

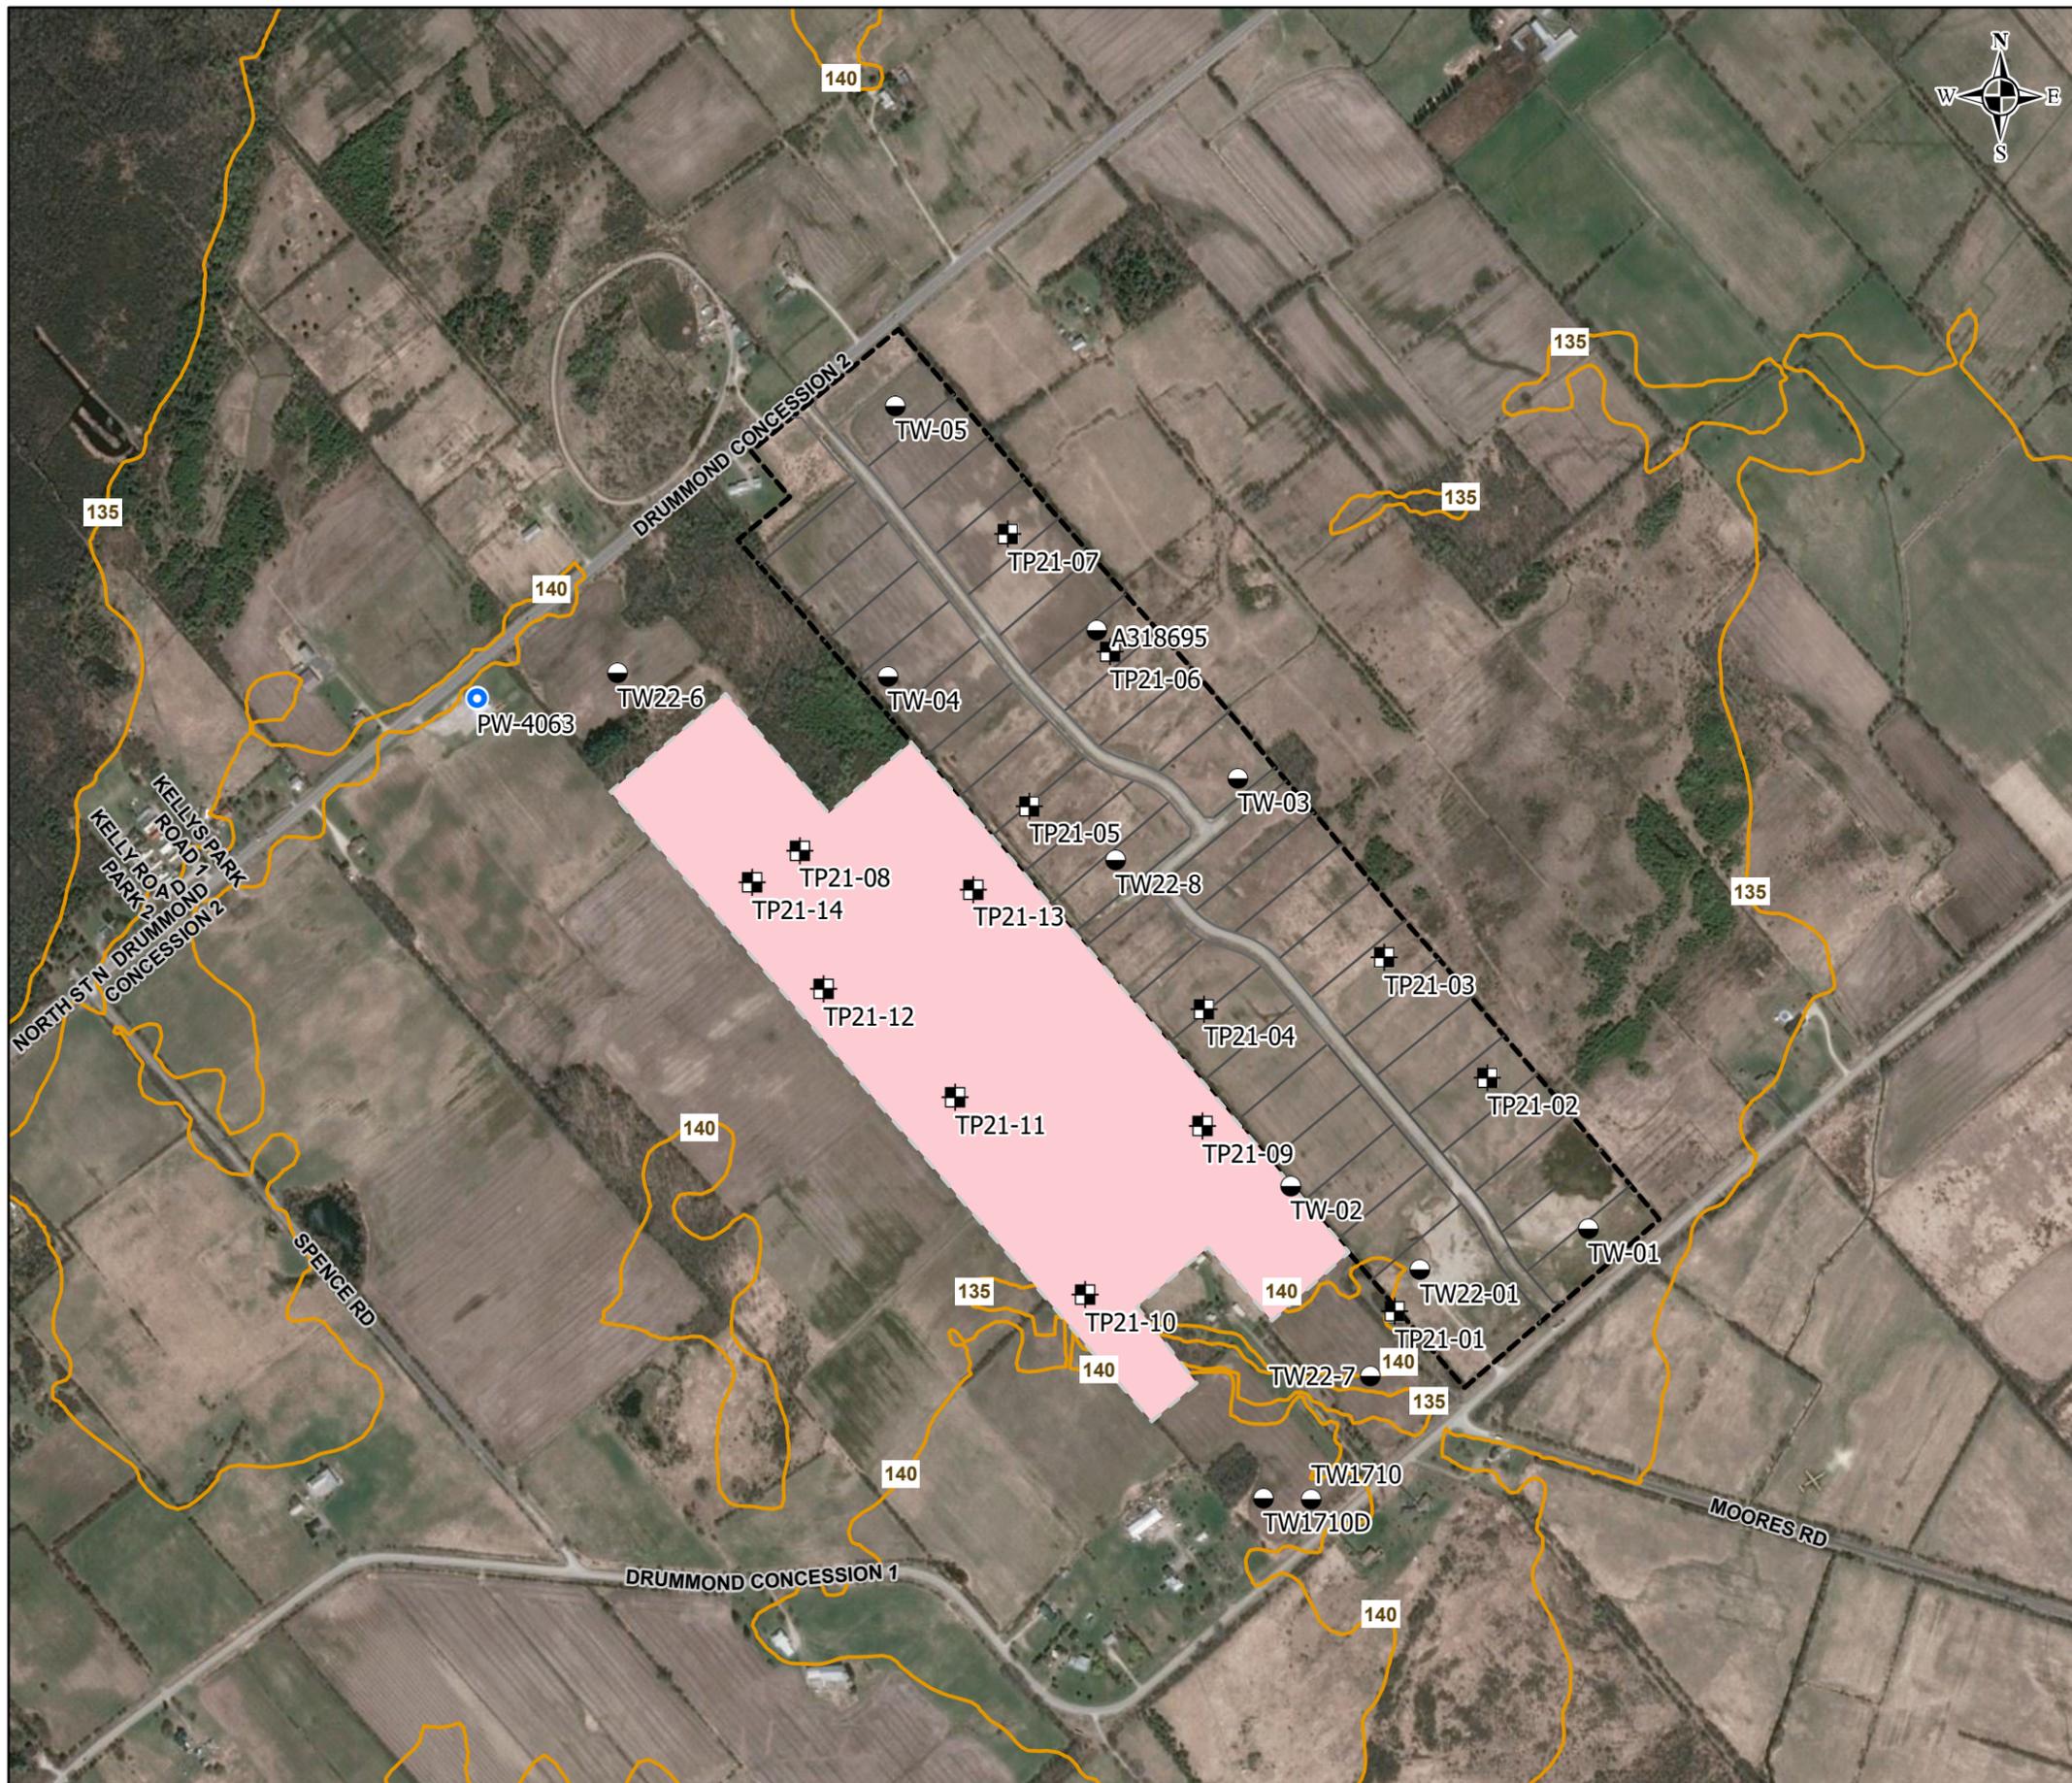
Drawing		<b>SITE PLAN</b>		Project		100227.008	
Title							
CONSOLIDATED HYDROGEOLOGICAL & TERRAIN ANALYSIS PROPOSED RESIDENTIAL SUBDIVISION PHASE 1 PART OF LOT 6 AND LOT 7, CONCESSION 1 DRUMMOND TOWNSHIP, ONTARIO							
Drwn By	Chkd By	Client					
C.Z.	A.P.	<b>Wilbert Crain</b>					
Date: September 2023				Rev.	00		
© Queen's Printer for Ontario				<b>FIGURE: 1</b>

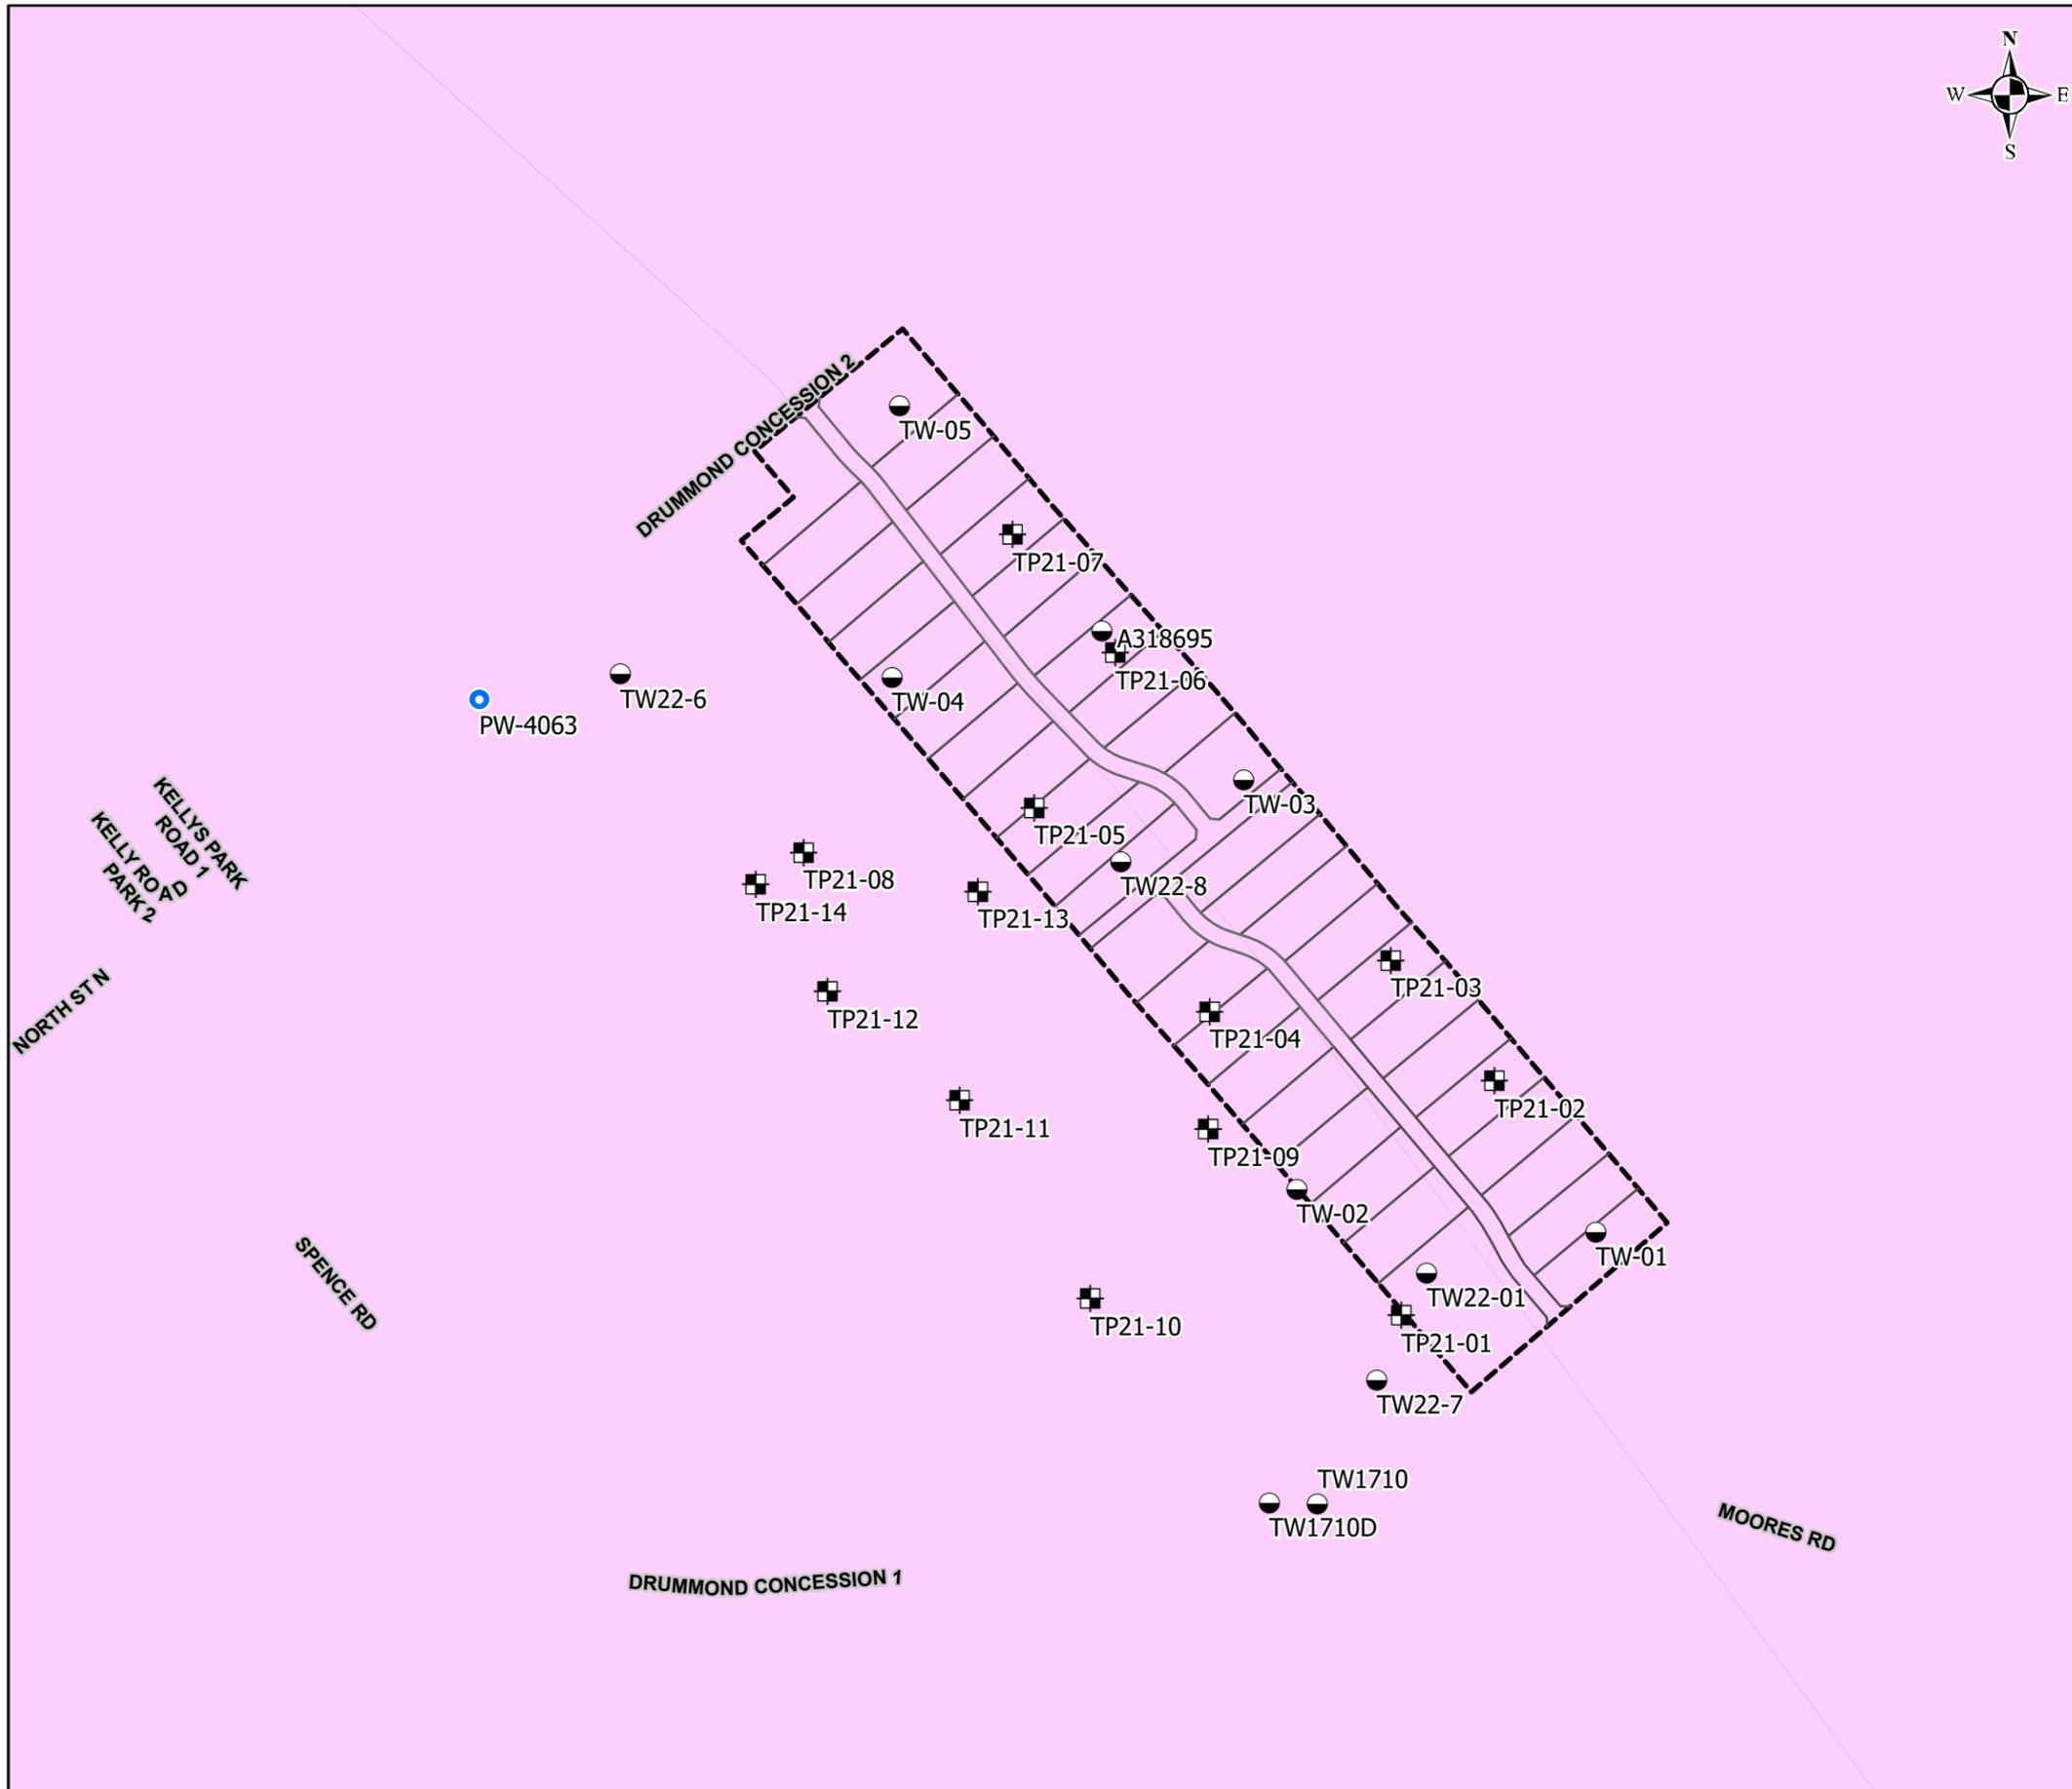
Drawing	<b>BEDROCK GEOLOGY</b>		Project
			100227.008
Title CONSOLIDATED HYDROGEOLOGICAL & TERRAIN ANALYSIS PROPOSED RESIDENTIAL SUBDIVISION PHASE 1 PART OF LOT 6 AND LOT 7, CONCESSION 1 DRUMMOND TOWNSHIP, ONTARIO			
Drwn By	Chkd By	Client	
S.L.	A.P.	<b>Wilbert Crain</b>	
Date: September 2023		Rev.	<b>FIGURE: 6</b>
© Queen's Printer for Ontario		00

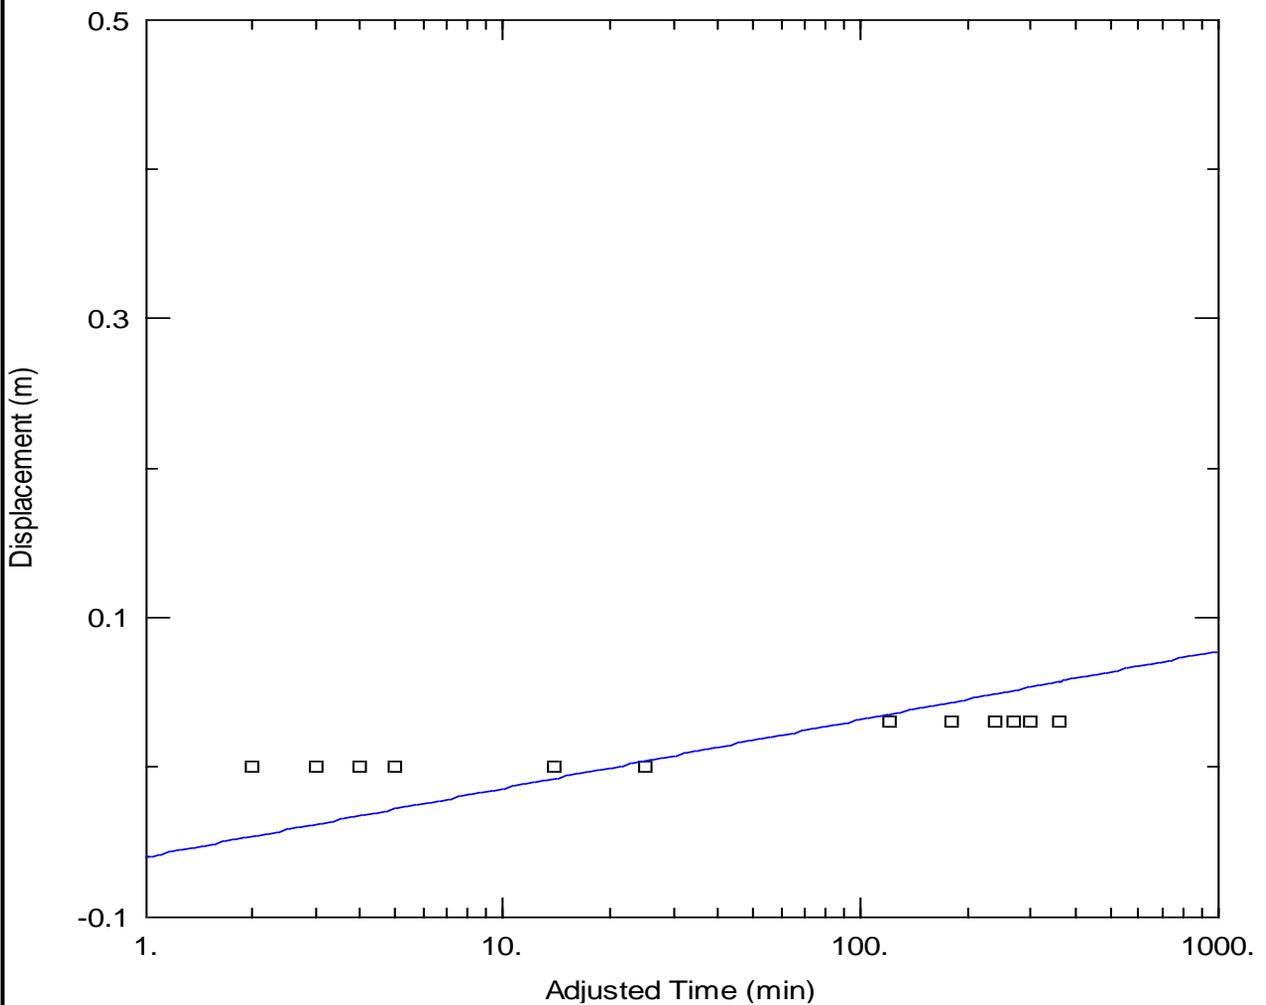
## Pumping Test Analysis: Cooper-Jacob (TW22-01)

**Aquifer Model: Confined**

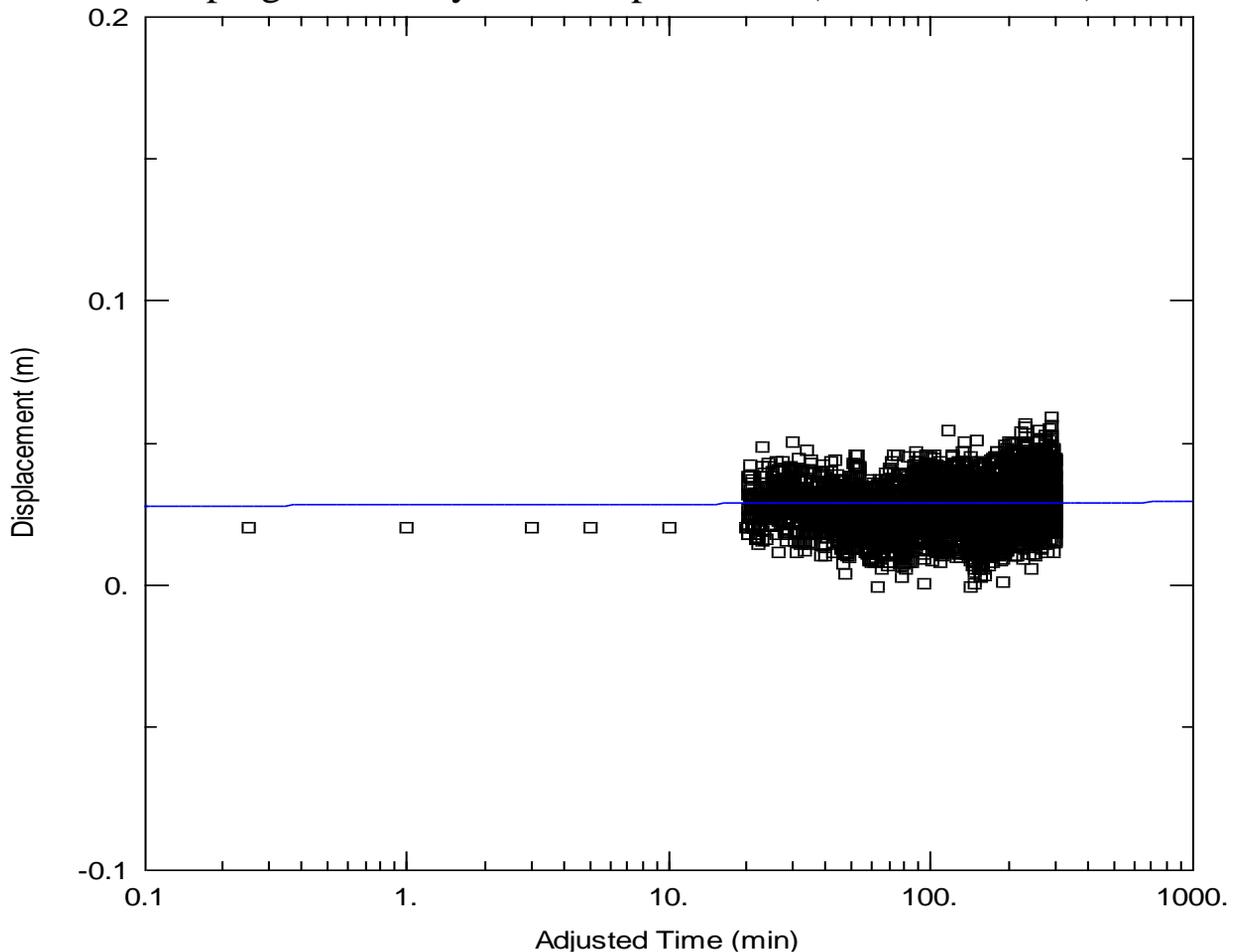
## Pumping Test Analysis – Cooper-Jacob (TW-22-1 Lined)

**Aquifer Model: Confined**

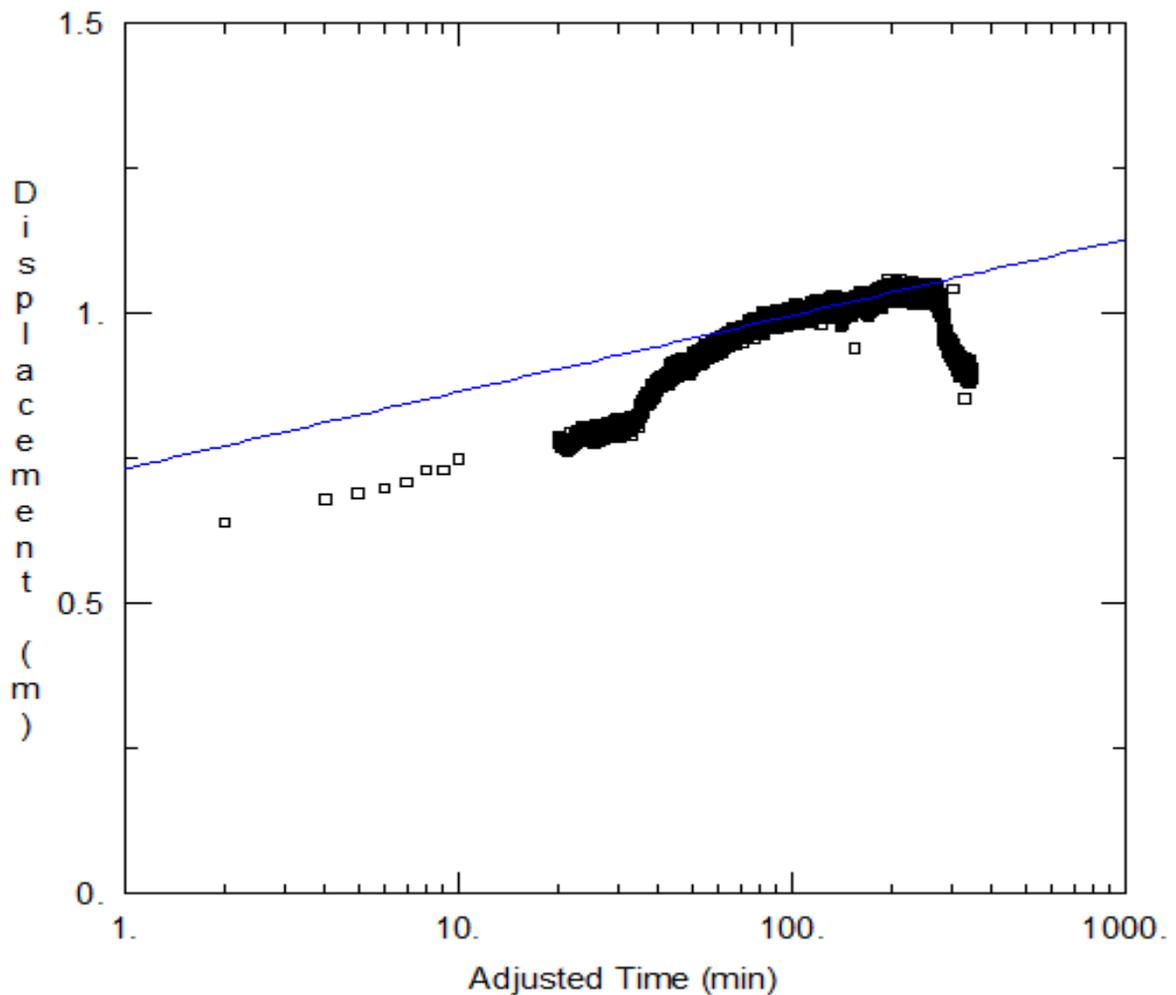
## Pumping Test Analysis: Cooper-Jacob (TW22-8 Lined)

**Aquifer Model: Confined**

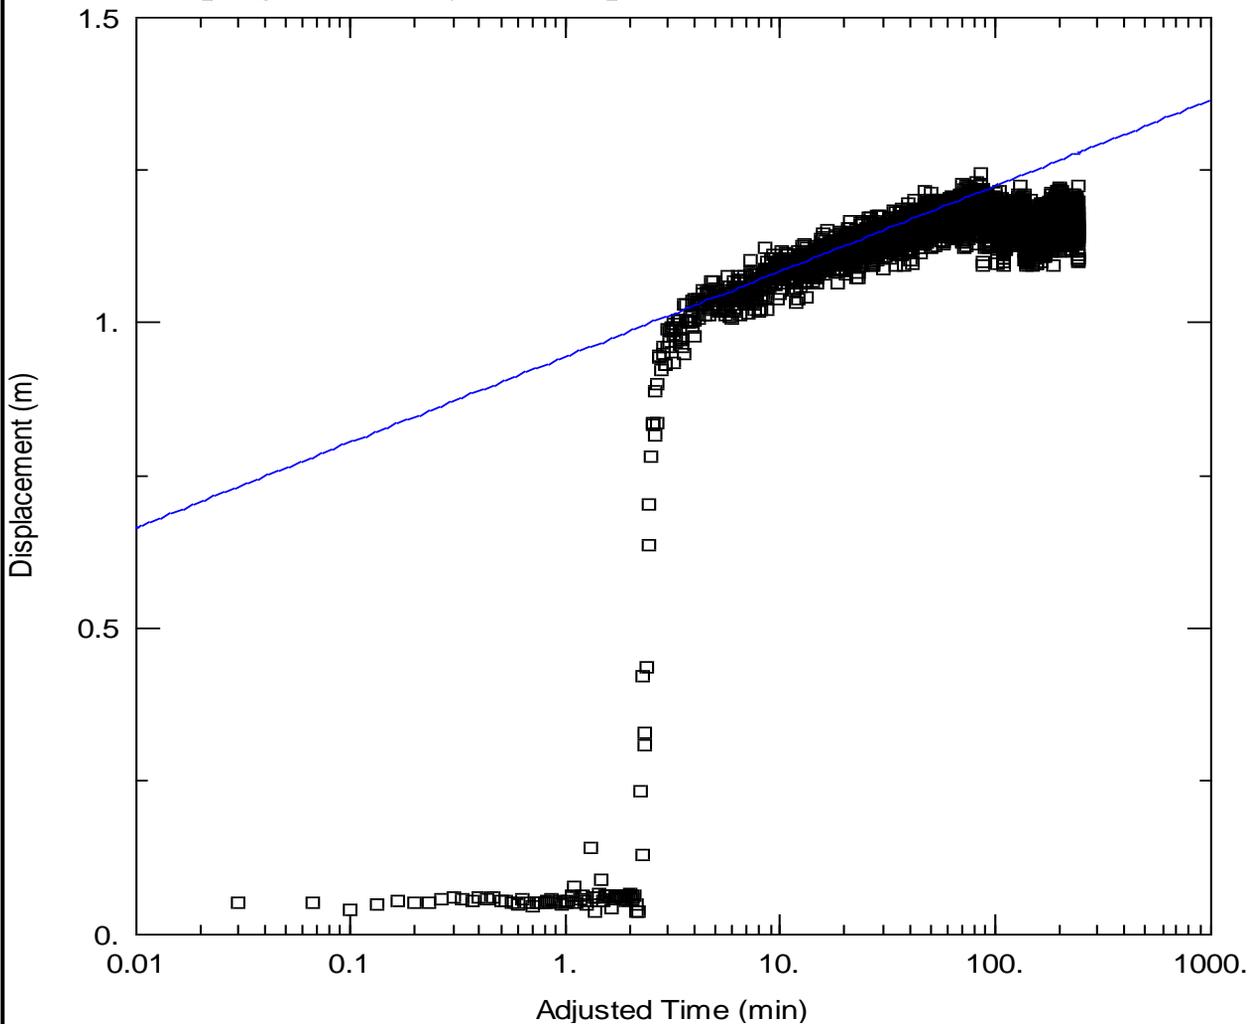
## Pumping Test Analysis: Cooper-Jacob (TW A318695 Lined)

**Aquifer Model: Confined**

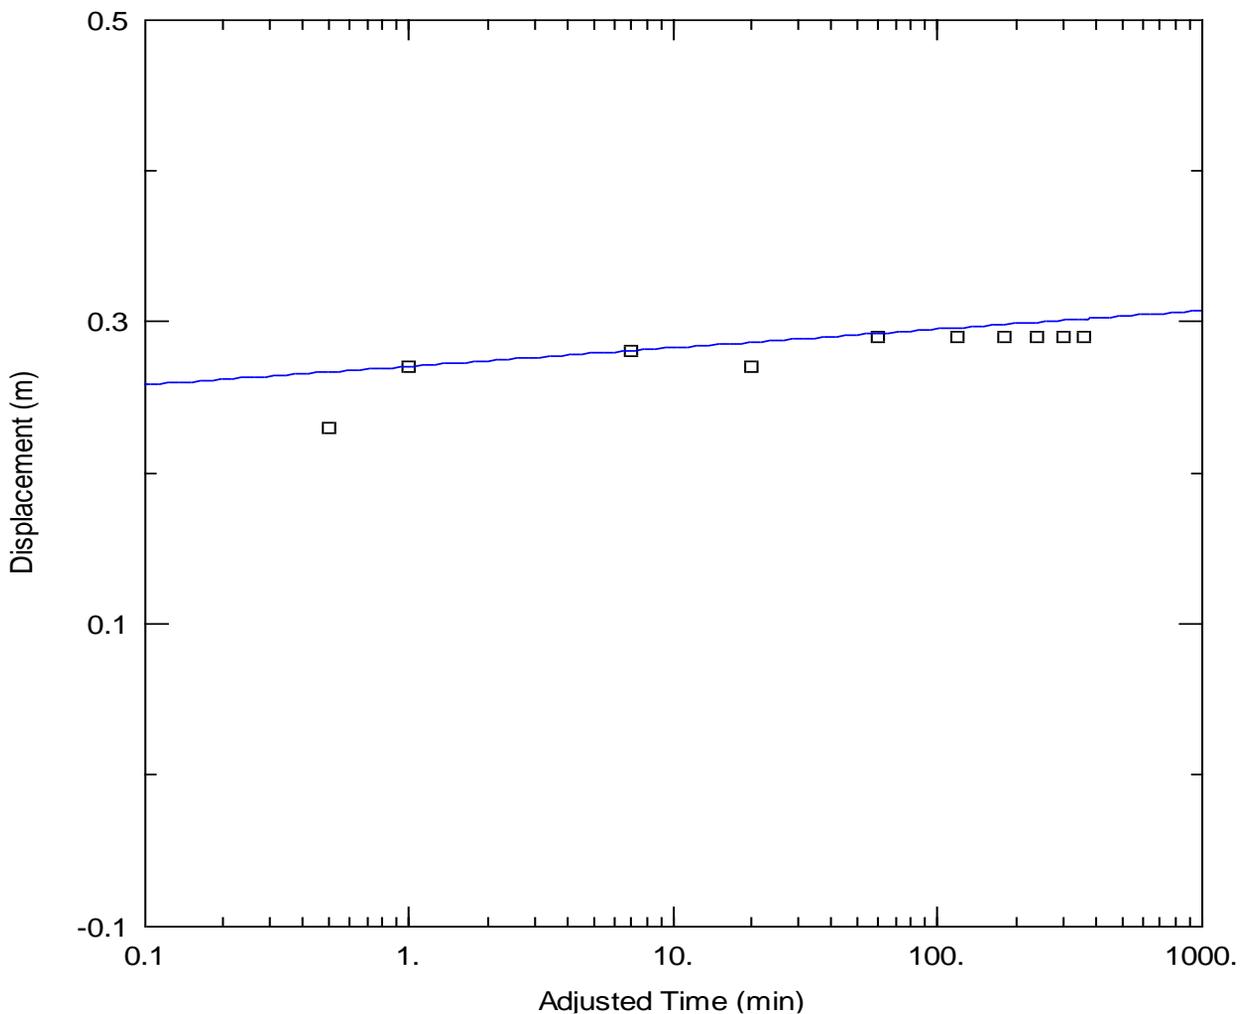
## Pumping Test Analysis: Cooper-Jacob (PW4063)

**Aquifer Model: Confined**

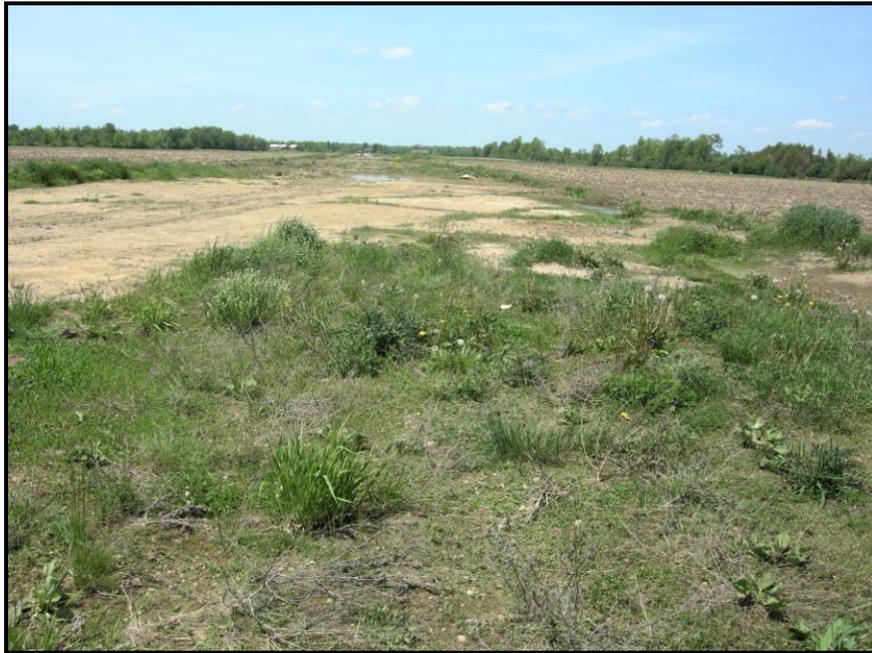
**Figure 14. Projected course of roadway currently under construction extending into wet conditions within southeast section of subject property, looking northwest.** Note the exposed bedrock surface in the foreground and machine piled topsoil to the right. (PR13-18D019)

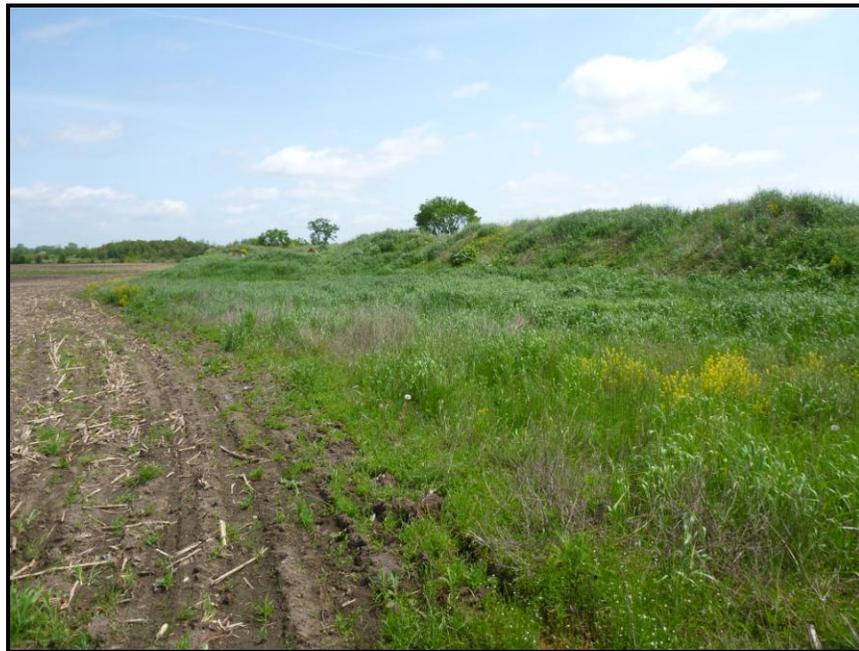
**Figure 15. Southern end of the property showing fill disturbance, looking northeast.** (PR13-18D055)
