Phase I - Environmental Site Assessment

Proposed Residential Development
Laing Lands, Highway No.15
Carleton Place, Ontario

September 22, 2020

Report: PE4835-1R

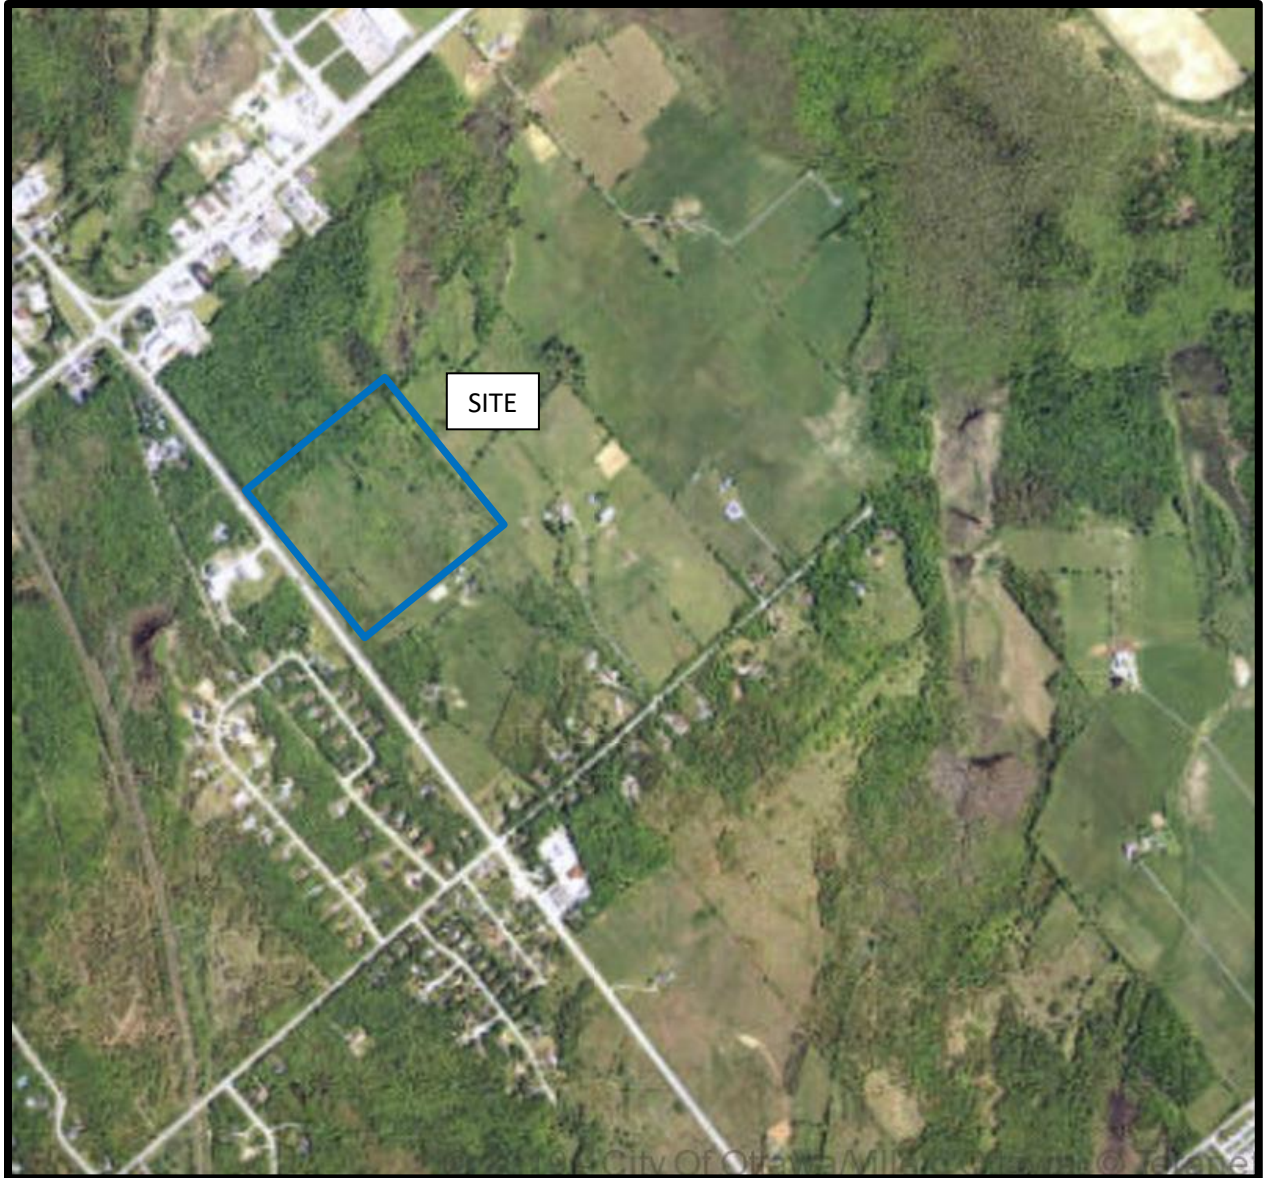
DRAWING: PE4835-2 – SITE PLAN

Paterson conducted a geotechnical investigation on the subject property in October of 2012. At that time six (6) test pits were placed on the subject property. The locations of these test pits can be seen on the attached Site Plan. Based on a review of our file, no unusual visual or olfactory observations were noted regarding the soil or groundwater encountered in these test pits.

A geotechnical Investigation was conducted by Paterson concurrently with this Phase I – ESA. A total of seven (7) test pits were excavated with a steel track excavator on January 9, 2020 on the subject site. Generally, the soil conditions encountered in the test pits consisted of a shallow bedrock profile overburdened by brown silty sand fill or by native brown to grey silty clay till. No unusual visual or olfactory observations were noted regarding the soil or groundwater encountered at the time of the geotechnical investigation.

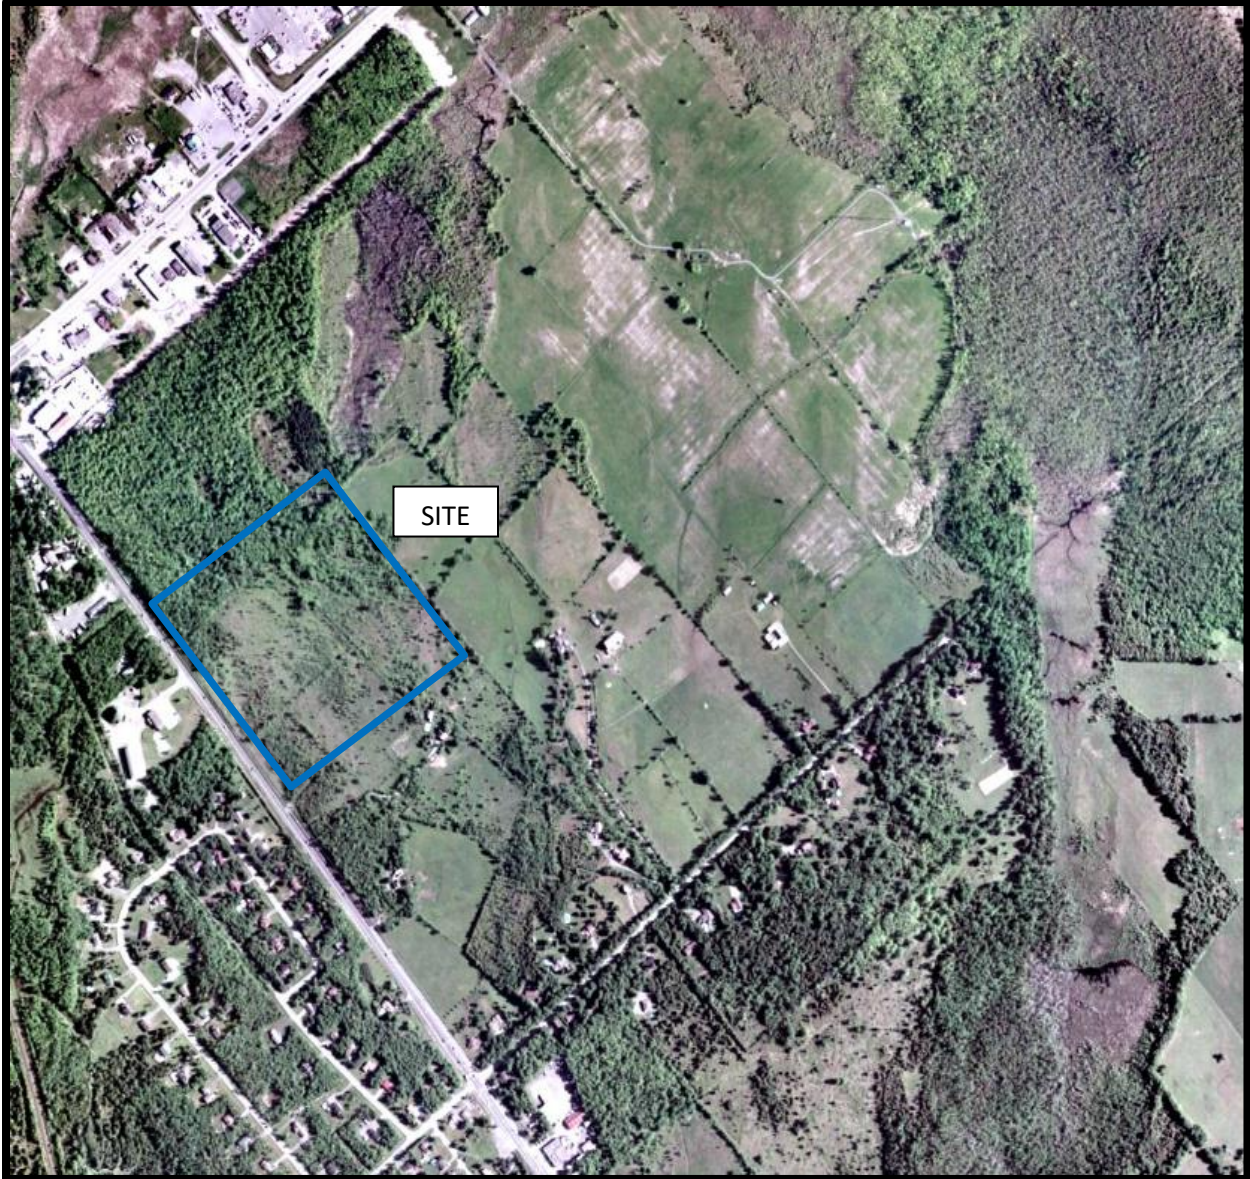
AERIAL PHOTOGRAPH
2002

| 2002 | The subject property is predominantly vacant agricultural land with some minor treed areas. The neighbouring properties to the north, south and west are vacant in this photo. A farmstead can be seen on the neighbouring property to the east. |

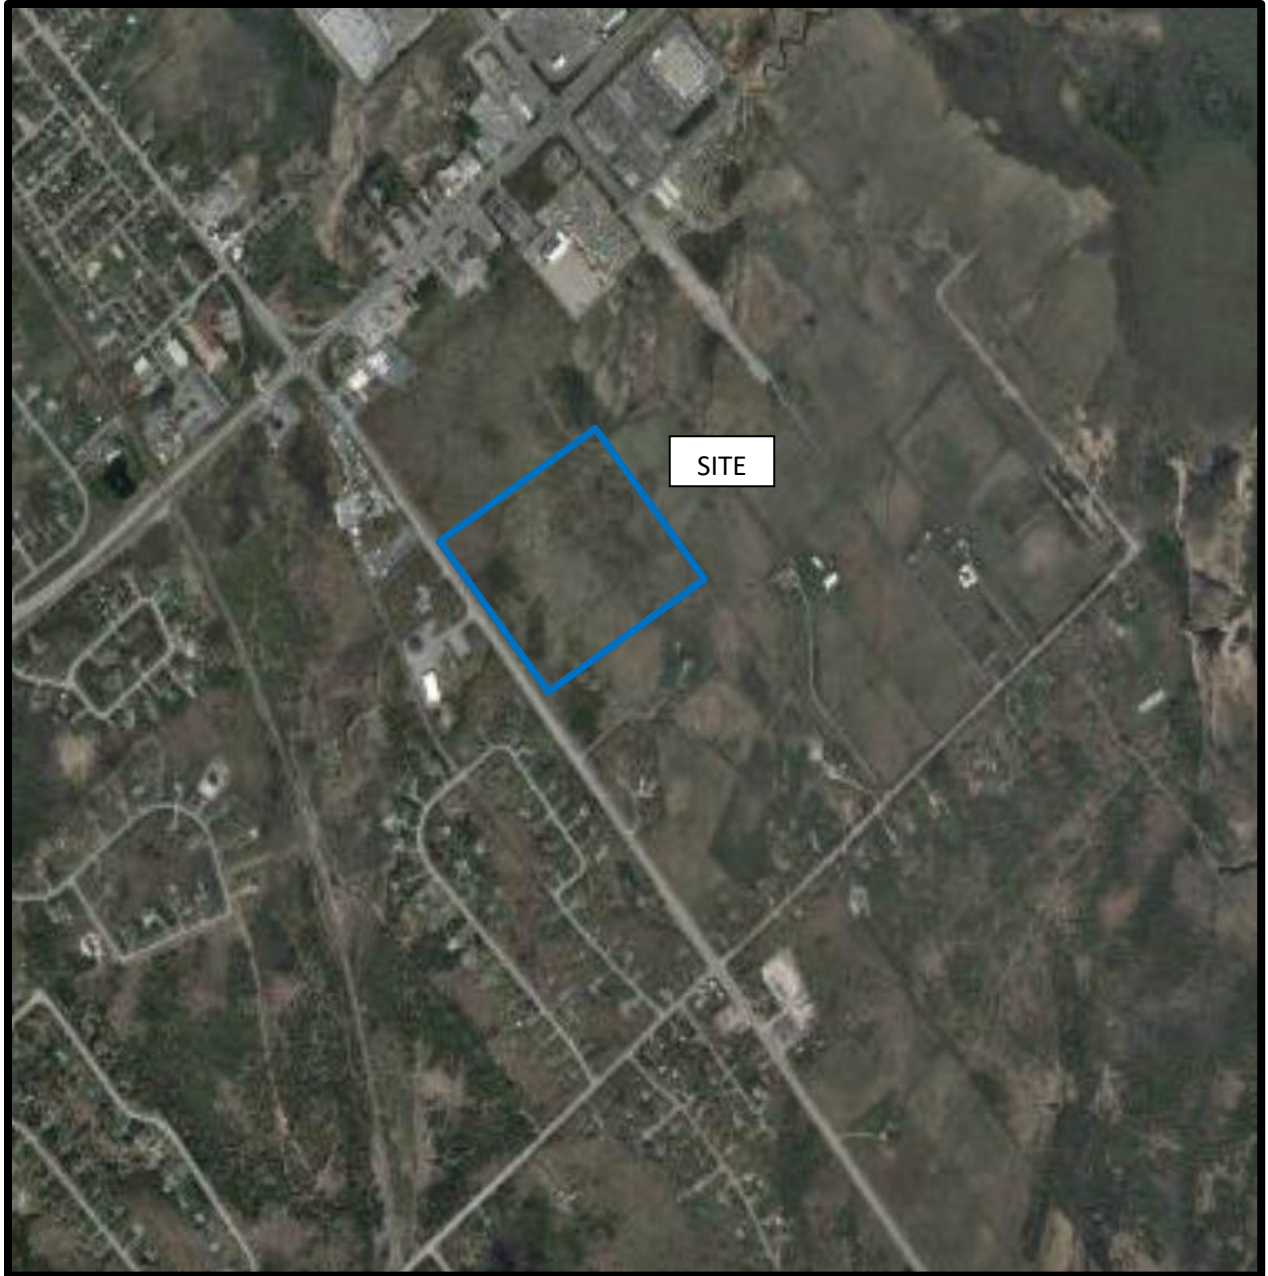
AERIAL PHOTOGRAPH
2005

| 2005 | No significant changes are apparent to the subject property or adjacent lands since the previous photo. |

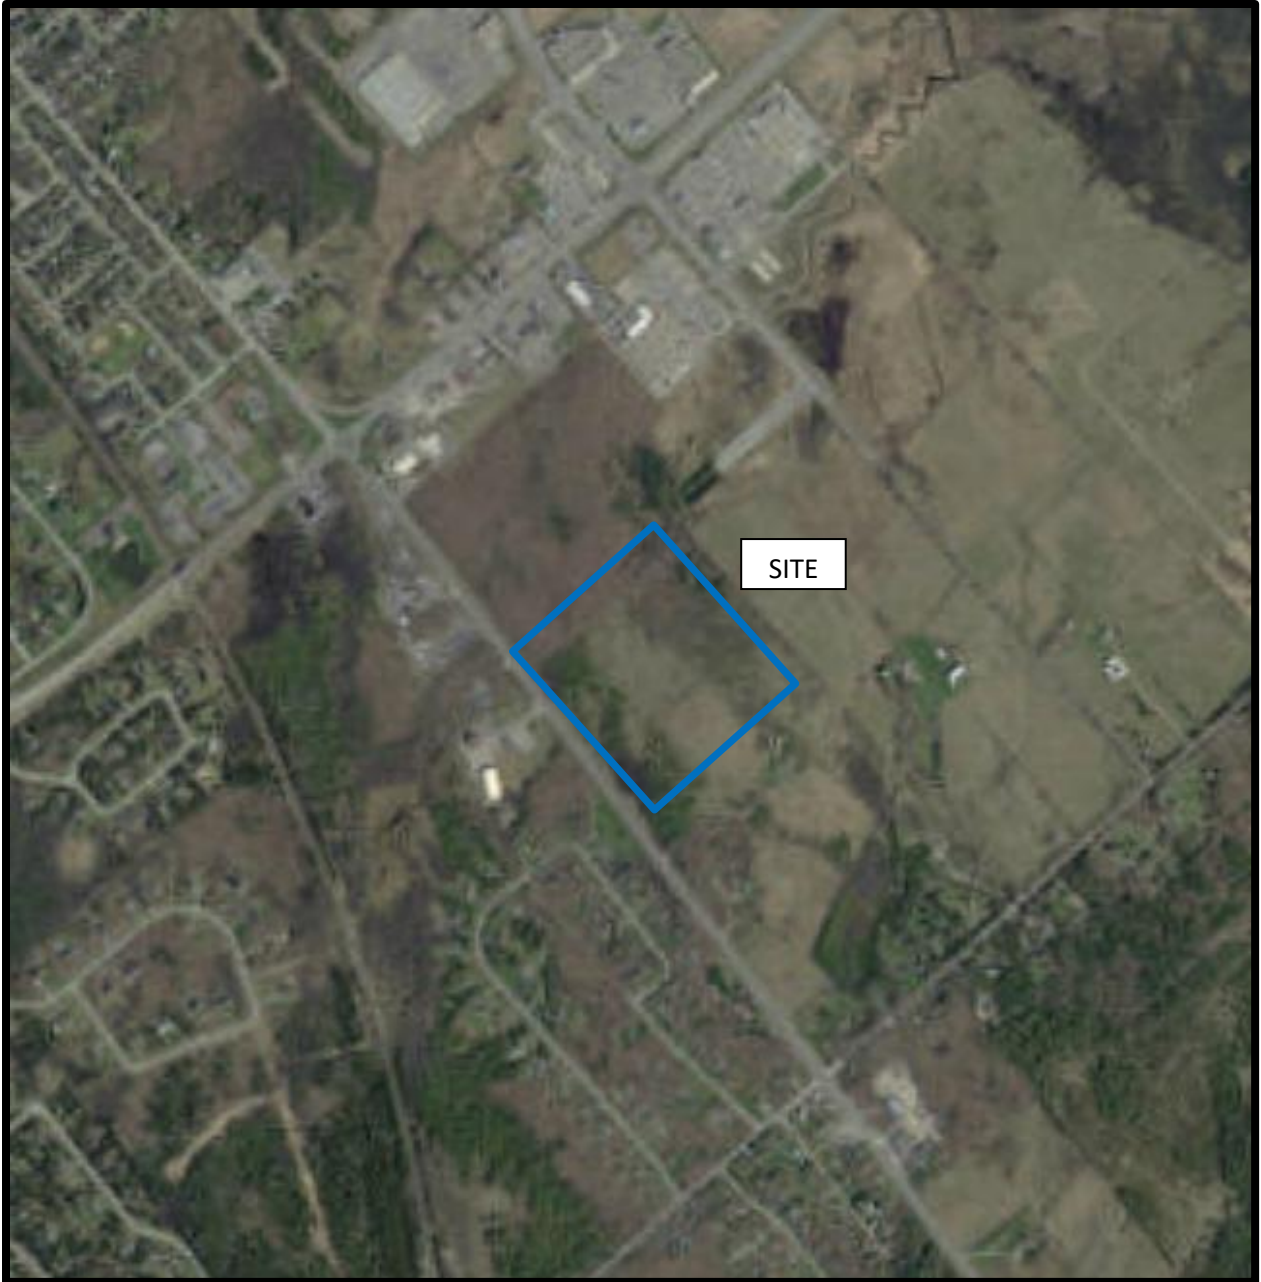
AERIAL PHOTOGRAPH
2011

| 2011 | No significant changes are apparent to the subject property. Retail development has increased further to the north of the subject property. The McNeely Avenue extension to the south can be seen in this photo. |

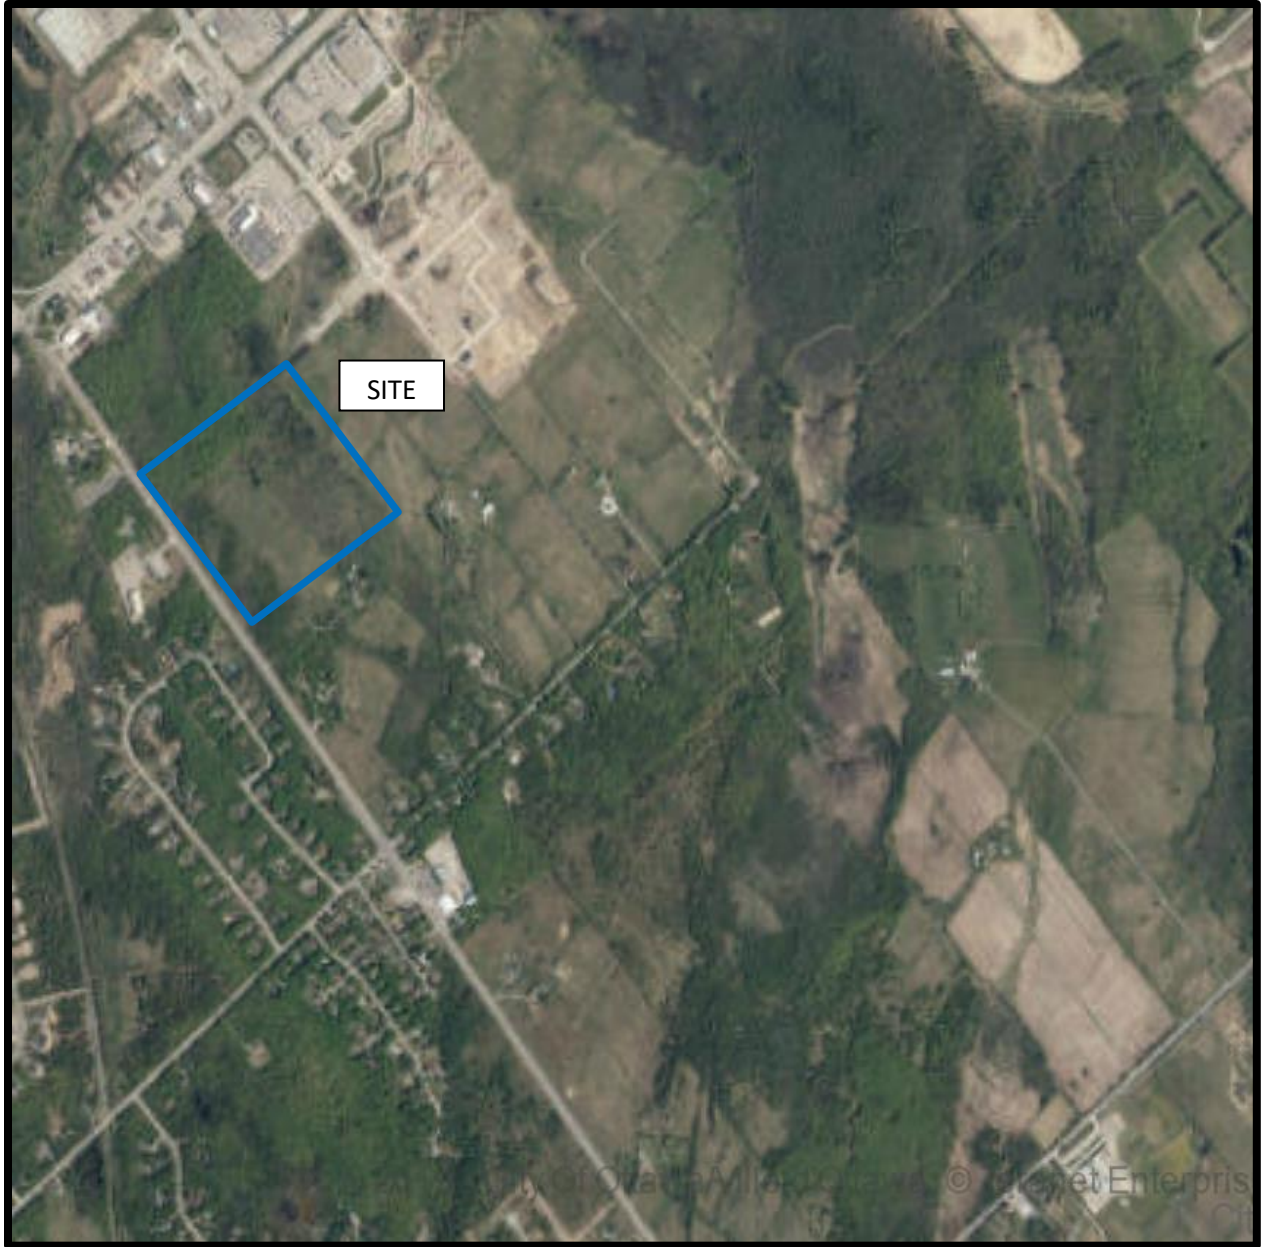
AERIAL PHOTOGRAPH
2014

| 2014 | No significant changes are apparent to the subject property or surrounding lands with one (1) exception. A portion of the future Riddell Street extension can be seen to the south of the subject property. |

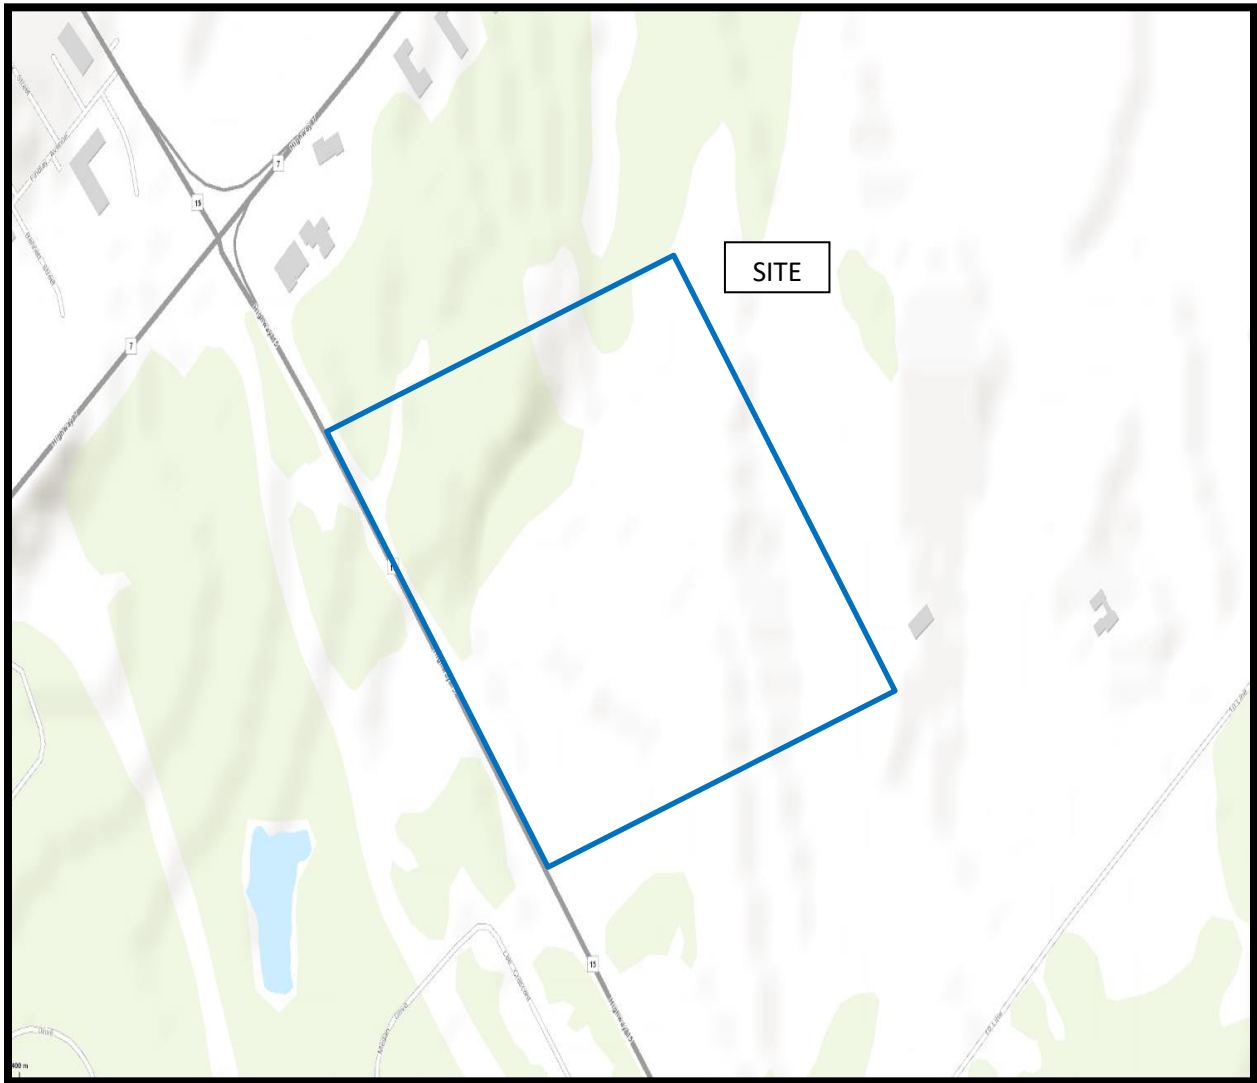
AERIAL PHOTOGRAPH
2017

| 2017 | No significant changes are apparent to the subject property and surrounding area with one (1) exception. The land further to the north is in the early stages of residential development. |
