ANDREWSVILLE BRIDGE WADING INSPECTION REPORT- JULY 2021

Lanark County, United Counties Leeds & Grenville

Keystone Bridge Management Corp.
Your Bridge Asset Management Specialist

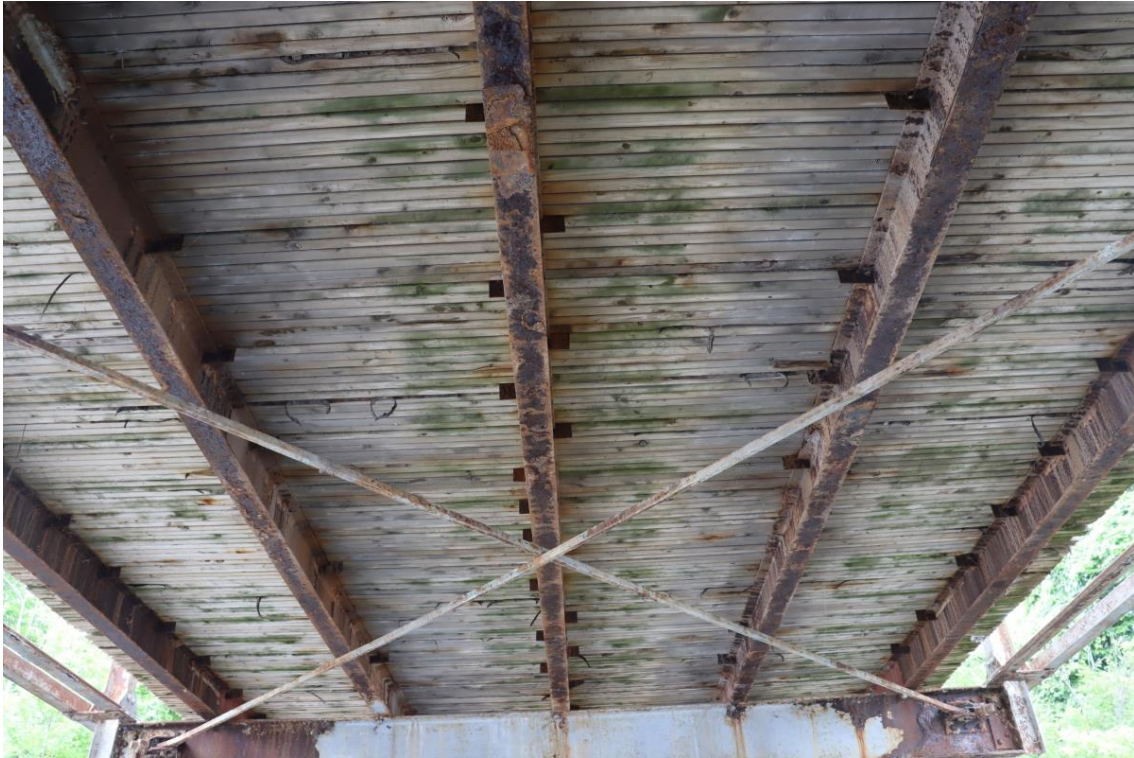
Figure 3: Bay 2 overview

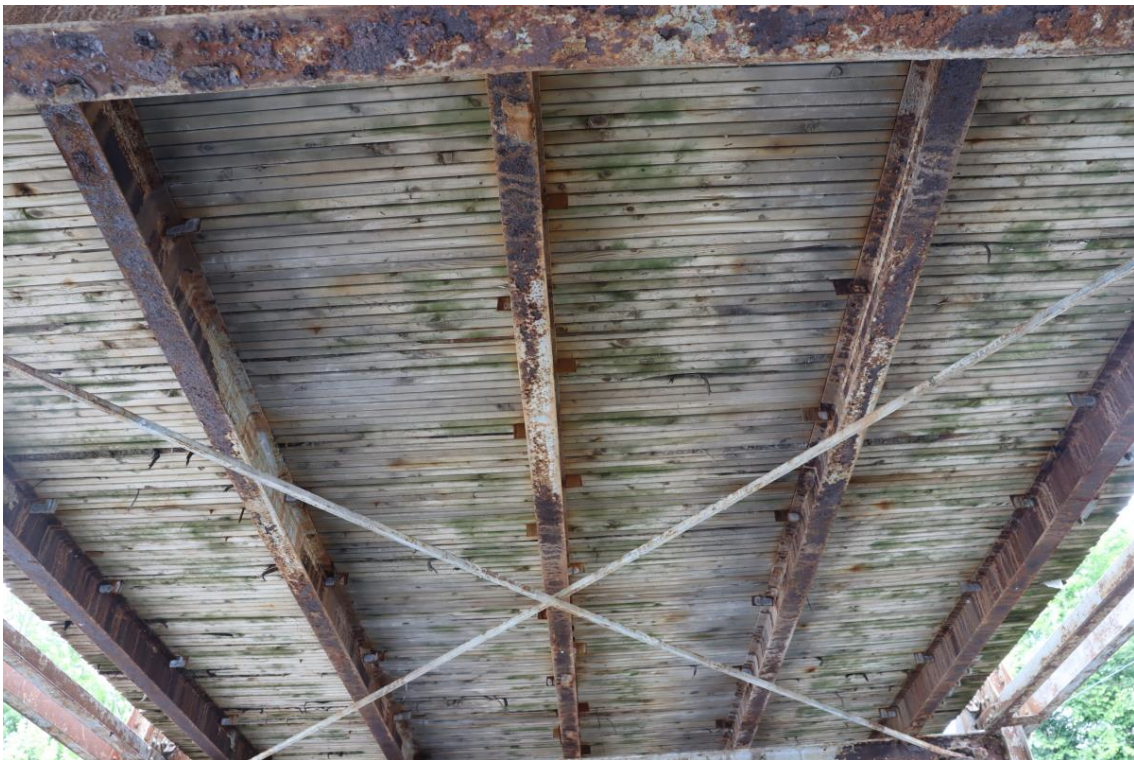
Figure 4: Bay 3 overview

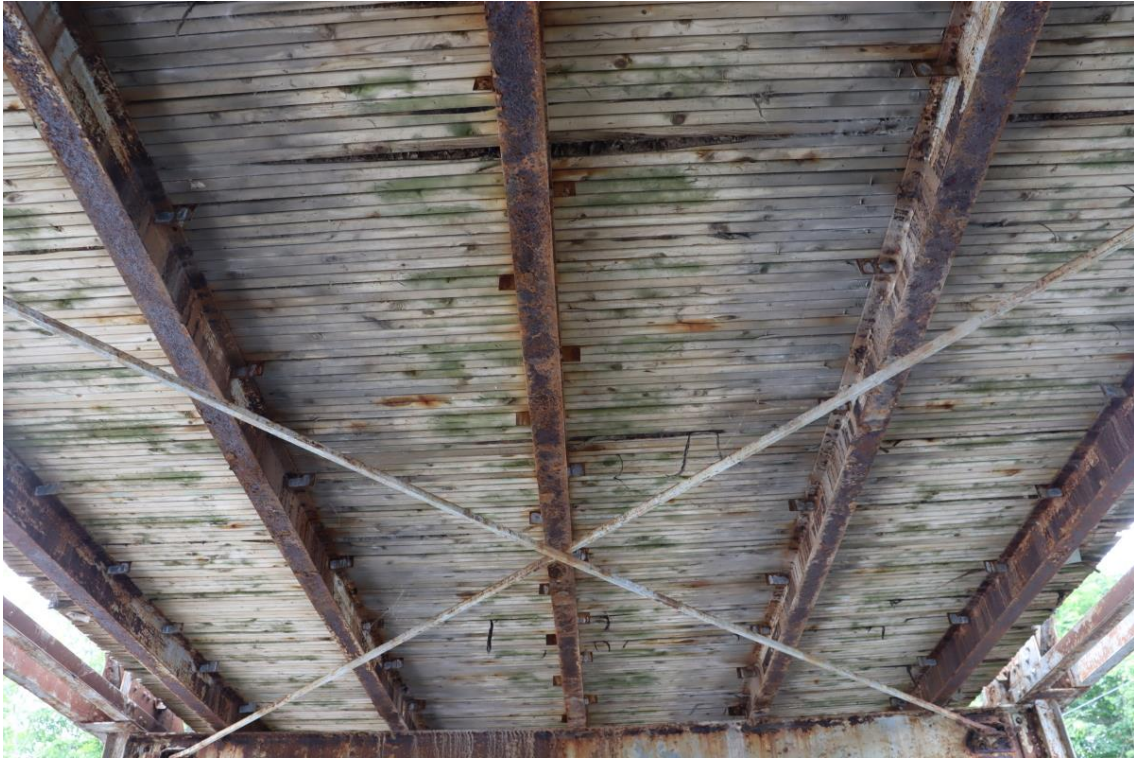
Figure 5: Bay 4 overview

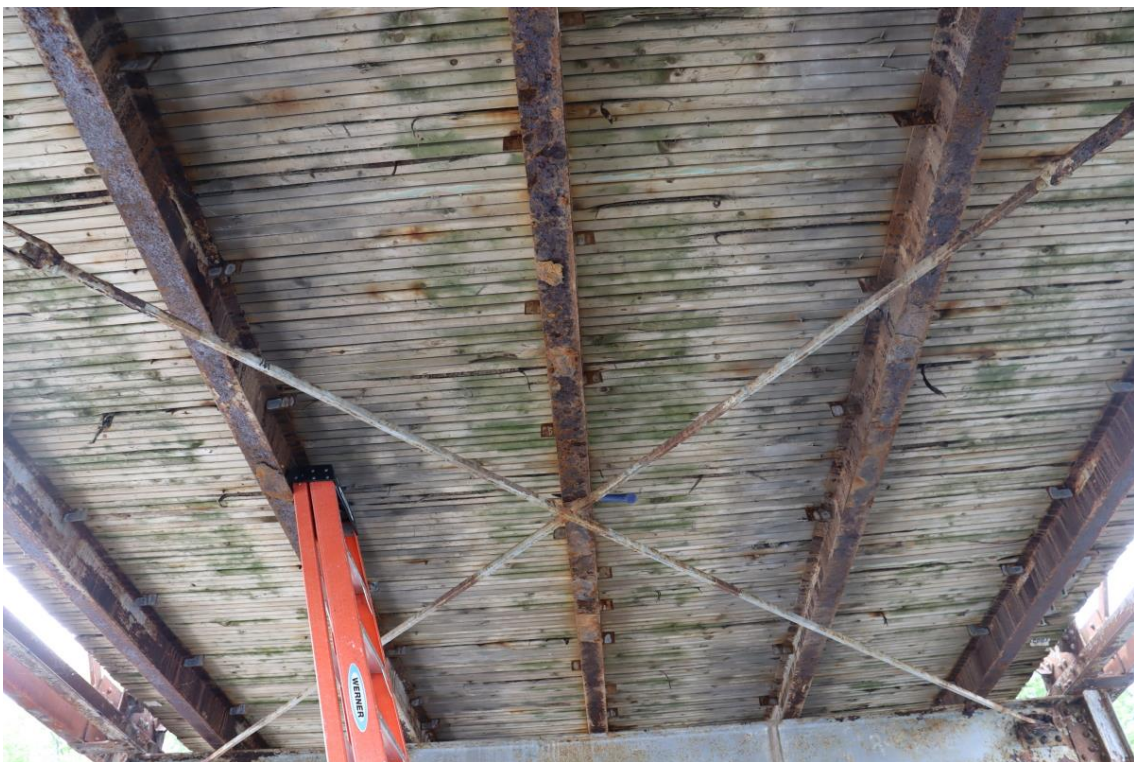
Figure 6: Bay 5 overview

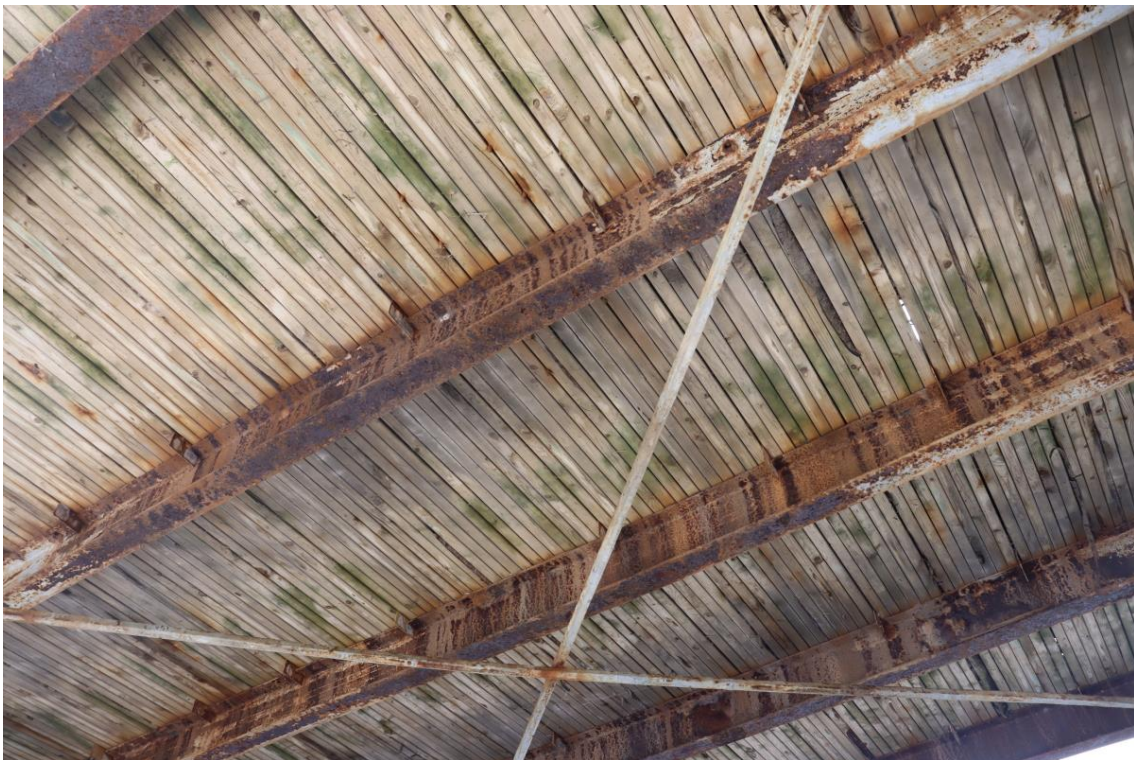
Figure 8: Bay 7 overview

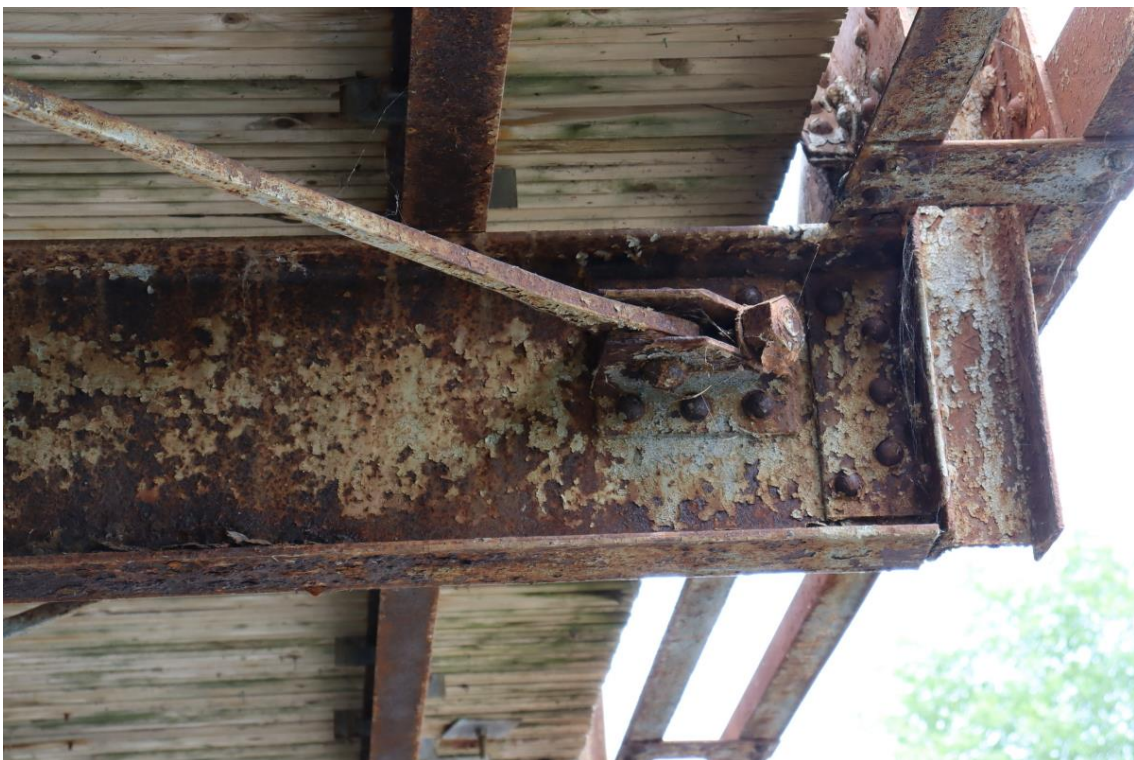
Figure 14: Floor beam 6 south end

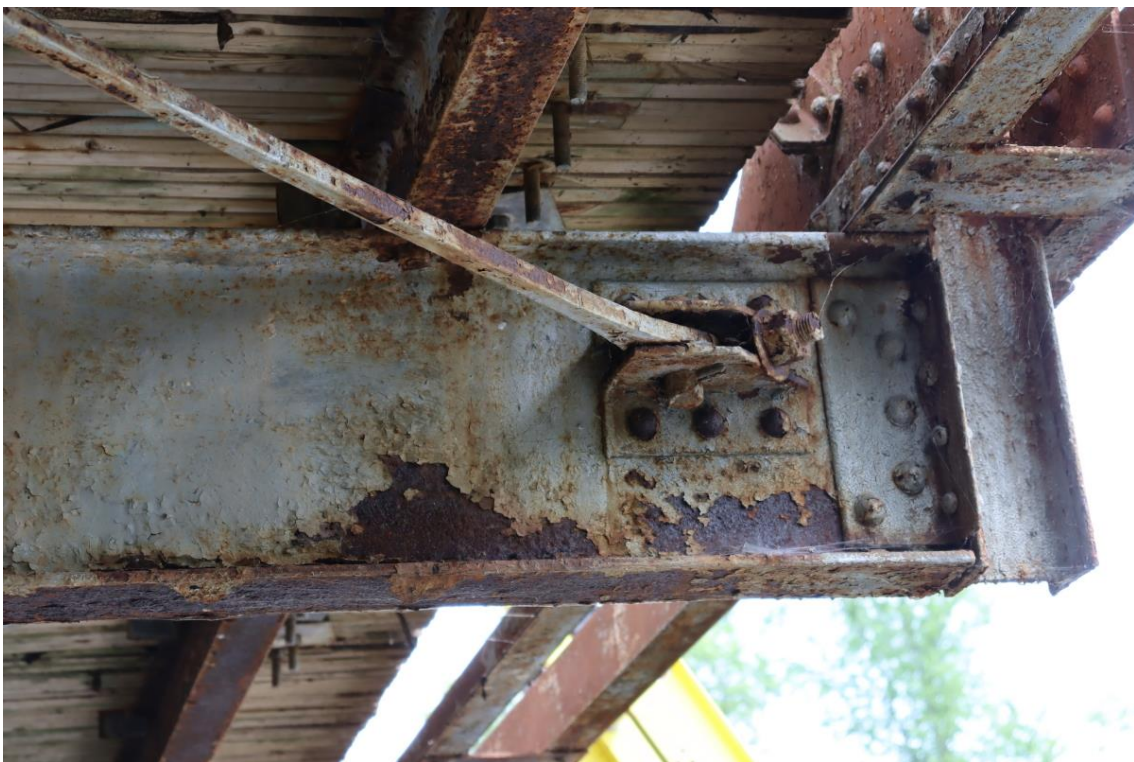
Figure 16: Floor beam 5 south end

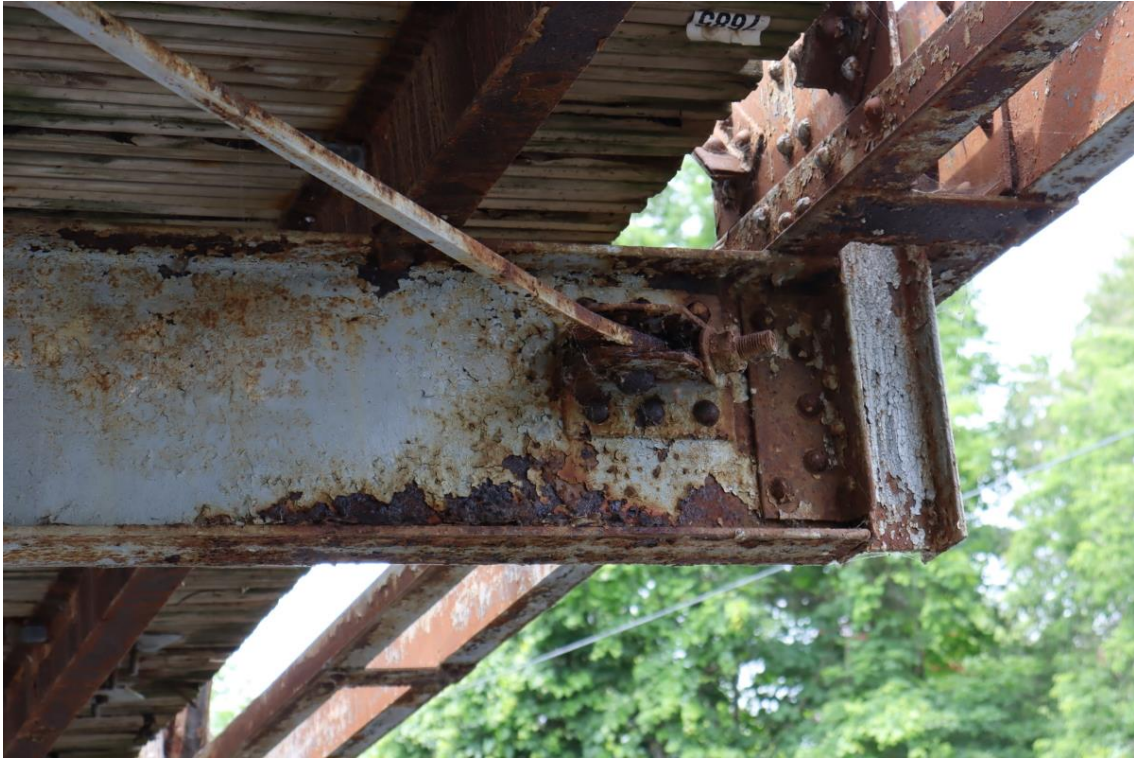
Figure 17: Floor beam 4 north end

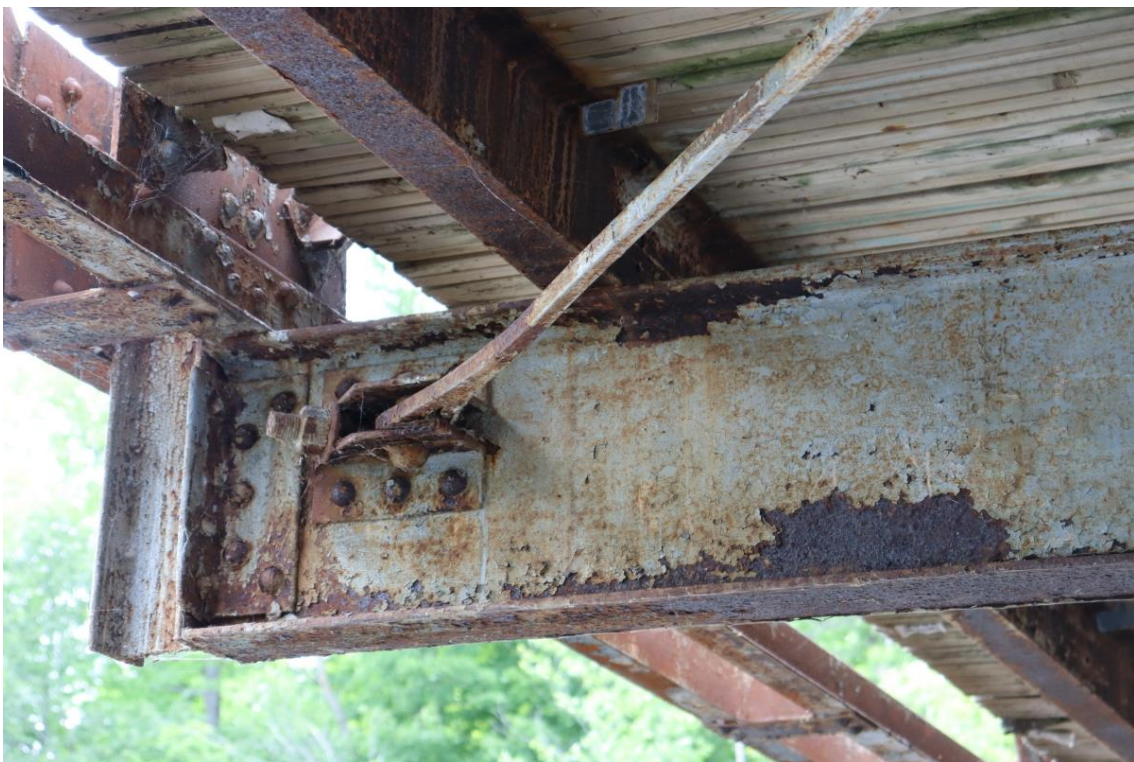
Figure 18: Floor beam 4 south end

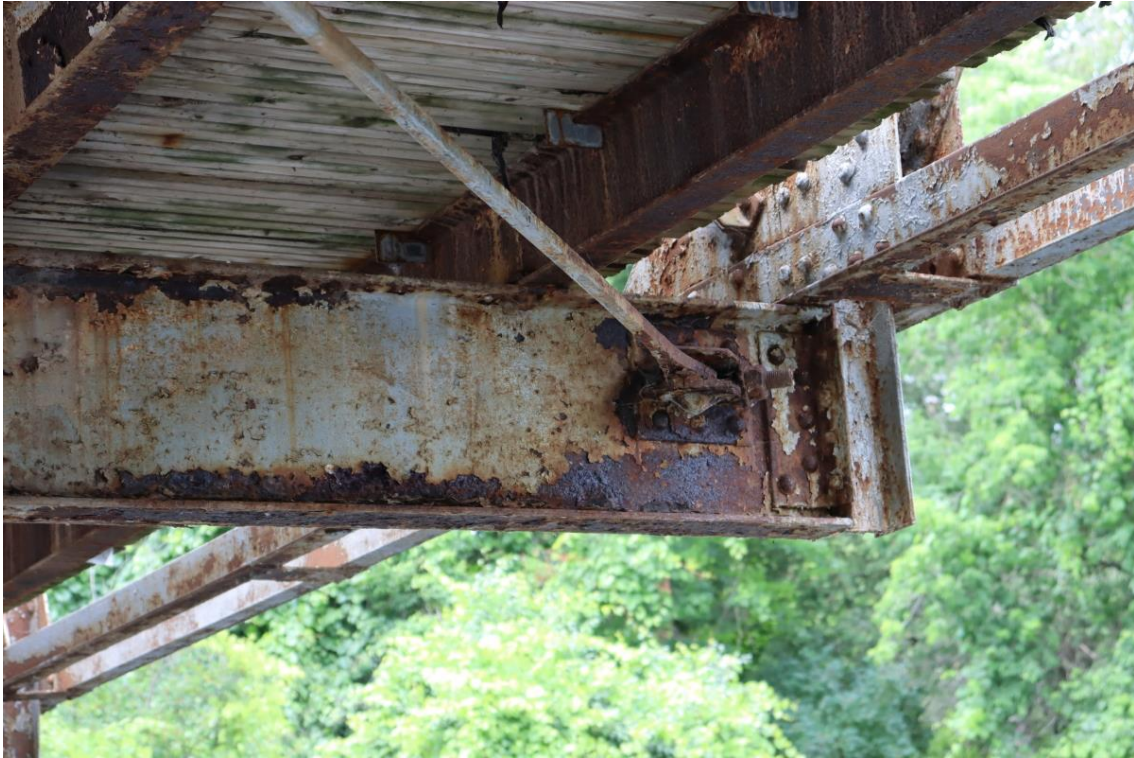
Figure 19: Floor beam 3 north end

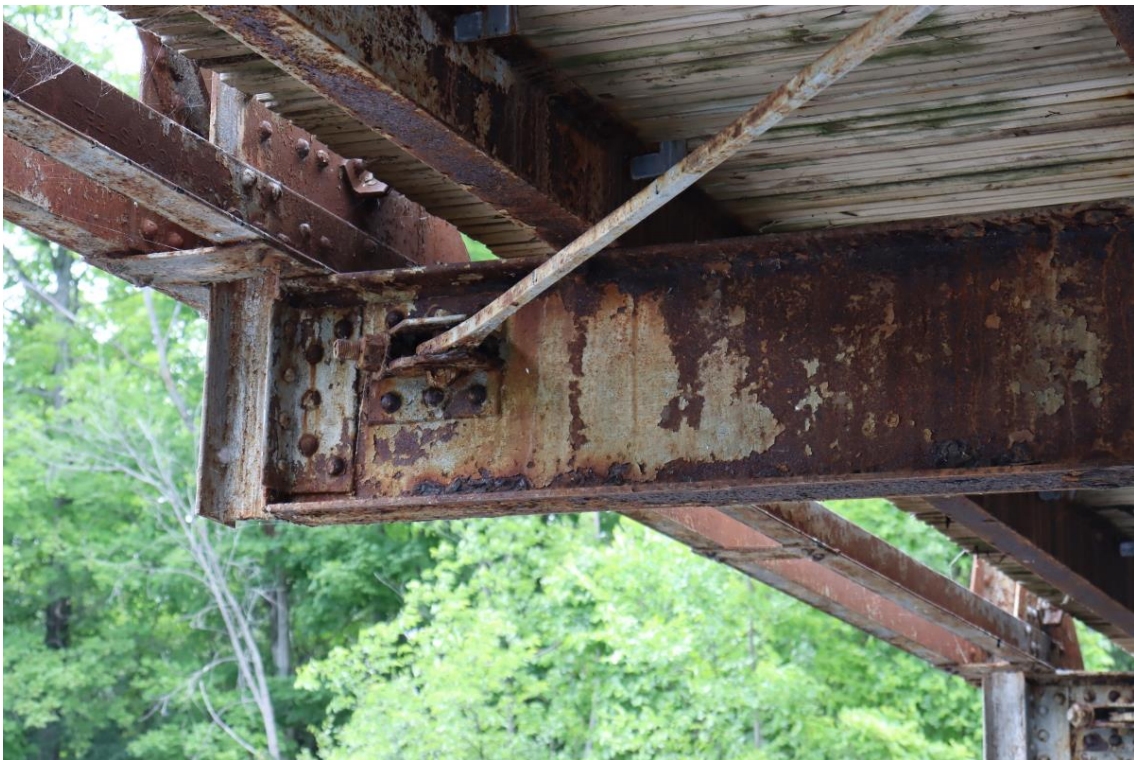
Figure 20: Floor beam 3 south end

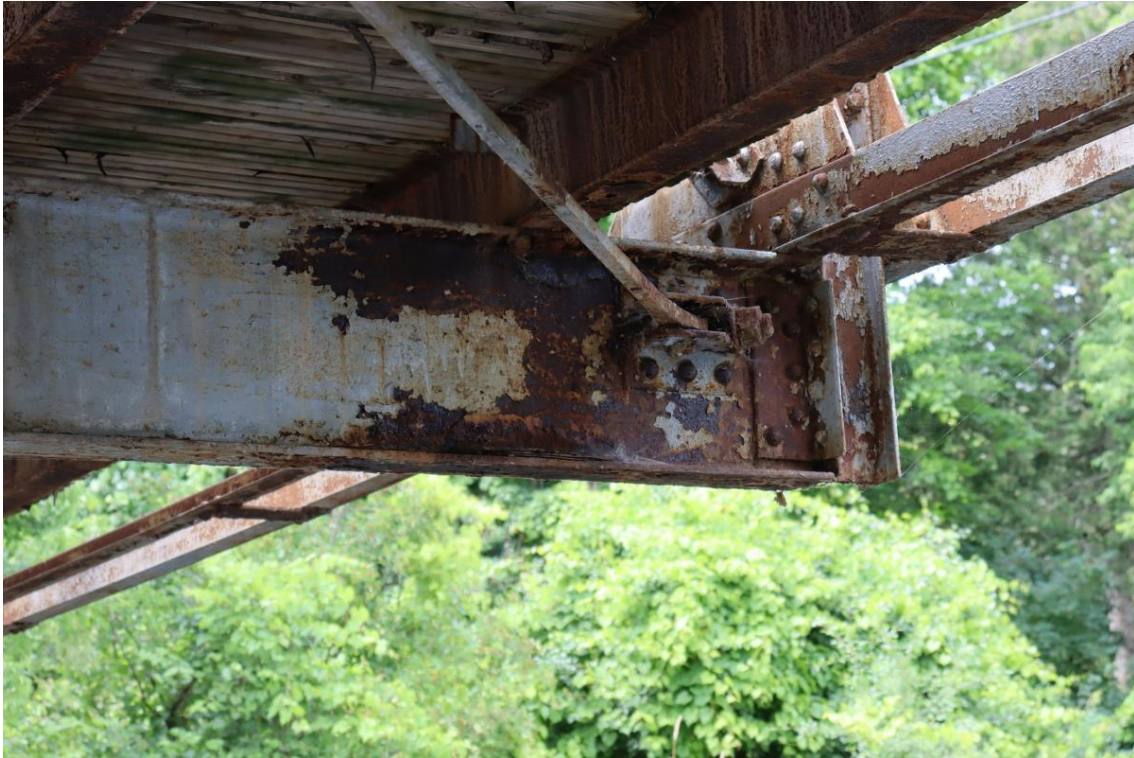
Figure 21: Floor beam 2 north end

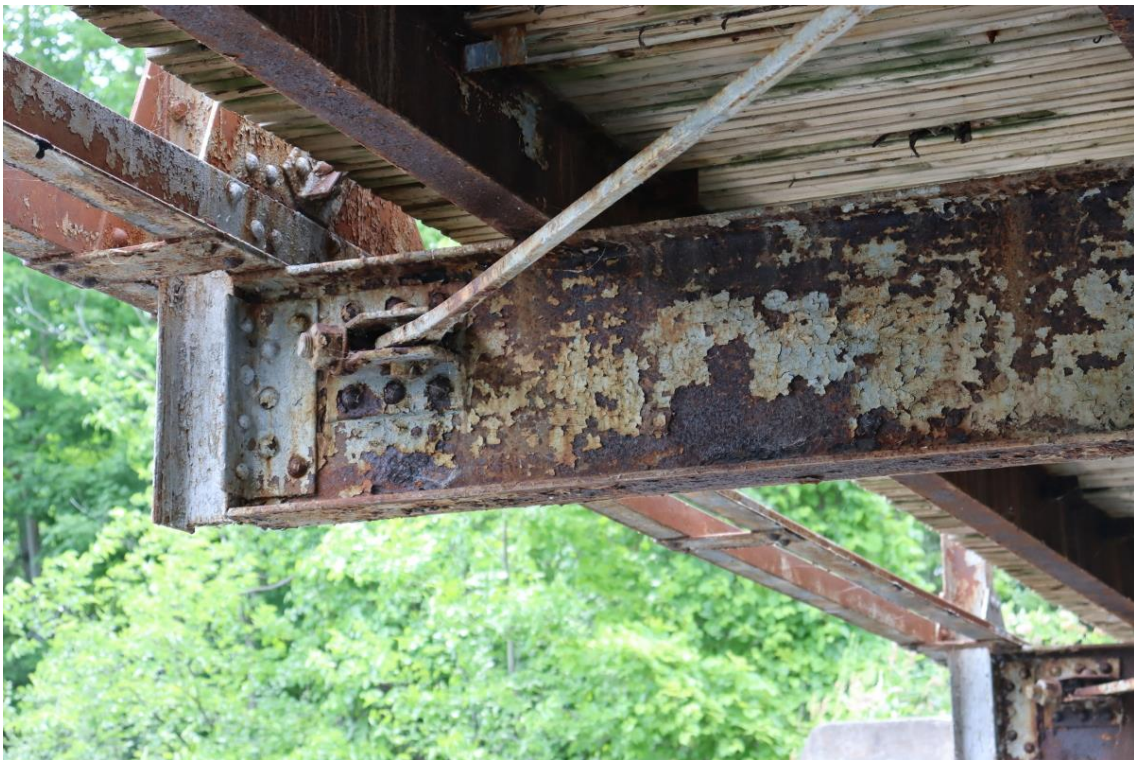
Figure 22: Floor beam 2 south end

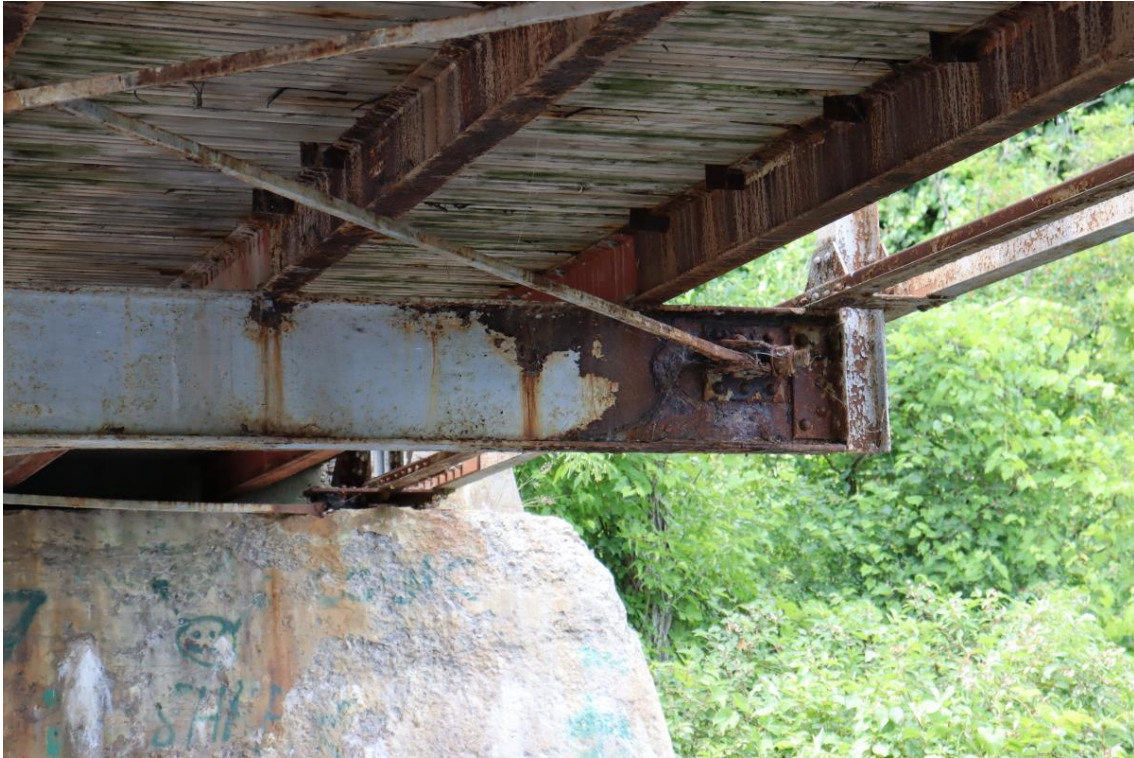
Figure 23: Floor beam 1 north end

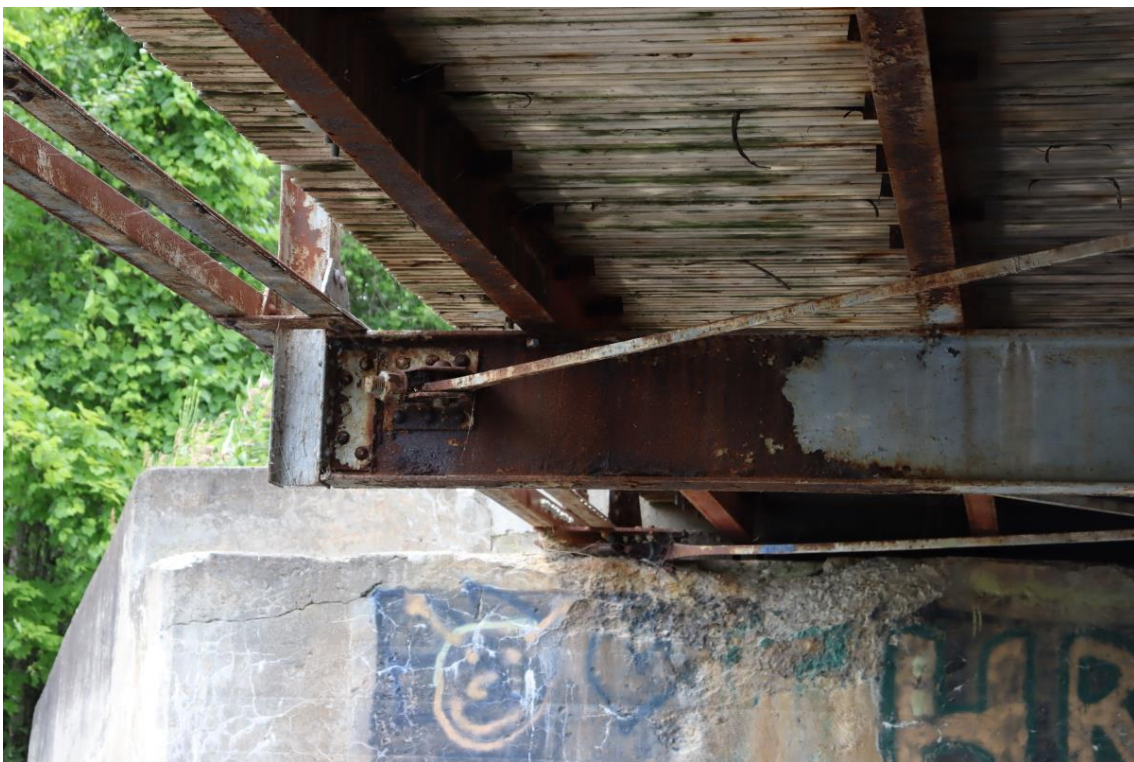
Figure 24: Floor beam 1 south end

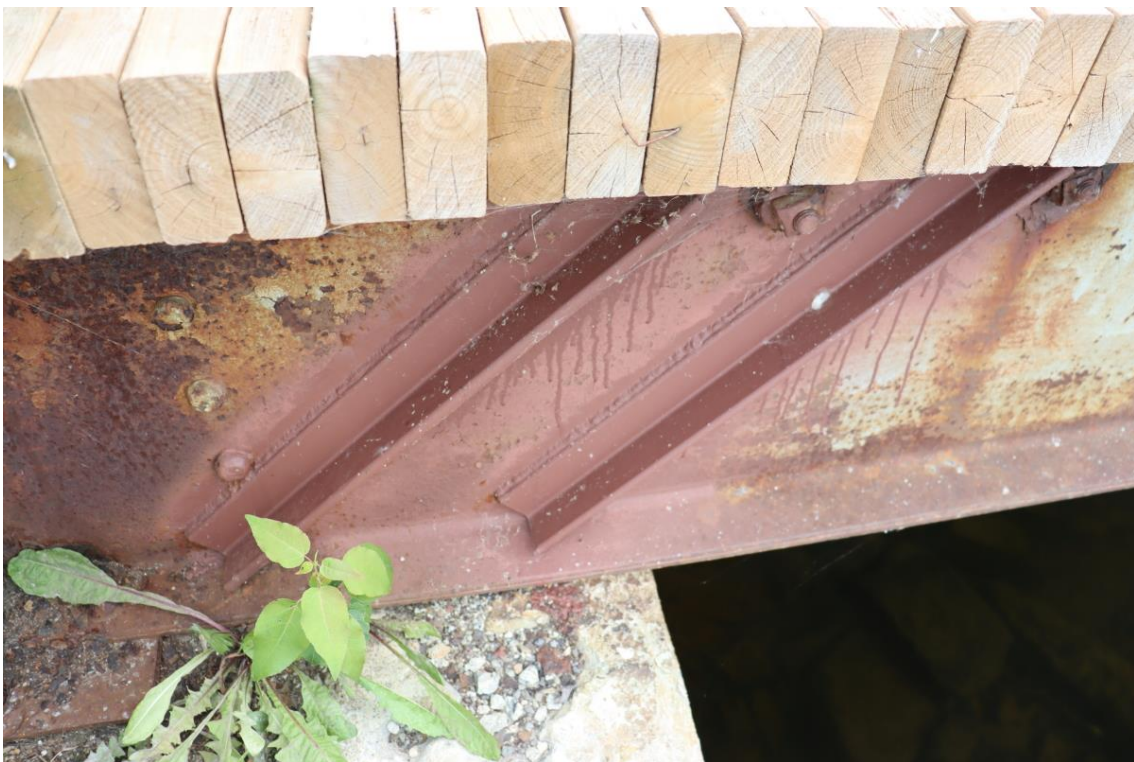
Figure 26: NE girder end web stiffening

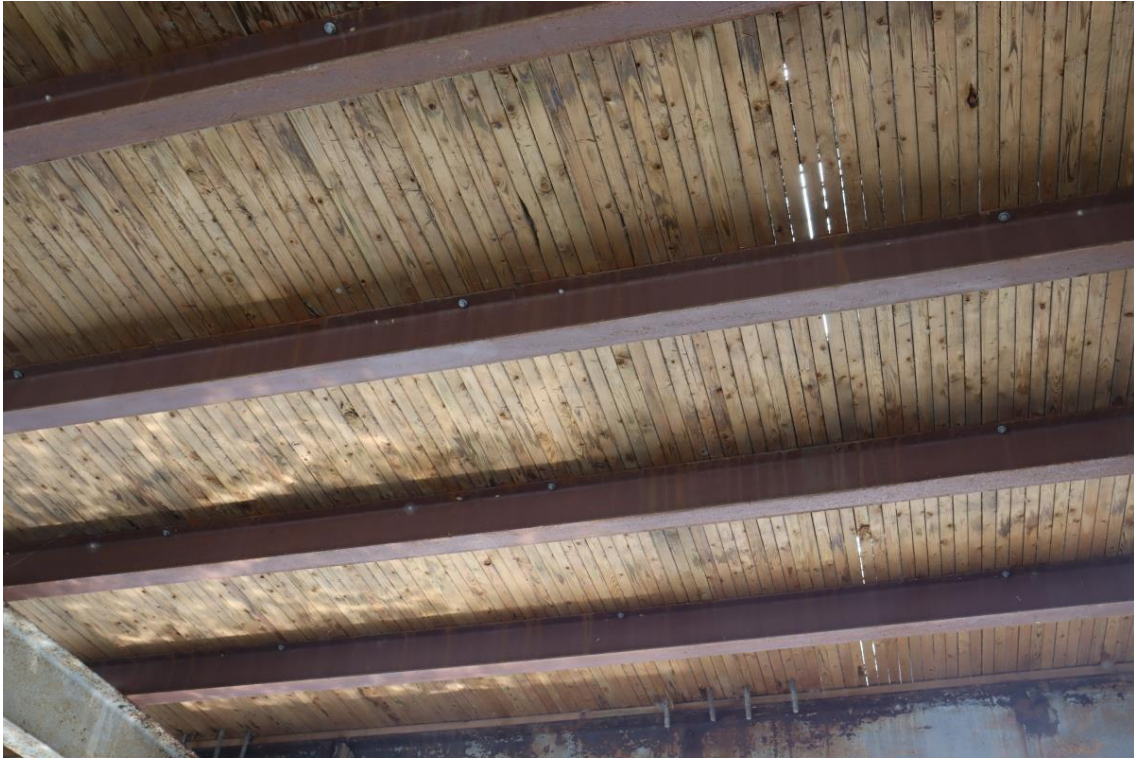
Figure 29: East span west end soffit

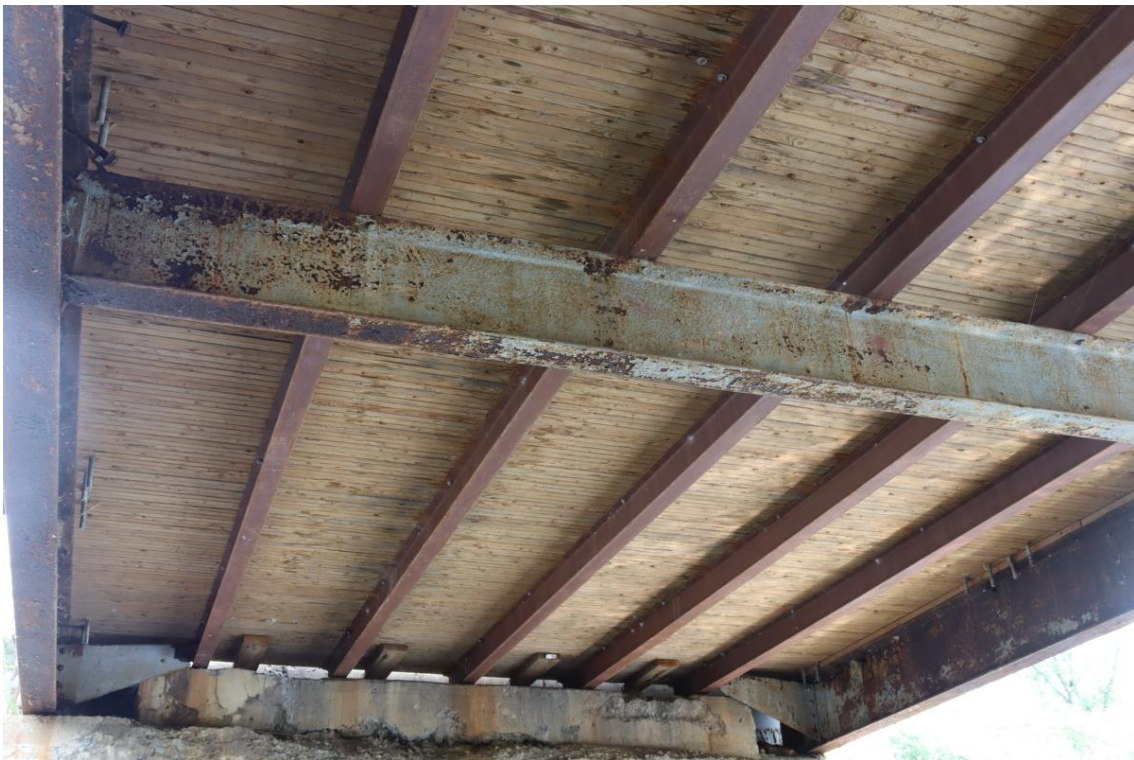
Figure 30: East span east end soffit

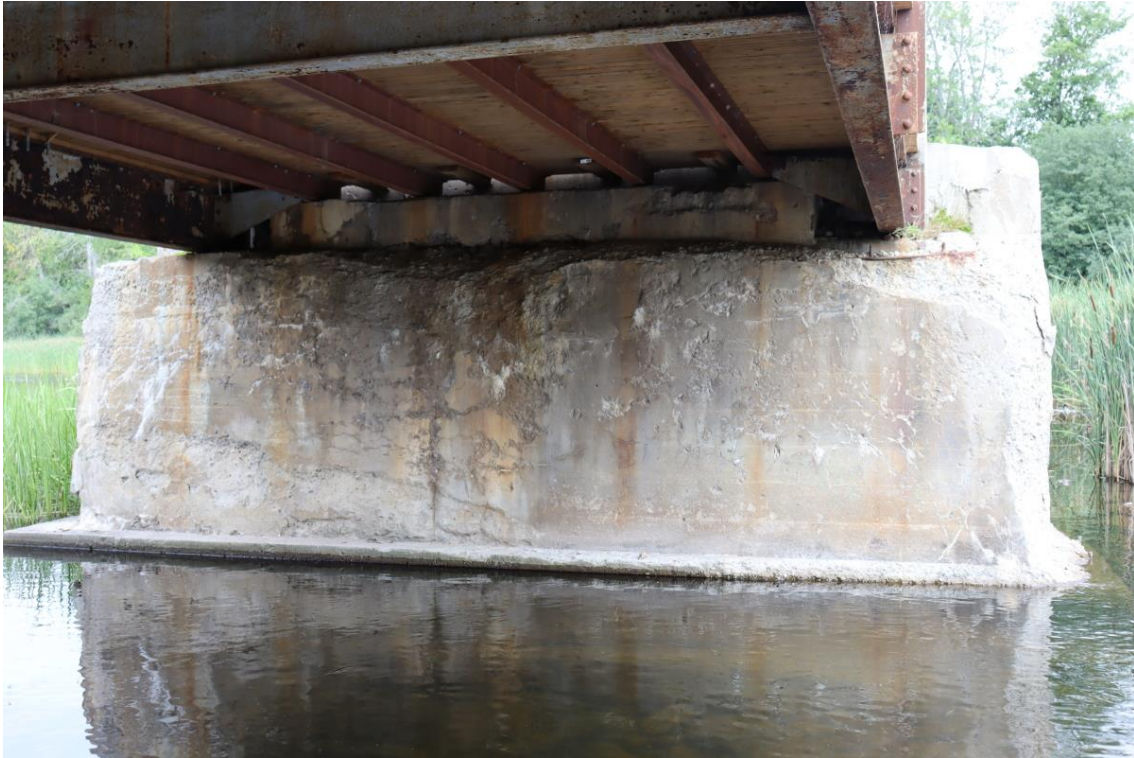
Figure 31: East abutment

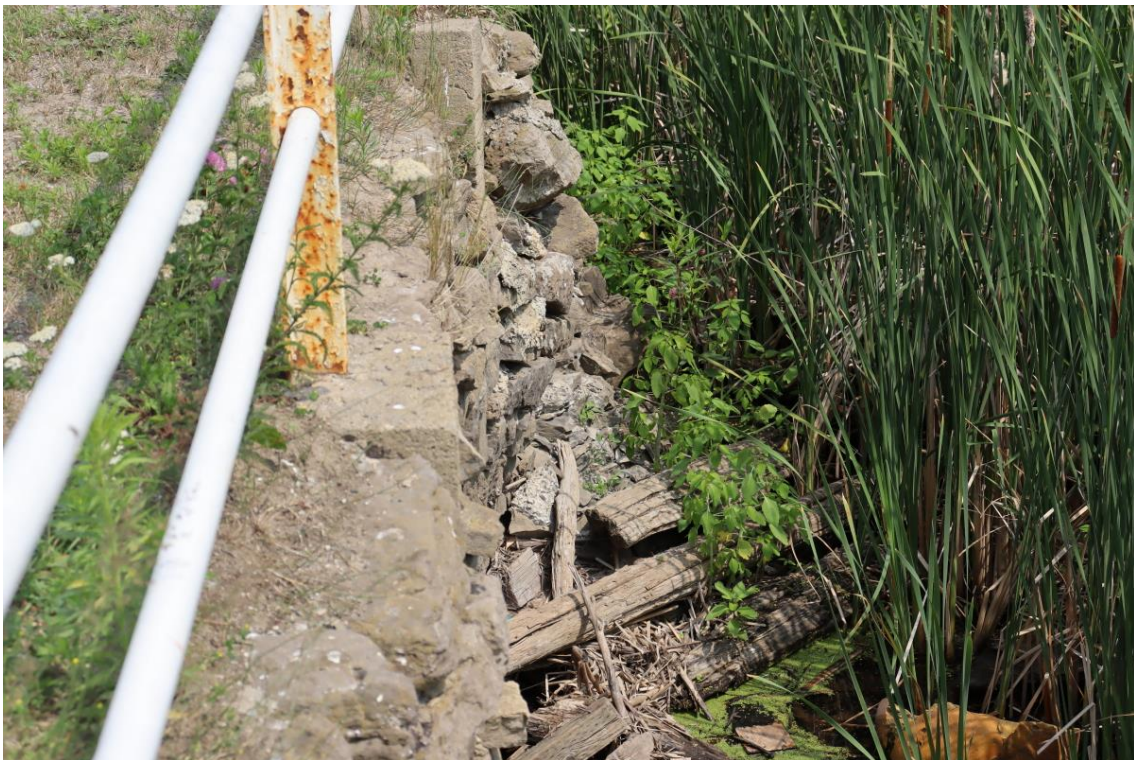
Figure 32: Bulging retaining wall in SE

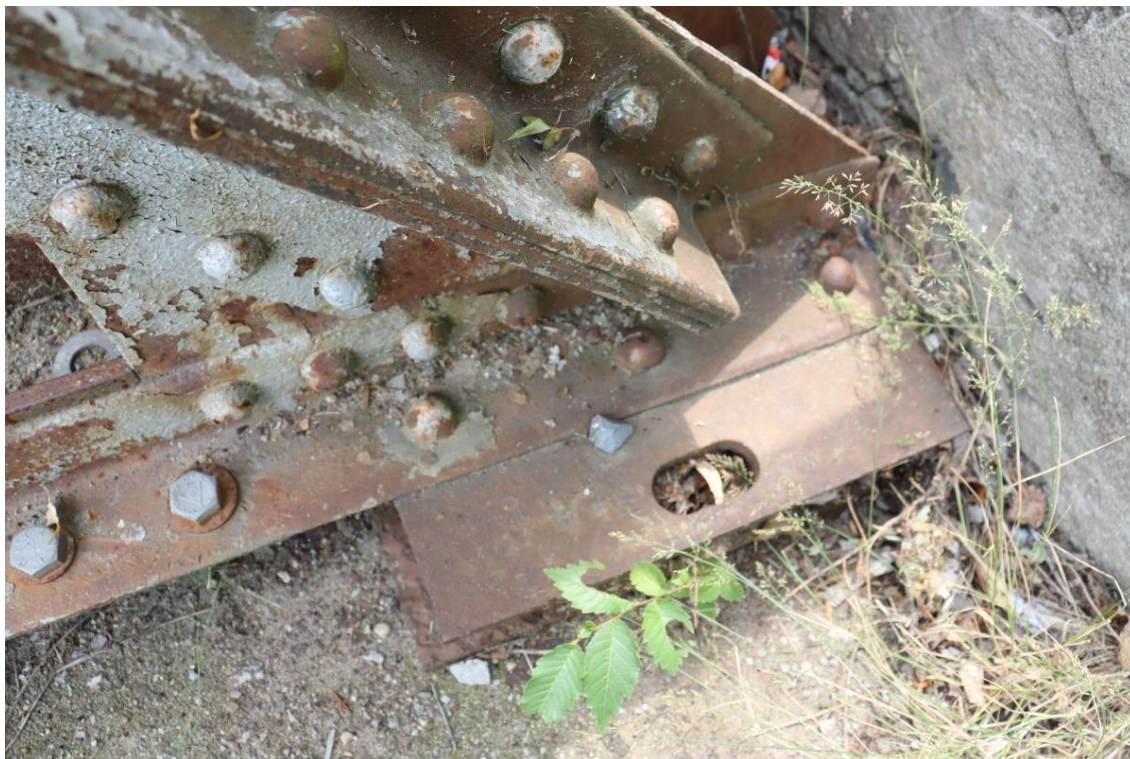
Figure 33: NW truss bearing

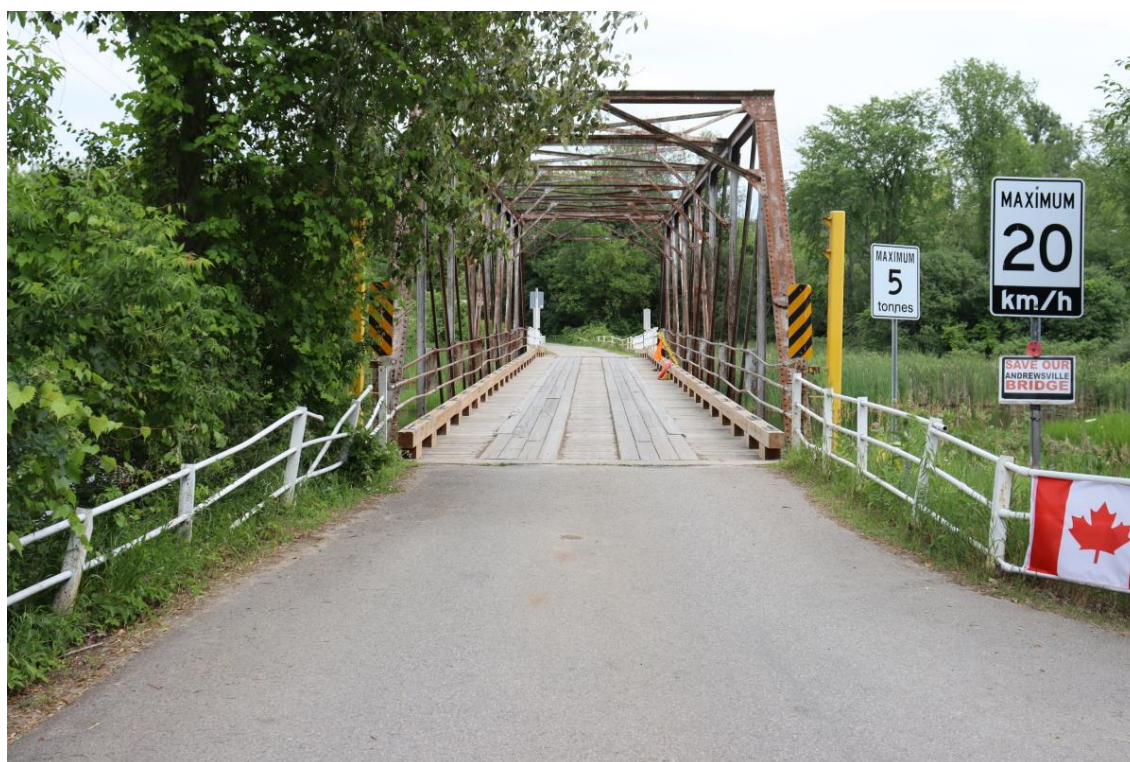
Figure 34: West approach

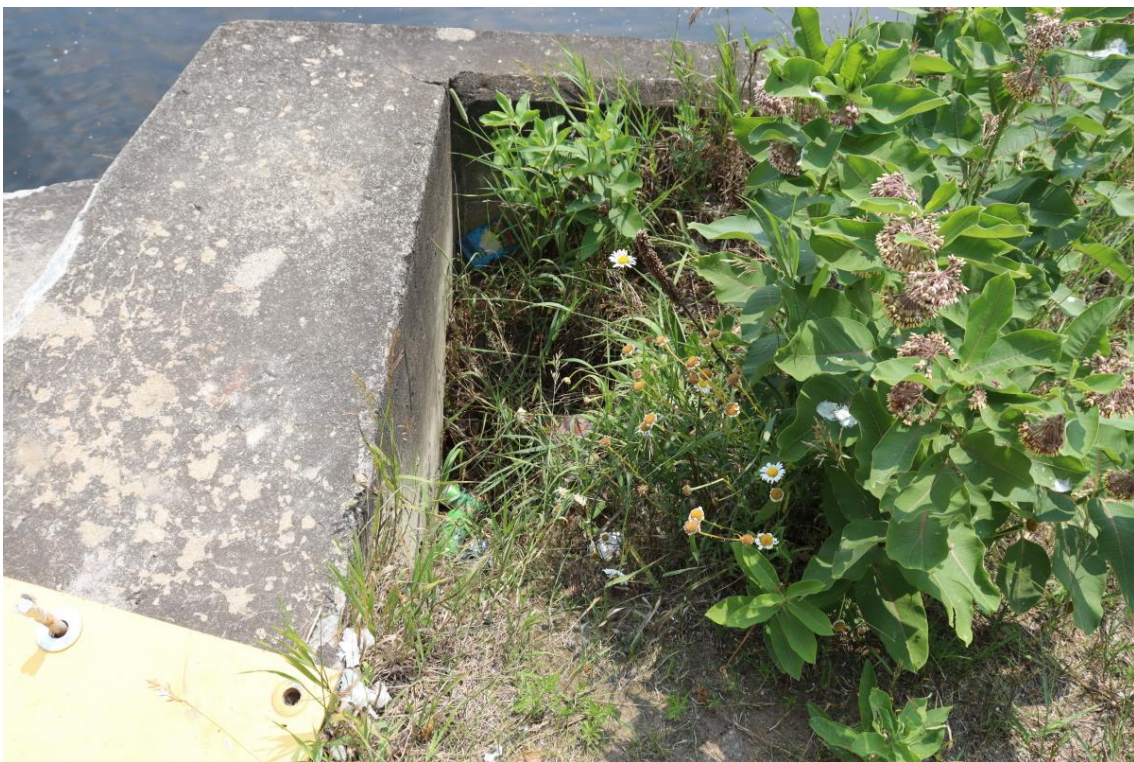
Figure 42: Sinkhole in SW corner

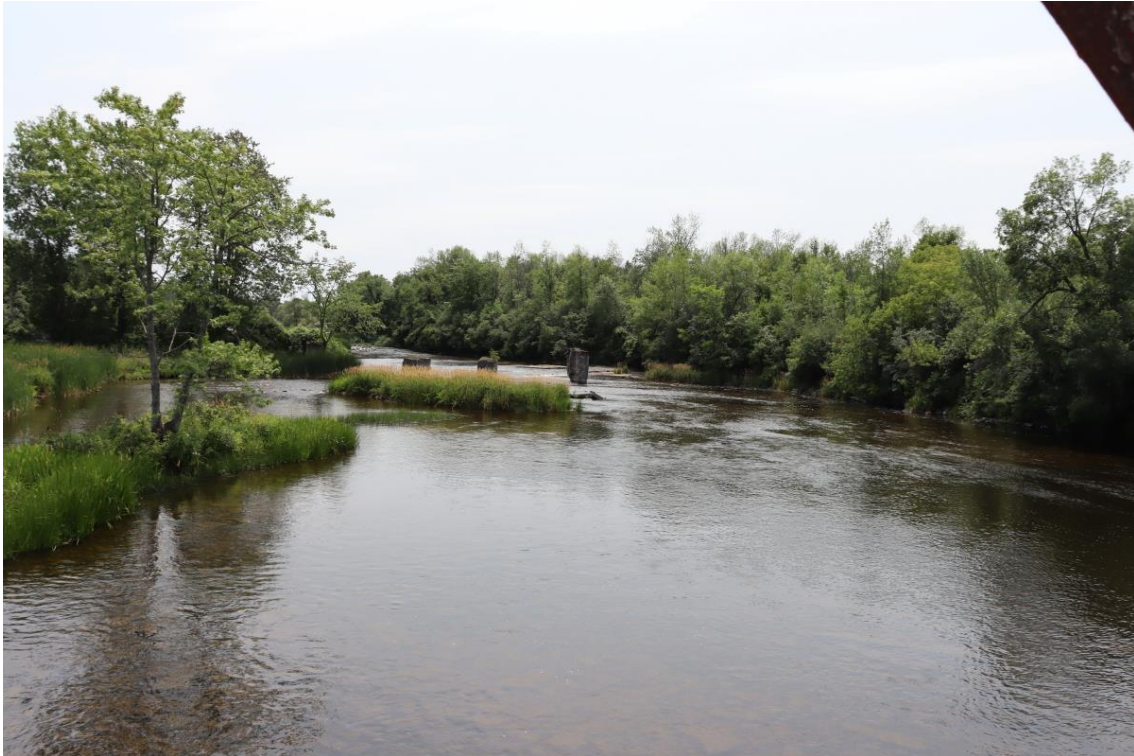
Figure 43: South channel upstream

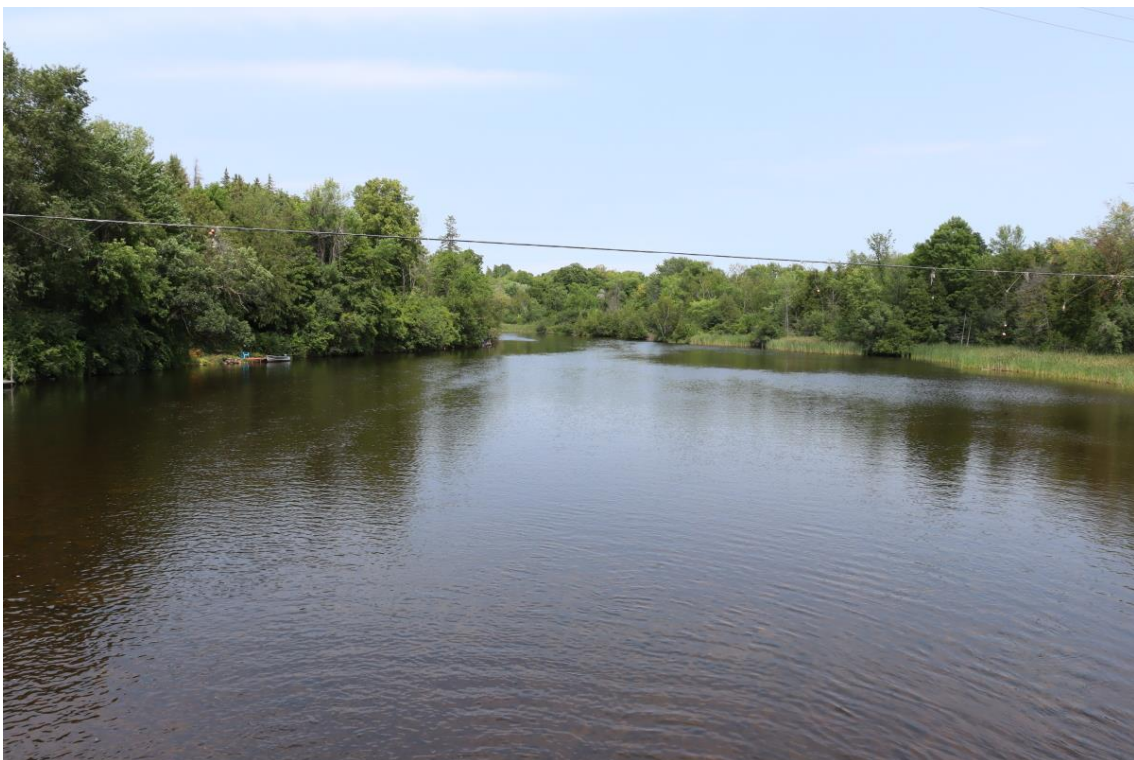
Figure 44: North channel downstream

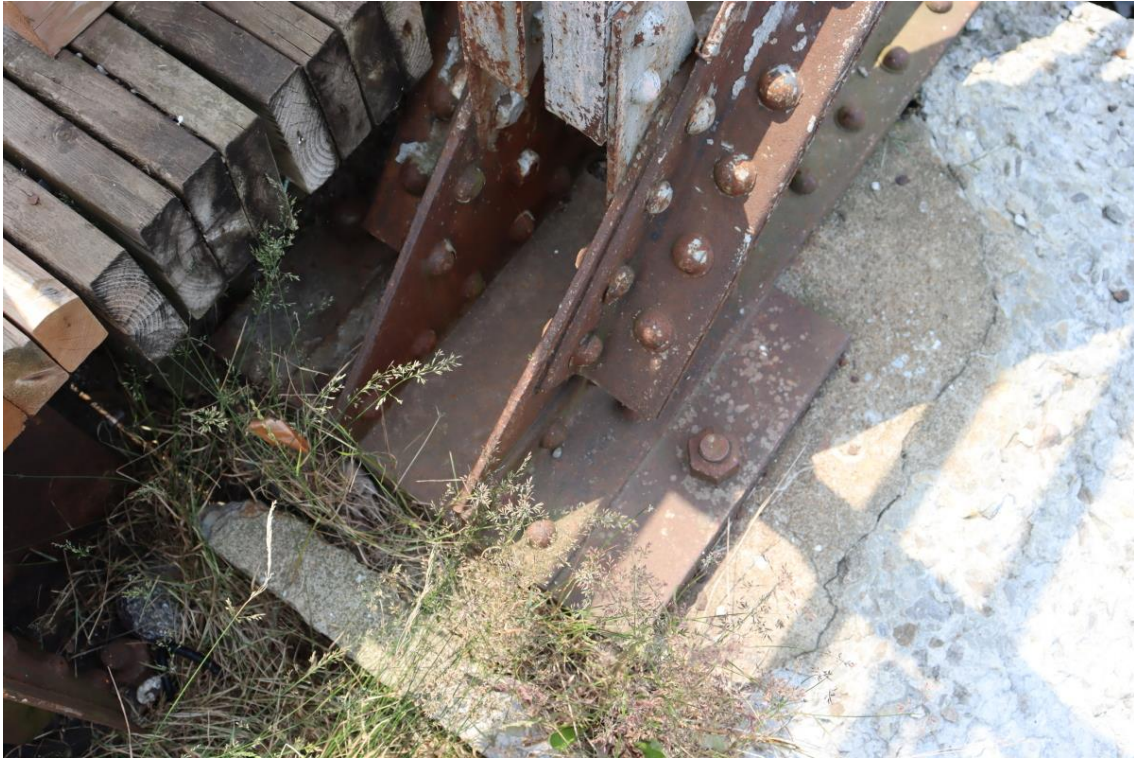
Figure 45: North pier truss bearing
