ANDREWSVILLE BRIDGE WADING INSPECTION REPORT- JULY 2021

Lanark County, United Counties Leeds & Grenville

Keystone Bridge Management Corp.
Your Bridge Asset Management Specialist

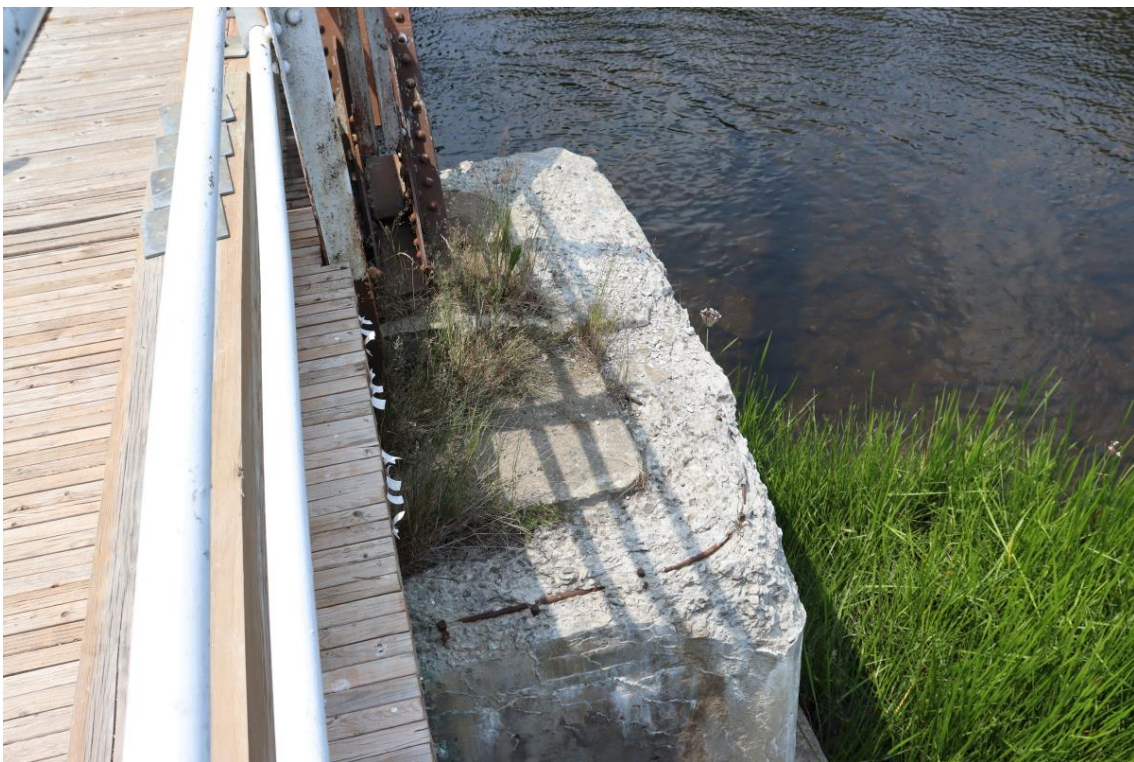
Figure 46: Pier top north end

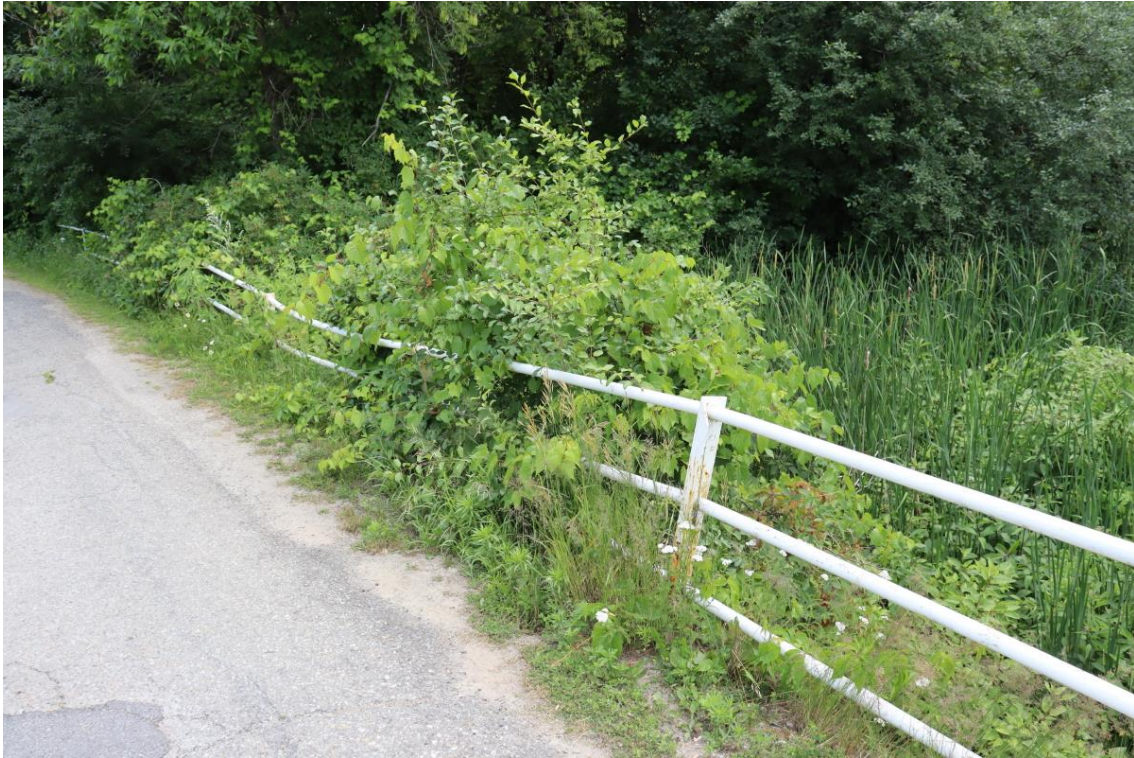
Figure 47: Railing south side of causeway

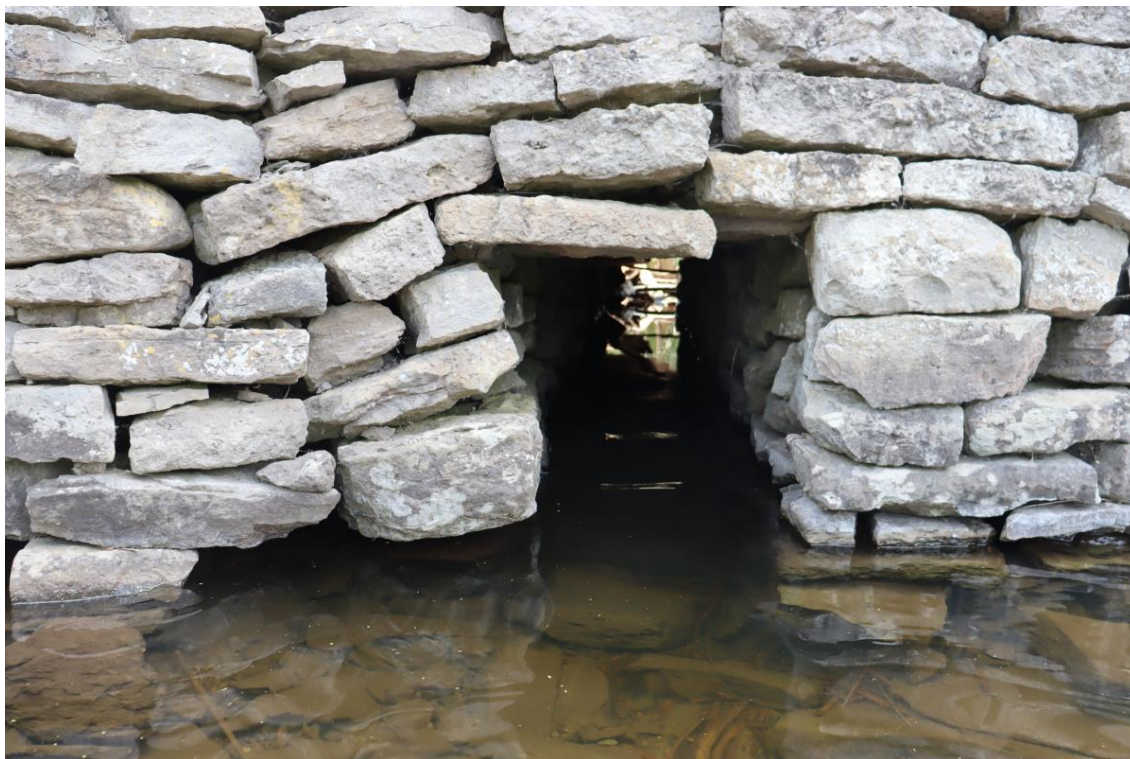
Figure 51: Drainage opening through causeway

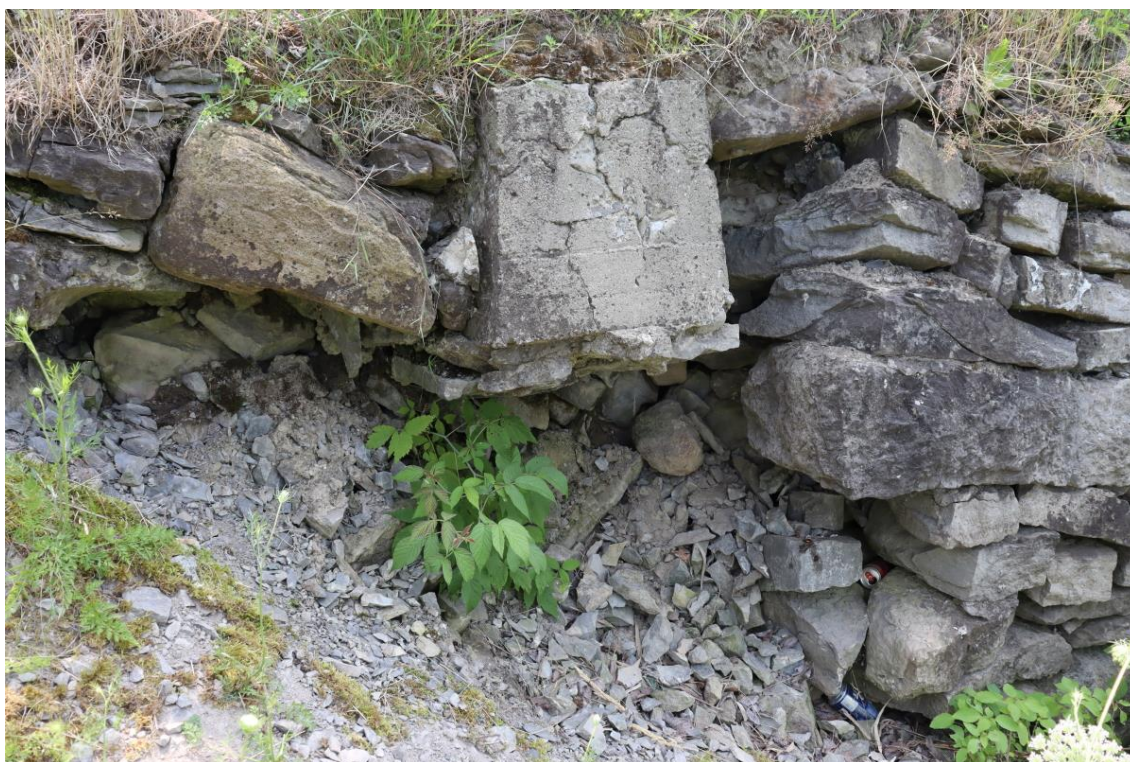
Figure 52: Undercut railing base in north retaining wall east end

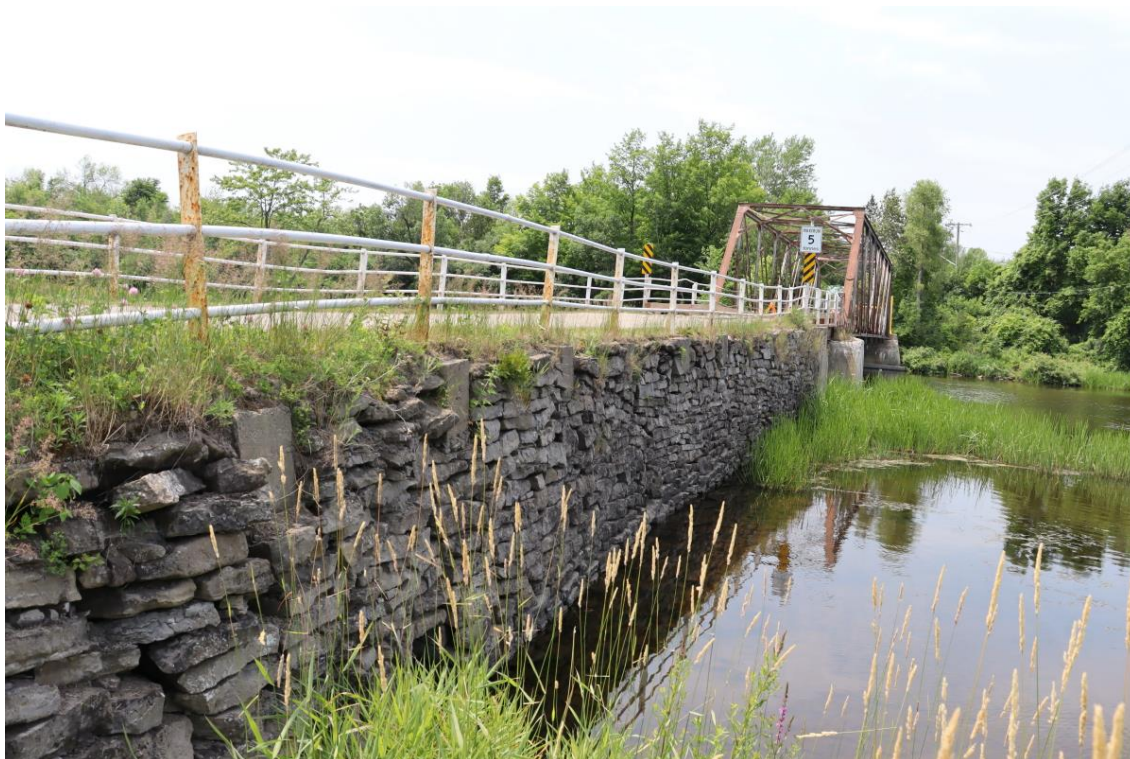
Figure 53: North dry-stone retaining wall east approach

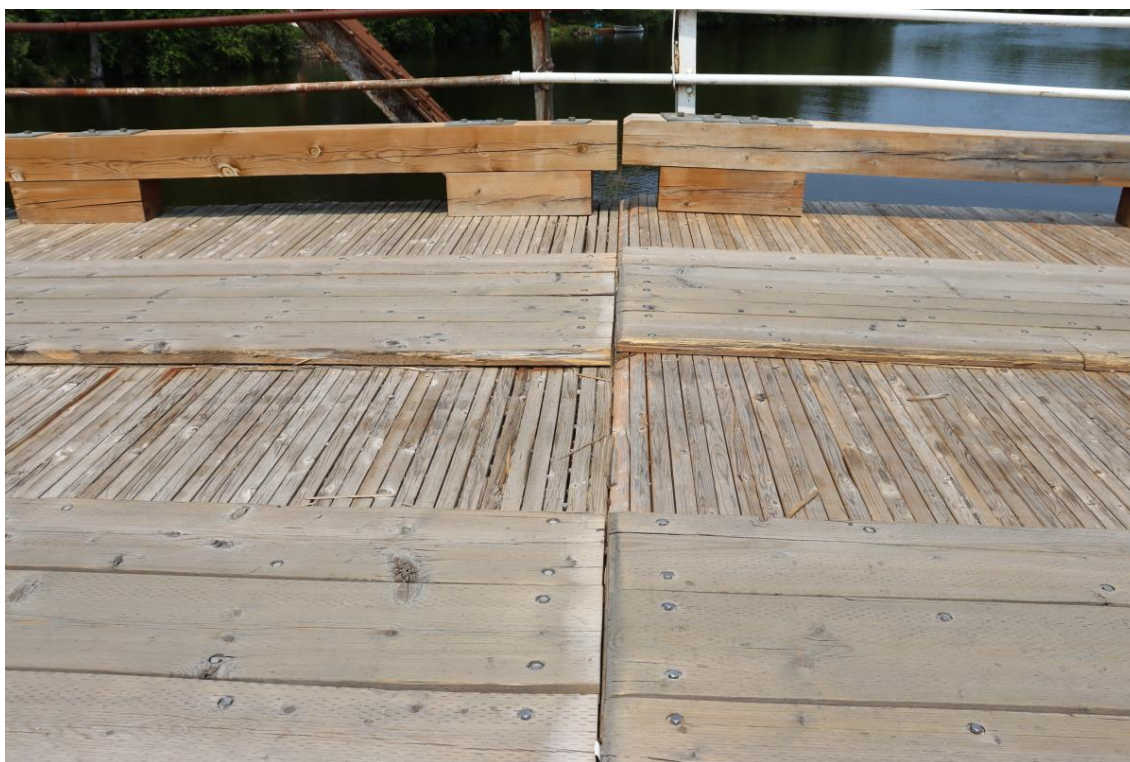
Figure 54: Grade change / bump over pier

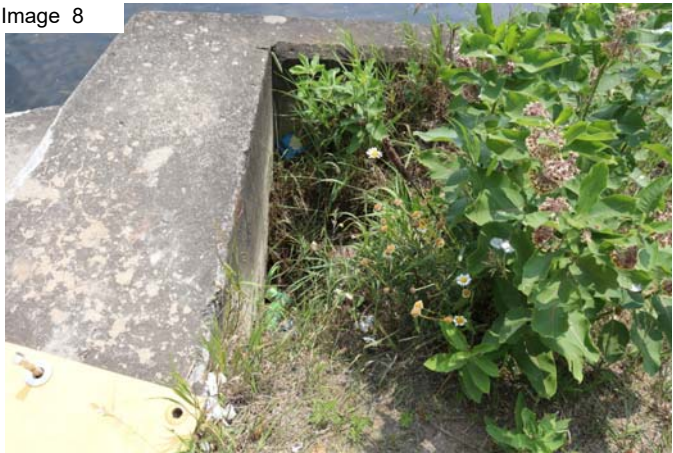
Image 8

Sinkhole in SW

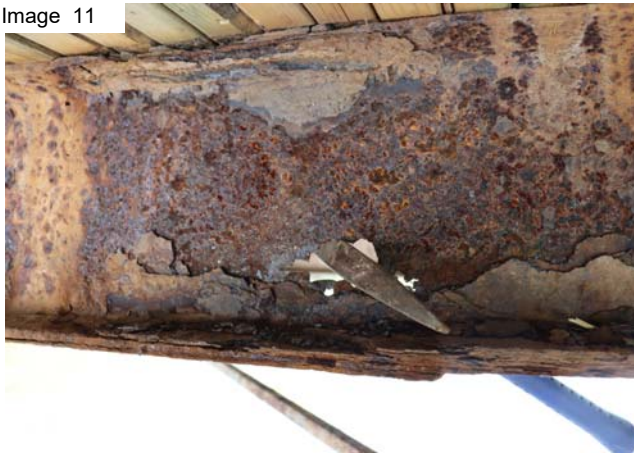
Image 11

Stringer 3 perforation in bay 5

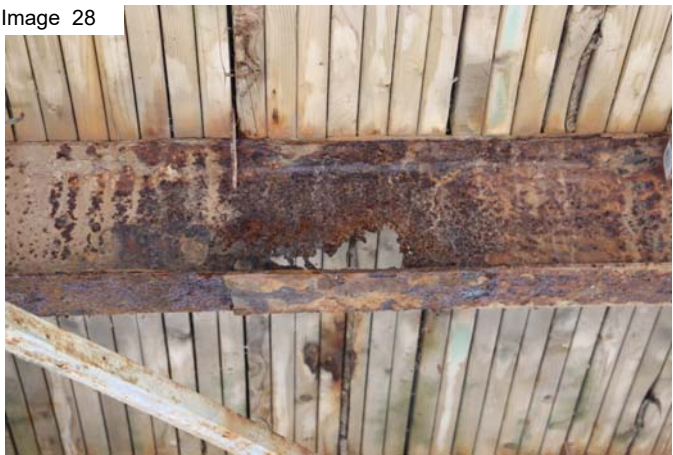
Stringer 2 perforation in bay 8

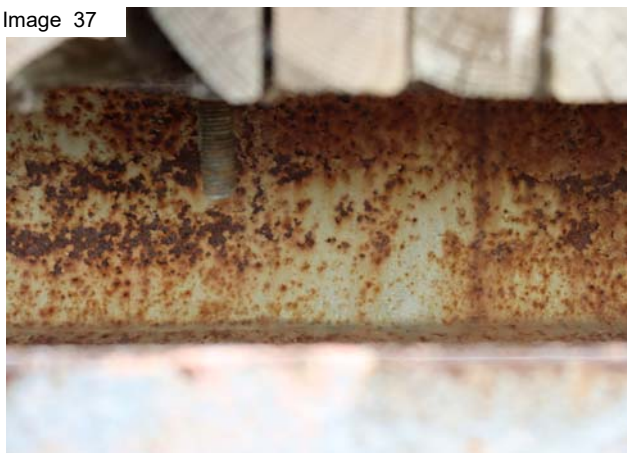
Image 37

South stringer condition in bay 6

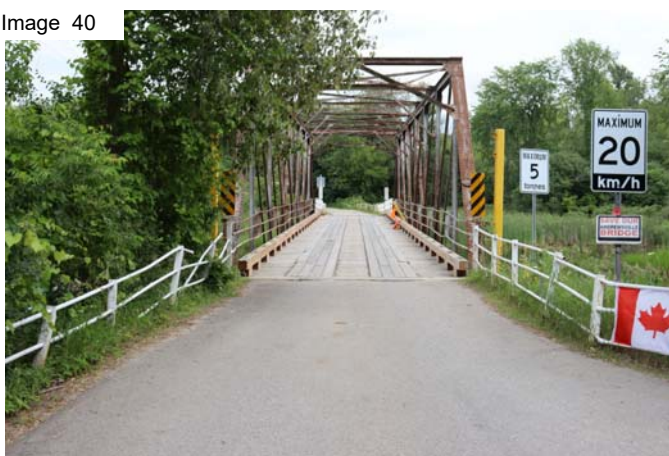
Image 40

West approach

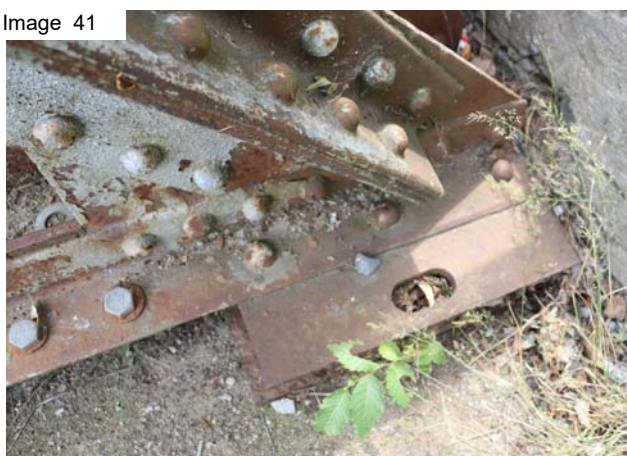
Image 41

NW bearing

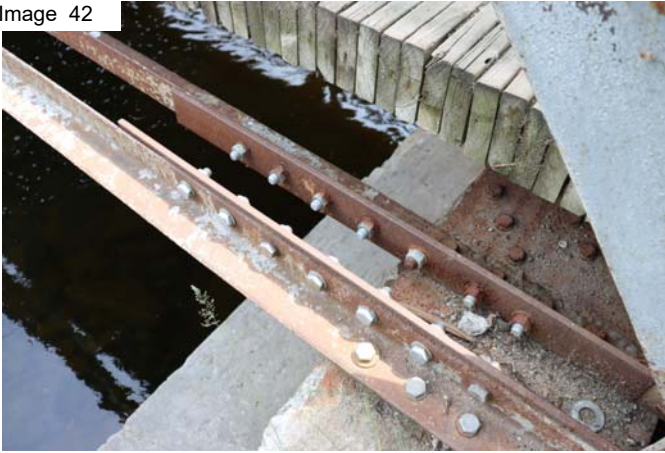
Image 42

NW bottom chord end

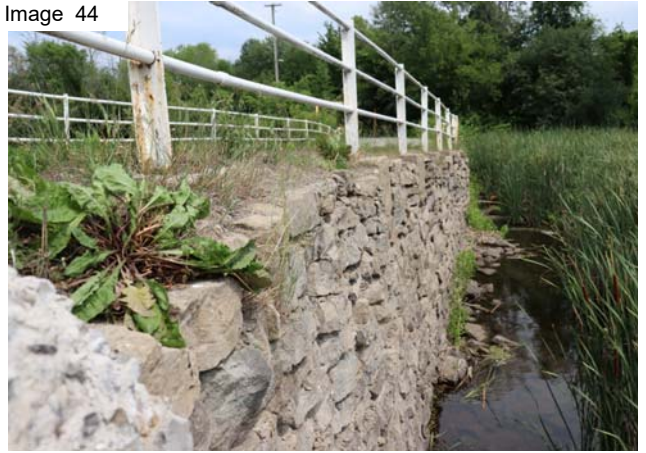
Image 44

South retaining wall

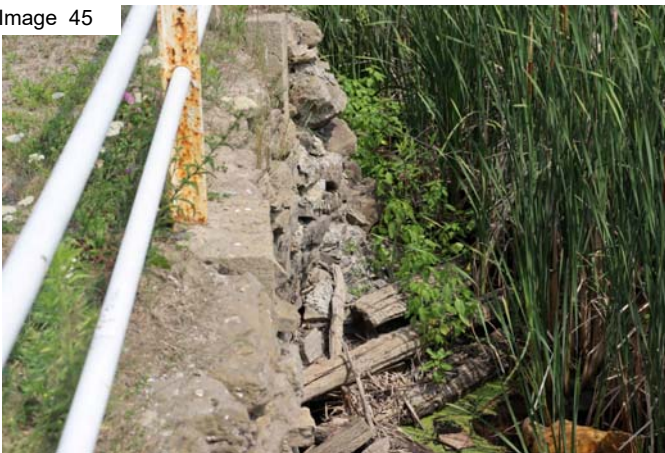
Image 45

Maintenance Slope revetment	
	Capital Rec. Repair in 1 year	Perf Def: Unstable
	<i>There is significant flow penetrating through the causeway on the south approach. The dry stone walls on the sides of the embankment have bulged on the east side. Frost action has loosened and disintegrated some of the stonework to a depth of 0.3 m. There is a strong possibility of partial collapse of in particular the east side of the causeway. This collapse could occur with little or no warning. Severe bulging of dry stone wall at NE quadrant, and is in serious condition. Water has partly undercut portions of wall on south approach. Sink hole developing in SW corner adjacent retaining wall noted in 2021. This could be due to scour effects.</i>

South retaining wall bulging

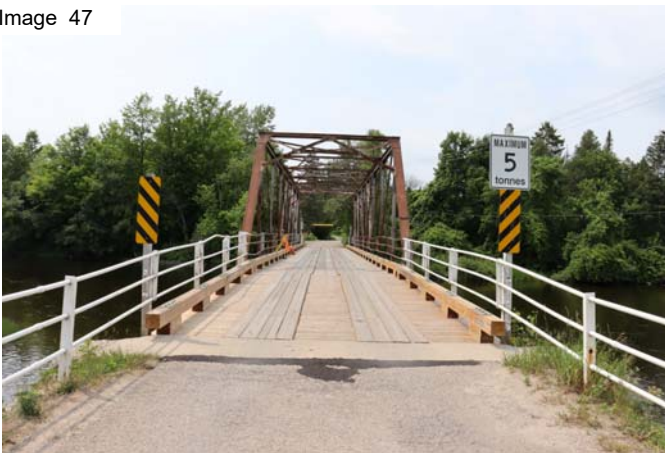
Image 47

East approach

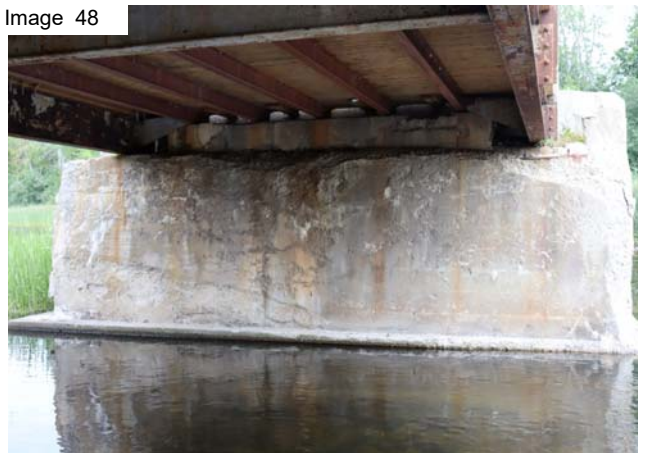
Image 48

East abutment

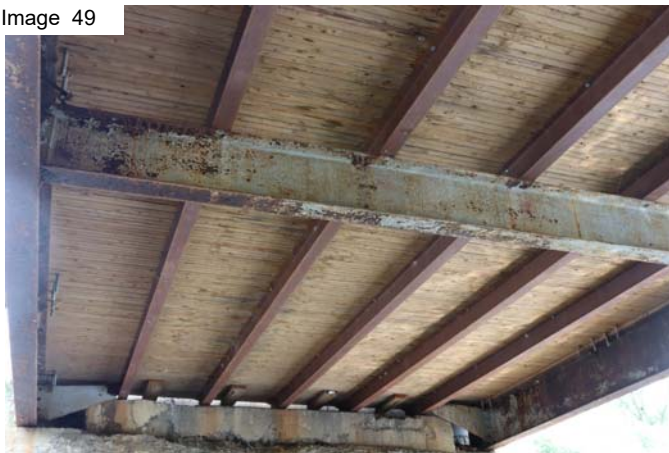
Image 49

East span east soffit

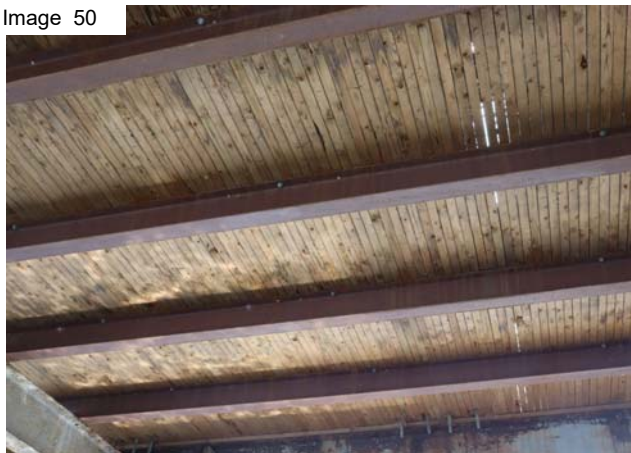
Image 50

East span west soffit

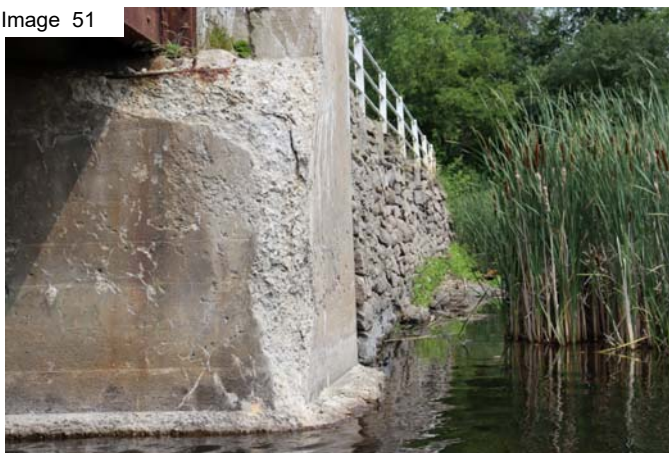
Image 51

East abutment and causeway from south

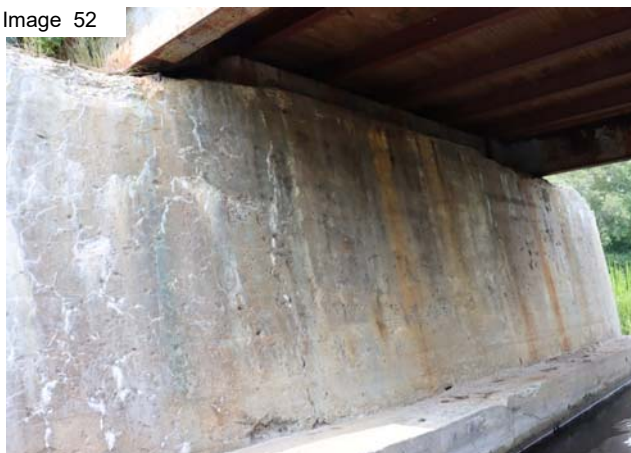
Image 52

Pier east face

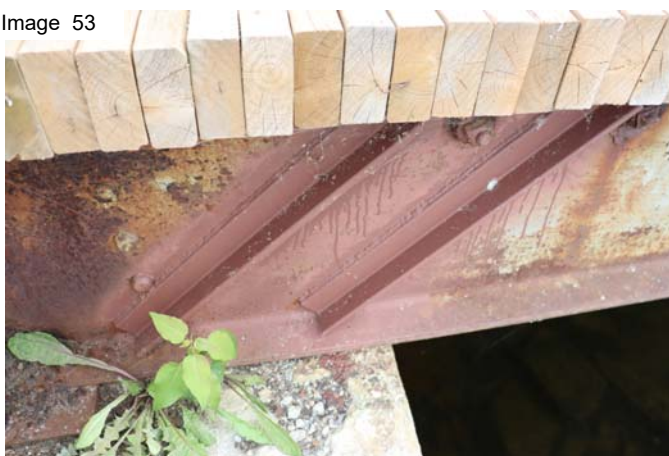
Image 53

NE girder end stiffening

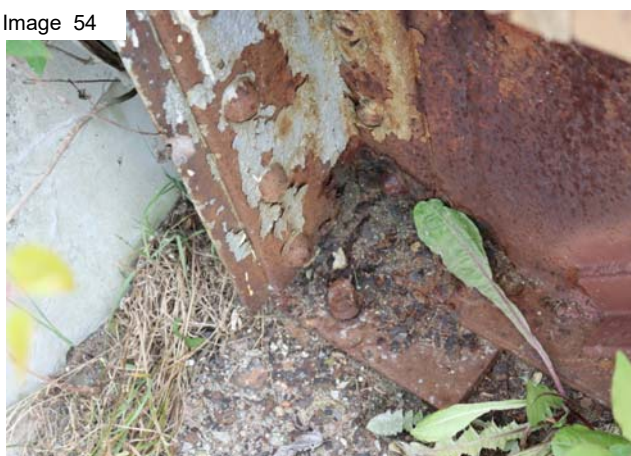
Image 54

Rocker or Roller Bearing (4)		Defects	80.0%	Moderate Corrosion, Checking
Roller bearing		Damage	20.0%	Moderate Seizing
Length:		Maintenance	Power Wash	
Width:		Capital Rec.	Replace in 1 year	Perf Def: Seizing
Height:		<i>Bearings are covered in debris at pier and should be power washed. Nested roller bearings at west abutment are heavily rusted.</i>		
Headwall (3)		Defects	0.0%	
Dry Stone Walls		Damage	20.0%	
Length:	40 m	Maintenance	None	
Width:		Capital Rec.	Repair in 5 years	Perf Def: Bulging
Height:	2.5 m	<i>See embankment comments.</i>

NE bearing

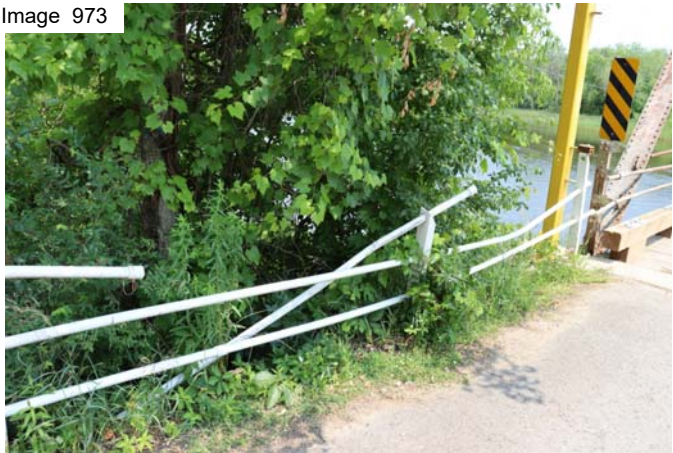
Image 973

NW approach railing

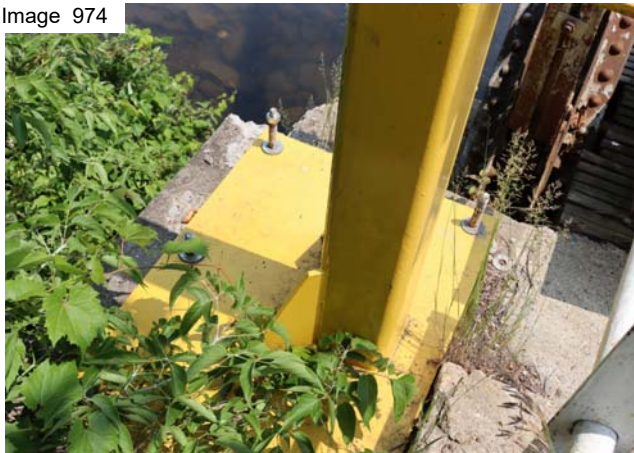
Image 974

NW portal base

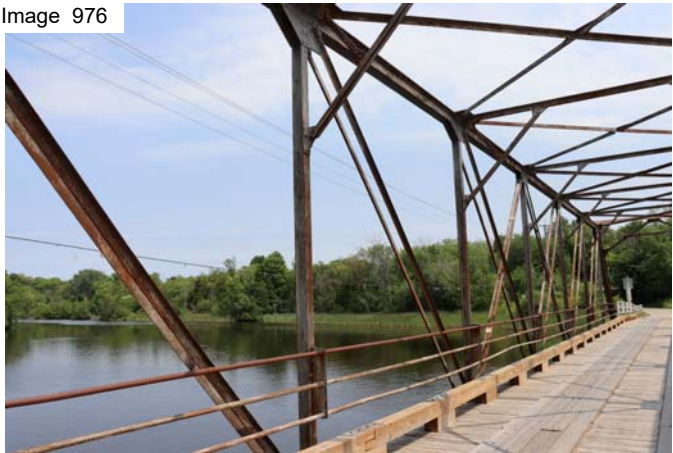
Image 976

North truss

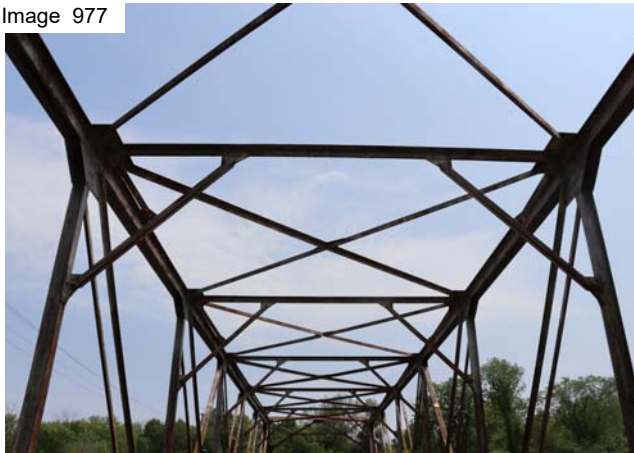
Image 977

Truss bracing

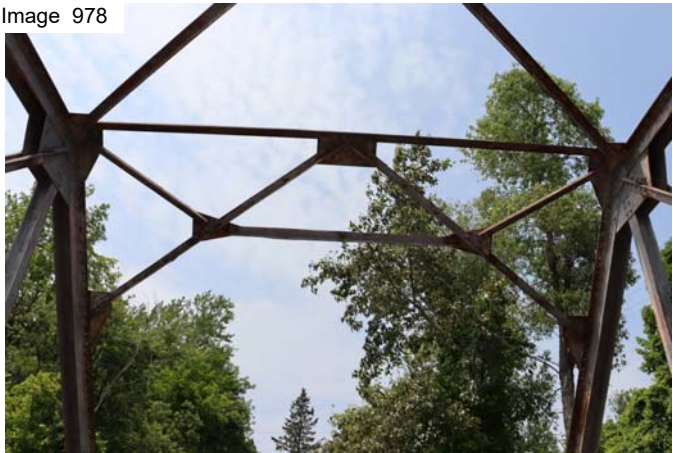
Image 978

Truss portal bracing

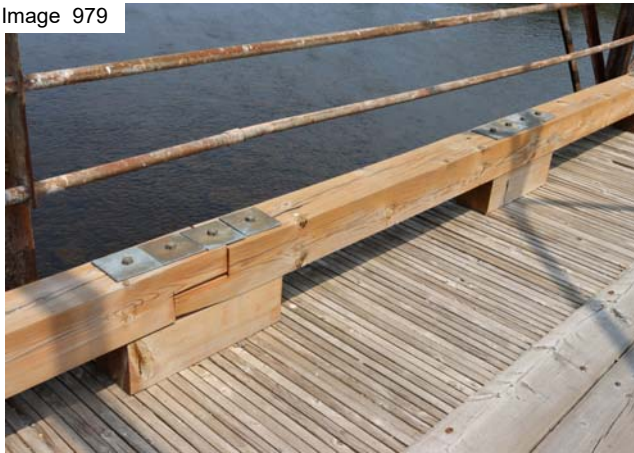
Image 979

New curbs (typical)

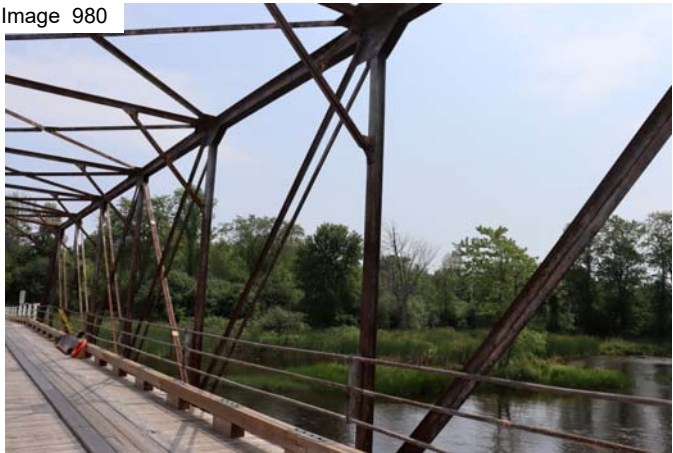
South truss

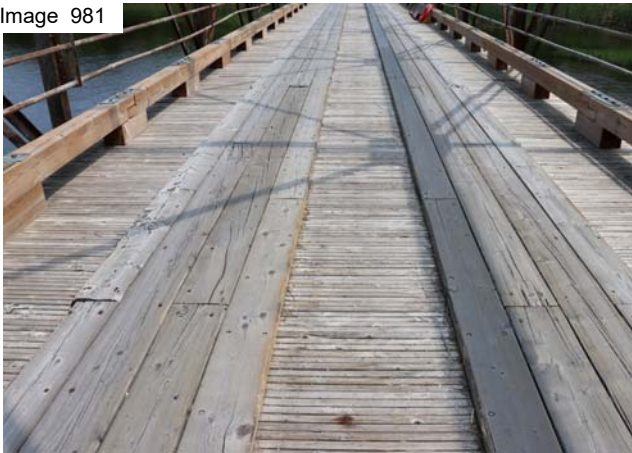
Deck surface on truss looking west

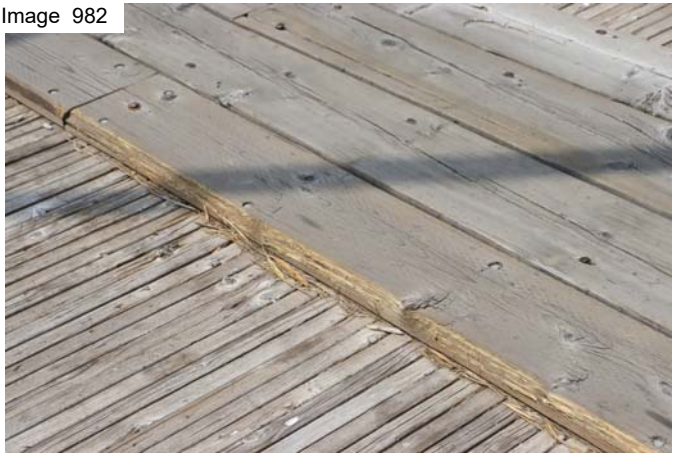
Running boards damage

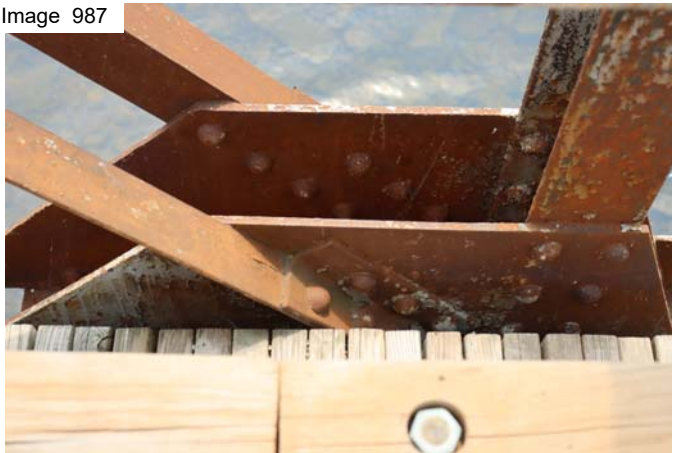
Typical bottom chord connection

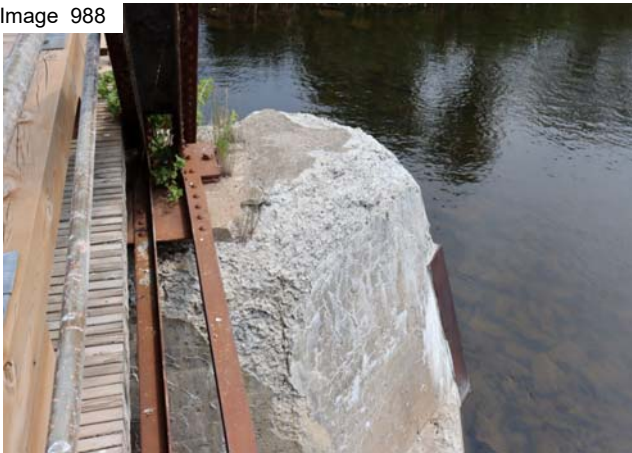
Pier top south side from west

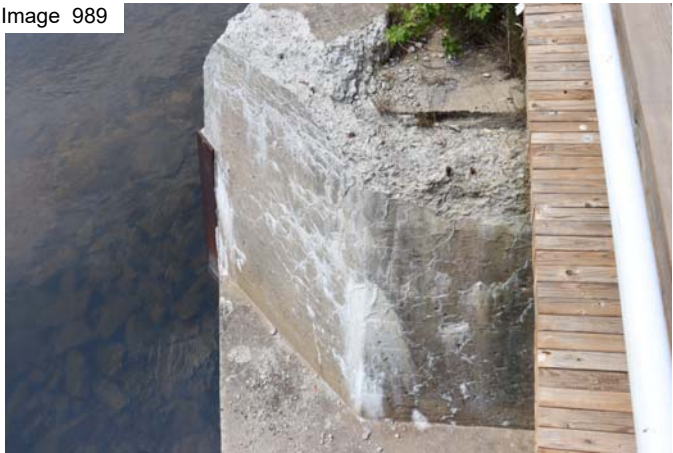
Pier top south side from east

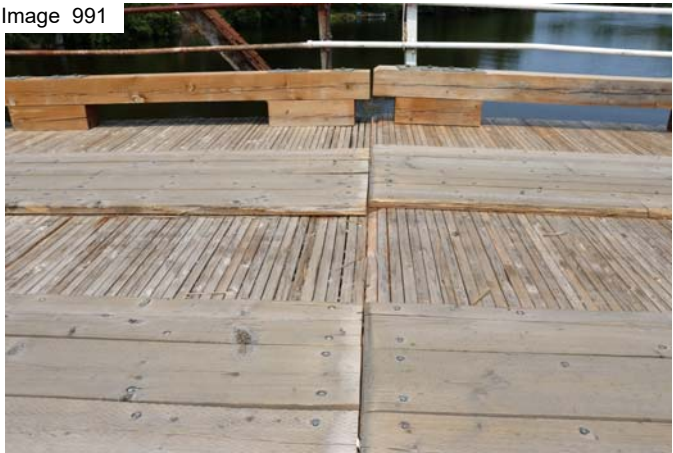
Grade change and grade separation over pier

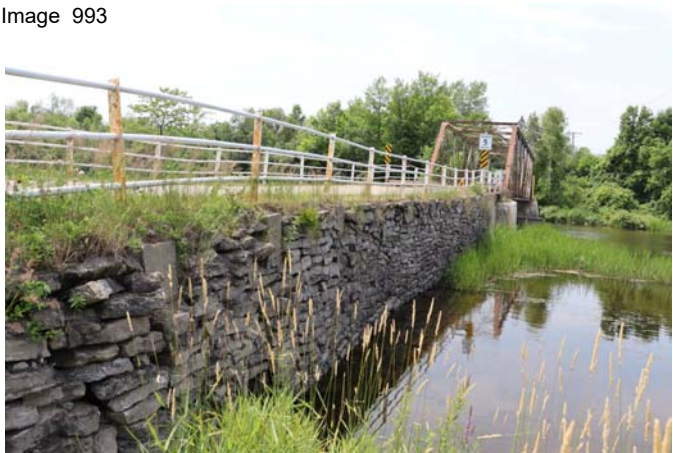
North retaining wall

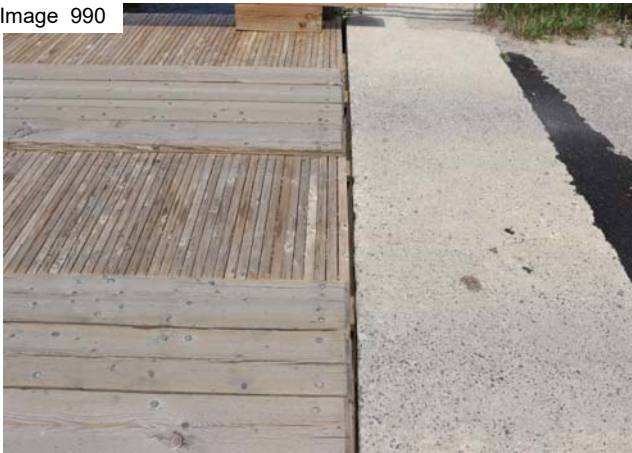
East deck end with gap

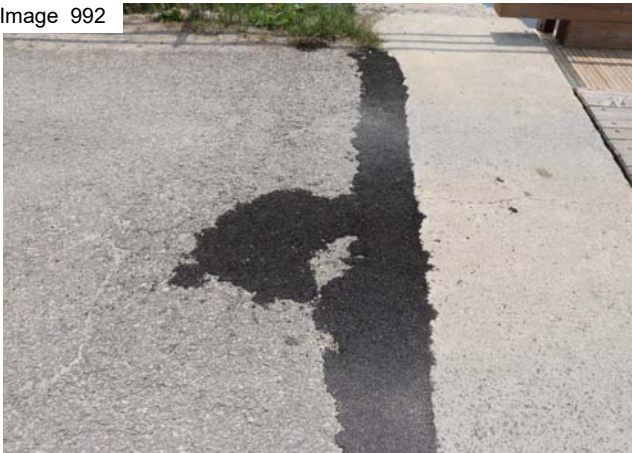
Patching at east end

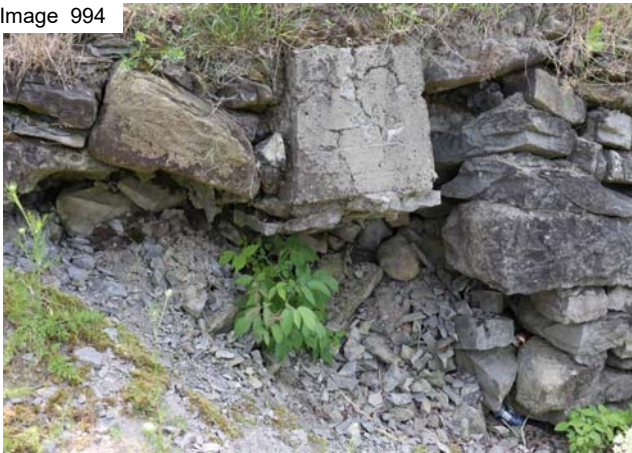
Railing bottom undercutting in north retaining wall

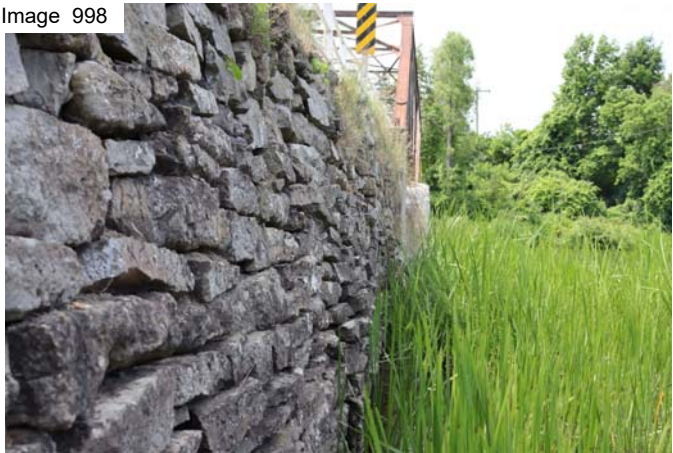
North retaining wall bulging

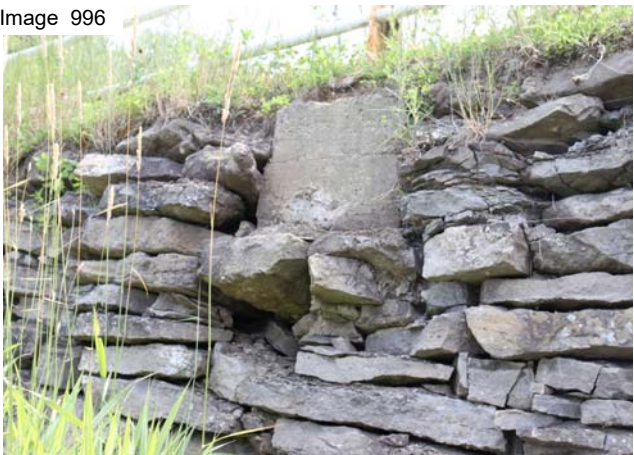
North retaining wall

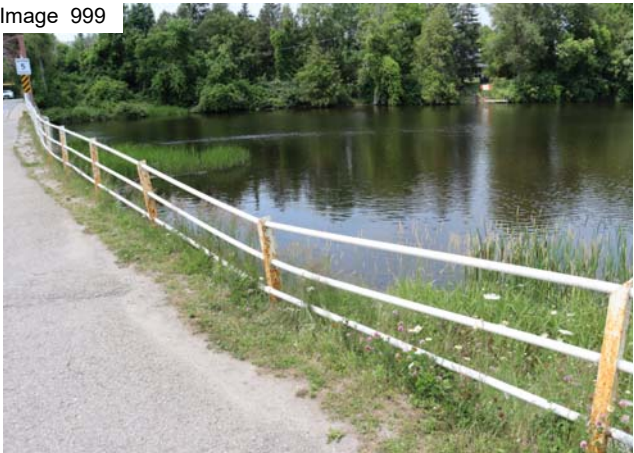
Railing over north retaining wall
